**GEOTECHNICAL ENGINEERING
AND
GEOLOGIC HAZARDS STUDY**

**Parking Garage and Roadway Widening Project
1650 Los Gamos Drive
San Rafael, California 94903
Kaiser Project # 839-951-01**

**GEOSPHERE CONSULTANTS, INC.
2001 Crow Canyon Road, Suite # 210
San Ramon, California 94583
GEO Project No. 91-03695-A**

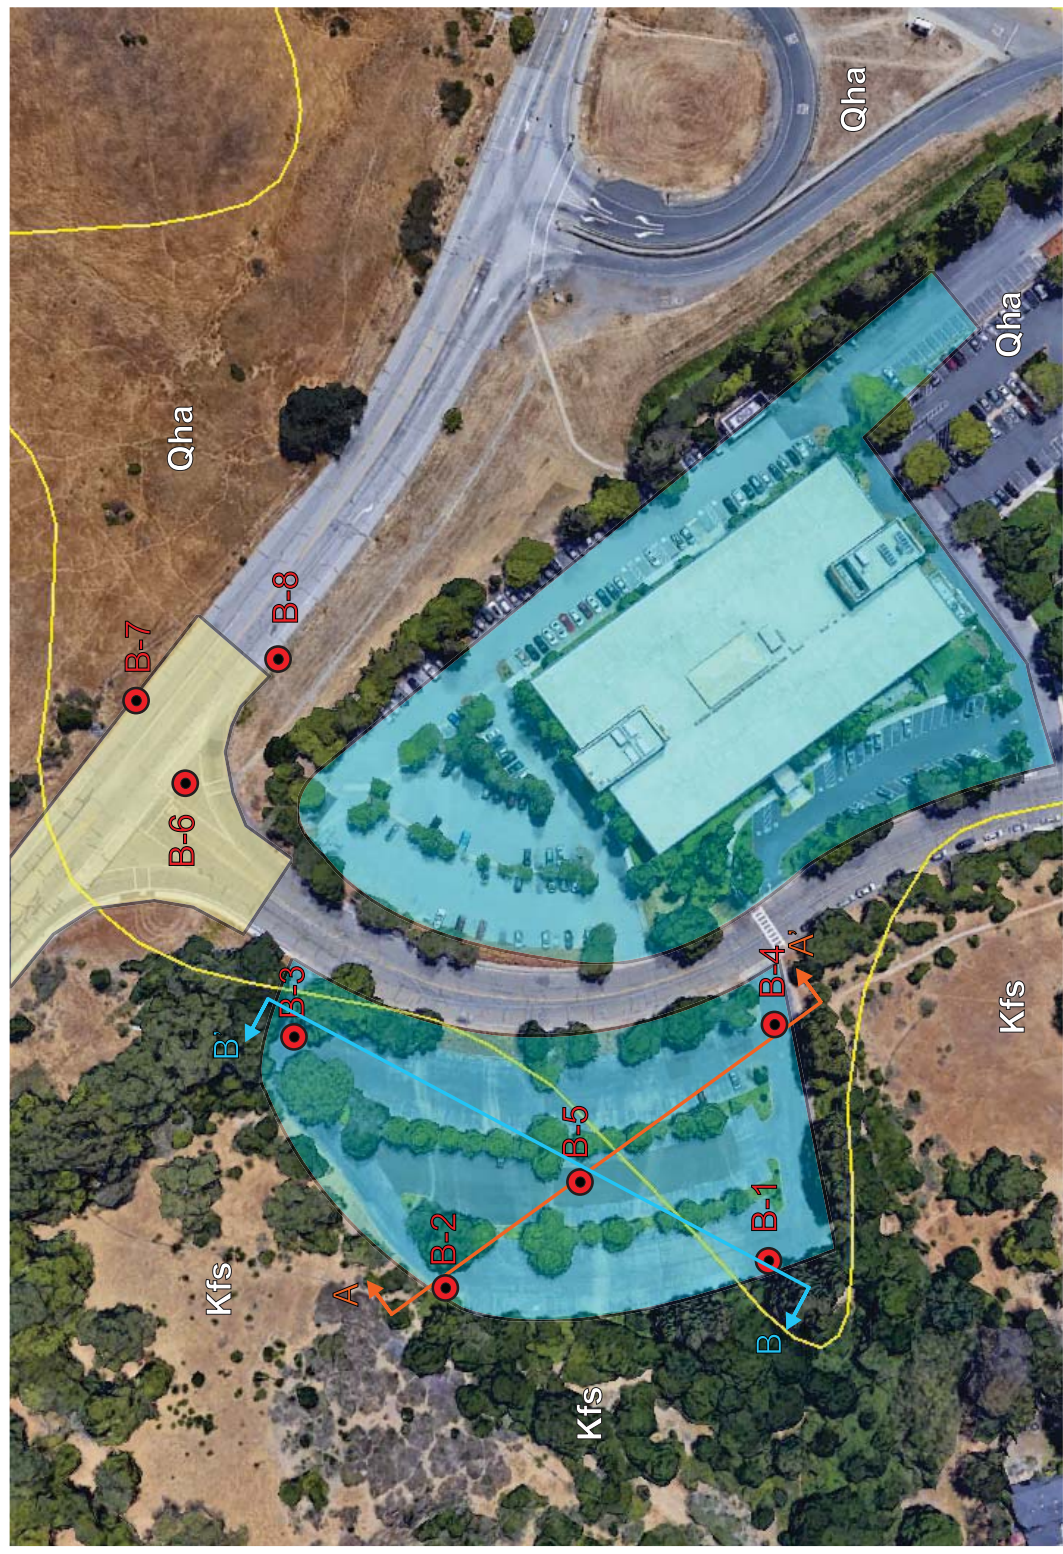
Kaiser San Rafael: MOB & Parking Garage 1650 Los Gamos Drive San Rafael, California		Base Map Reference: Google Earth	
Geophysical Consultants, Inc. A S I S COMPANY Environmental Geologists & Seismic Risk Engineers		91-03695-A	February 2017
		Site Plan and Site Geology Map	Figure 2

■ - Proposed Mitigation Measure

↔ - Geologic Cross-Section

In order to characterize the subsurface conditions beneath the proposed improvement areas, two separate field exploration programs were conducted which consisted of the drilling of five borings within or near the proposed building footprint area and three borings in the proposed street widening areas as indicated by the Project Civil Engineer on July 21, 2016 and August 28, 2016 respectively, by a Staff Engineer under the supervision of a California-Certified Professional Engineer. The borings were sited to satisfy the project requirements and to facilitate development of soil cross section profiles across the area of the subject project. The locations of the borings relative to the proposed improvements are shown on Figure 2. The borings were drilled using a MCE-75 drill rig equipped with 4" solid flight augers.

The mapped geologic units at the site are shown on Figure 2 and Figure 3. The site is shown to be underlain partly by Cretaceous-age Franciscan Complex Sedimentary rocks (Kfs) and partly by quaternary Holocene alluvium (Qha) deposits overlying the bedrock at depth.

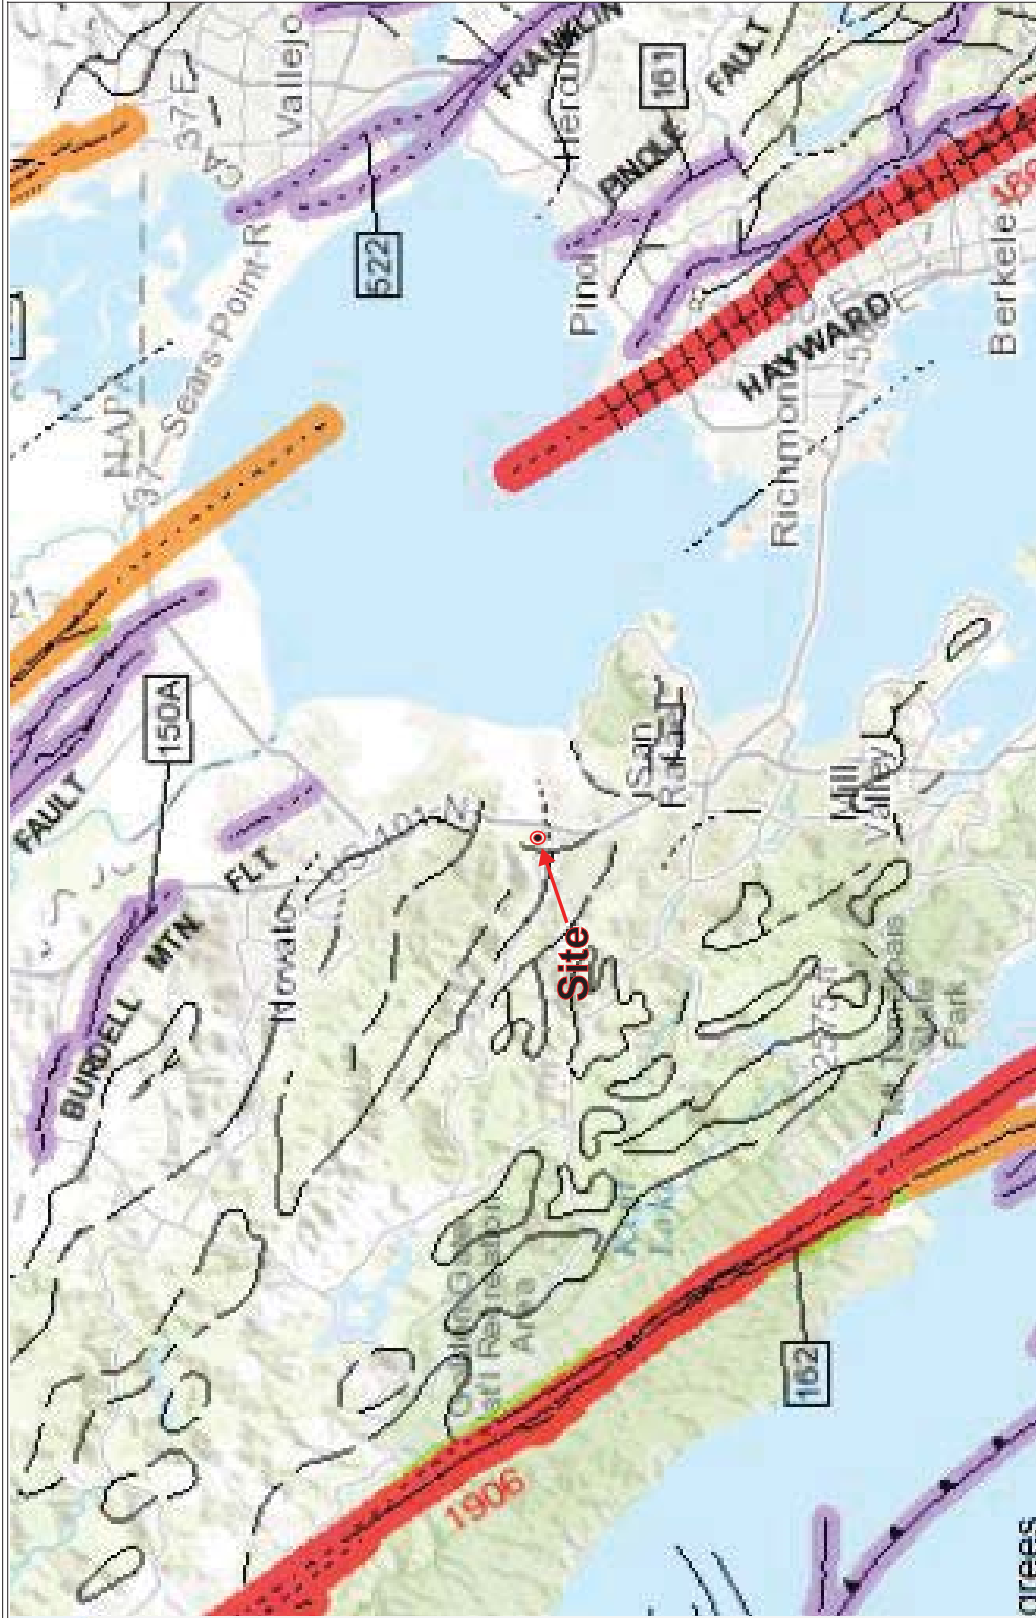
Geoplyware Consultants, Inc. A GIS COMPANY Environmental, Municipal, & Water Solutions	Regional Fault Map	Figure 4

Low angle fault (barts on upper plate).

Base Map Reference: California Geological Survey - 2010 Fault Activity Map of California

The site is not currently within a designated Earthquake Fault Zone as defined by the State (Hart and Bryant, 1997). The closest Earthquake Fault Zone is associated with Hayward Fault, located about 8.5 miles from the site (see Regional Fault Map, Figure 4). Since the site is not within an Earthquake Fault Zone, the potential for fault ground rupture and fault creep hazards are judged to be very low.
