Geotechnical Feasibility Study

December 30, 2022

Project No. 21034-01

Subject: Updated Geotechnical Feasibility Study for Proposed Project at South Coast Plaza
Village, Santa Ana, California

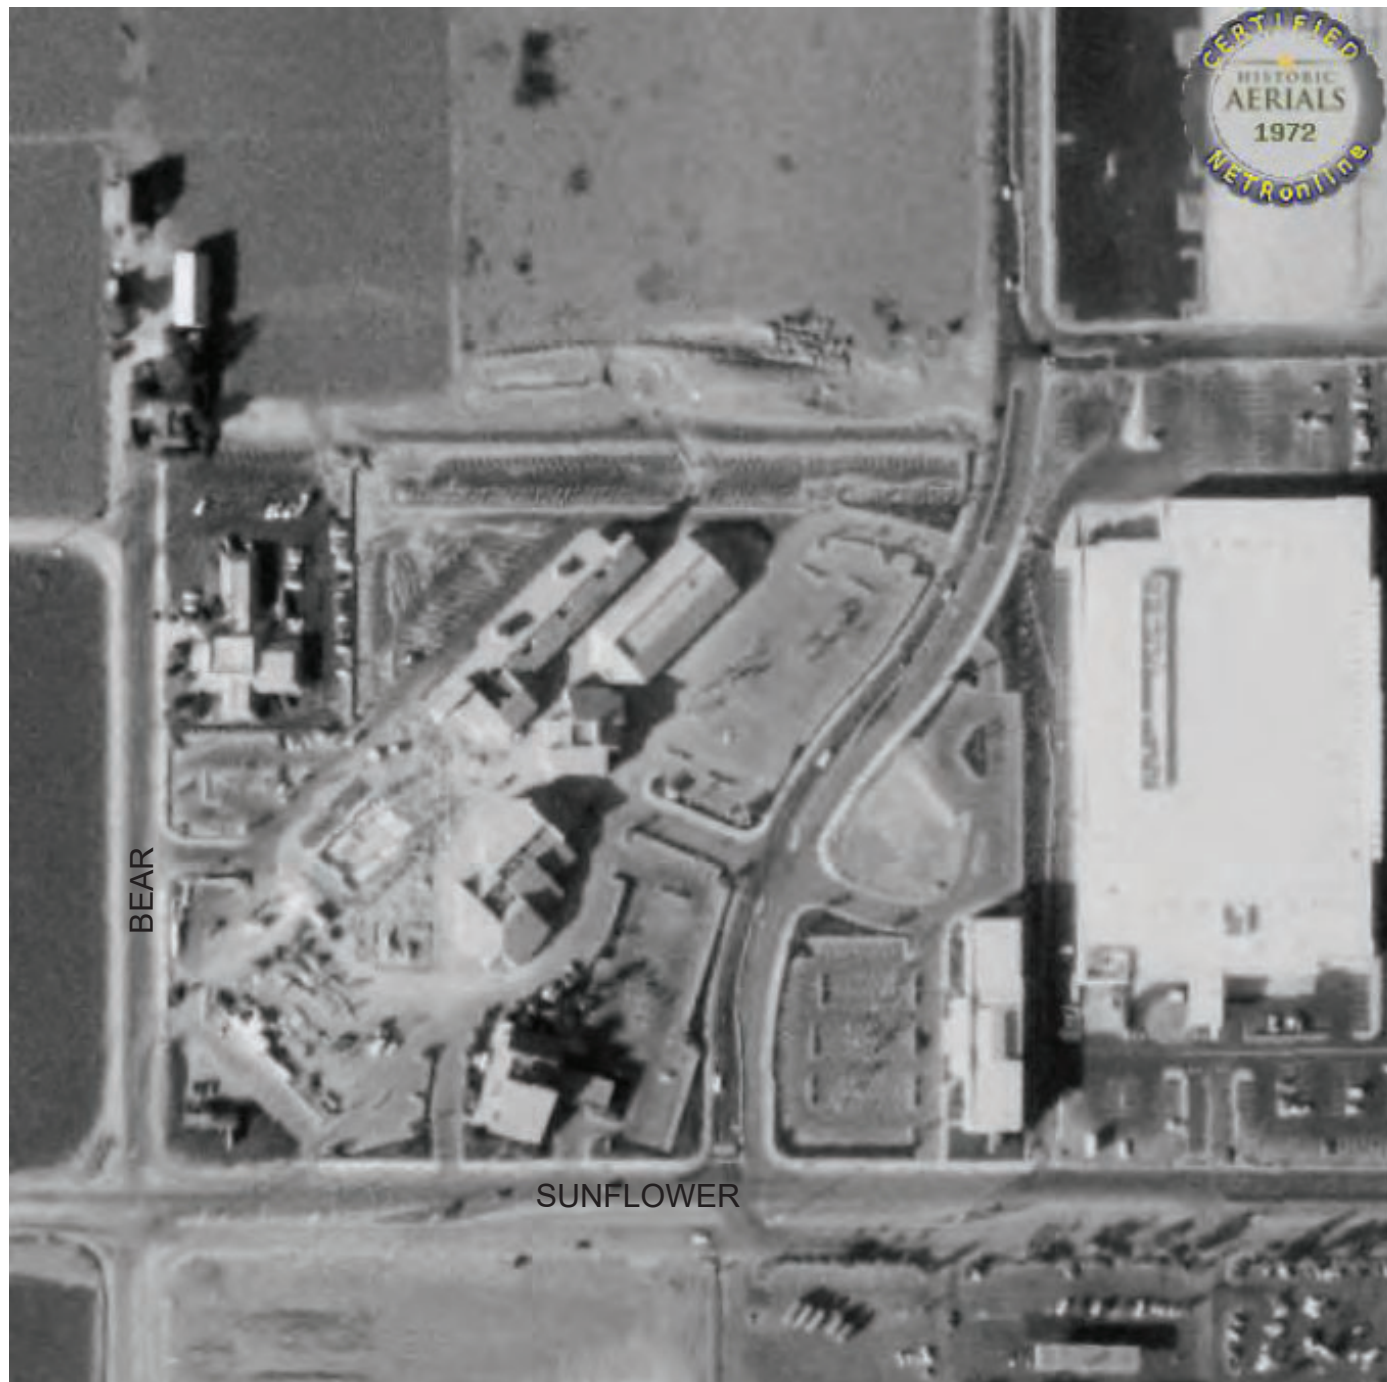
Figure No. 2

1972 HISTORIC AERIAL PHOTO

- The 1965 topographic map shows a building in the northwest corner of the subject property, to the southeast of the previously mentioned house.
- The 1972 aerial photo shows the site was being graded and buildings were being constructed. It appeared that the central and northeast portion of the site had lighter soils, possibly imported sandy soils to raise grades and/or replace unsuitable native soils. (See Figure 2, a historic aerial photograph.) It also shows the larger building in the northwest corner of the site.

- By 1980, buildings for the Village were constructed in a similar configuration as today, except for the empty pad on the east side of South Plaza Drive (Figure 2), north of the theater. The large building in the northwest corner was still in place.

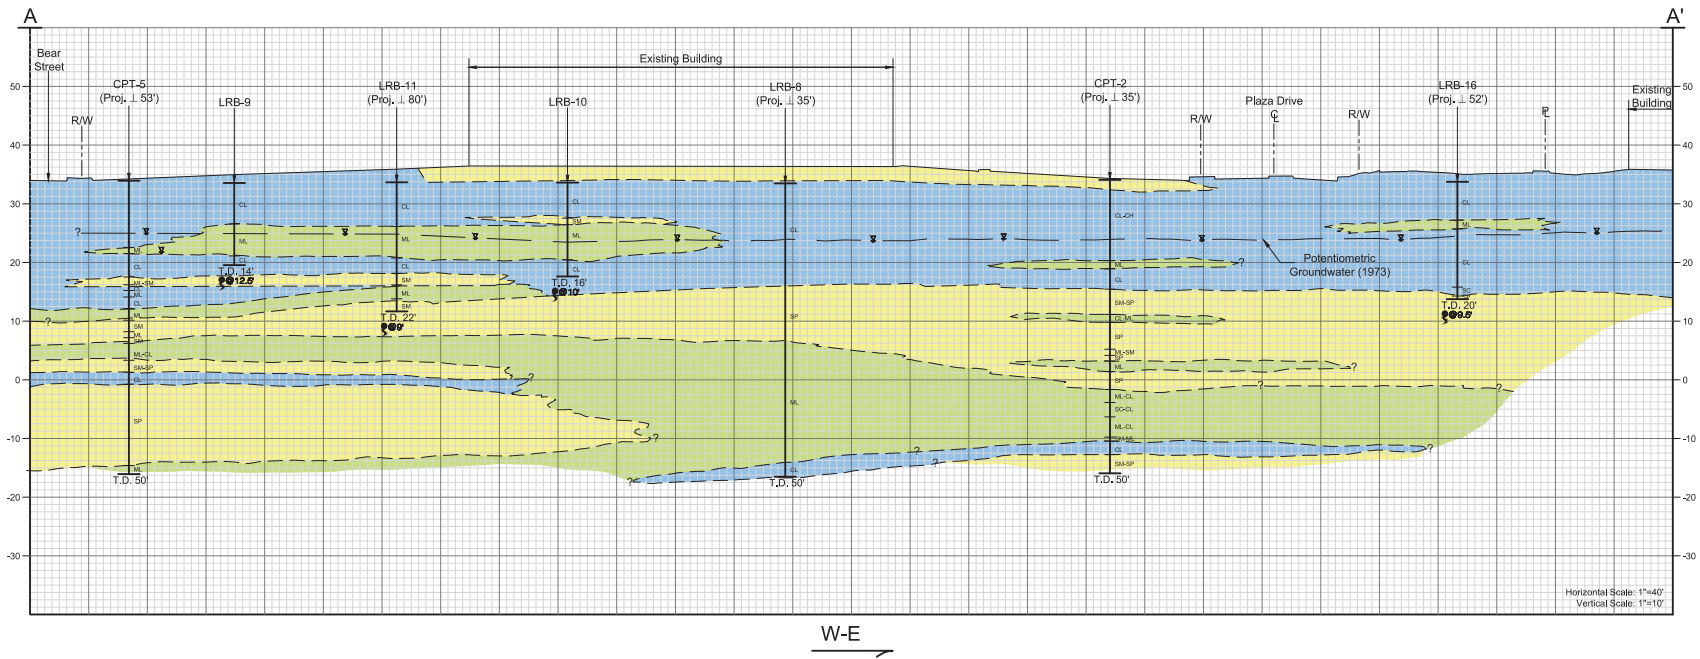
LEGEND

CLAYS (CL, CH)
	SILTS (ML)
	SANDS (SM, SC, SP)

The references reviewed for this study are listed in Appendix A. The approximate CPT locations and historic borings by others are shown on Plate 1, the Boring and CPT Location Map (rear of text). Geologic Cross-Section A-A' is also included at rear of text (Plate 2). CPT and boring logs

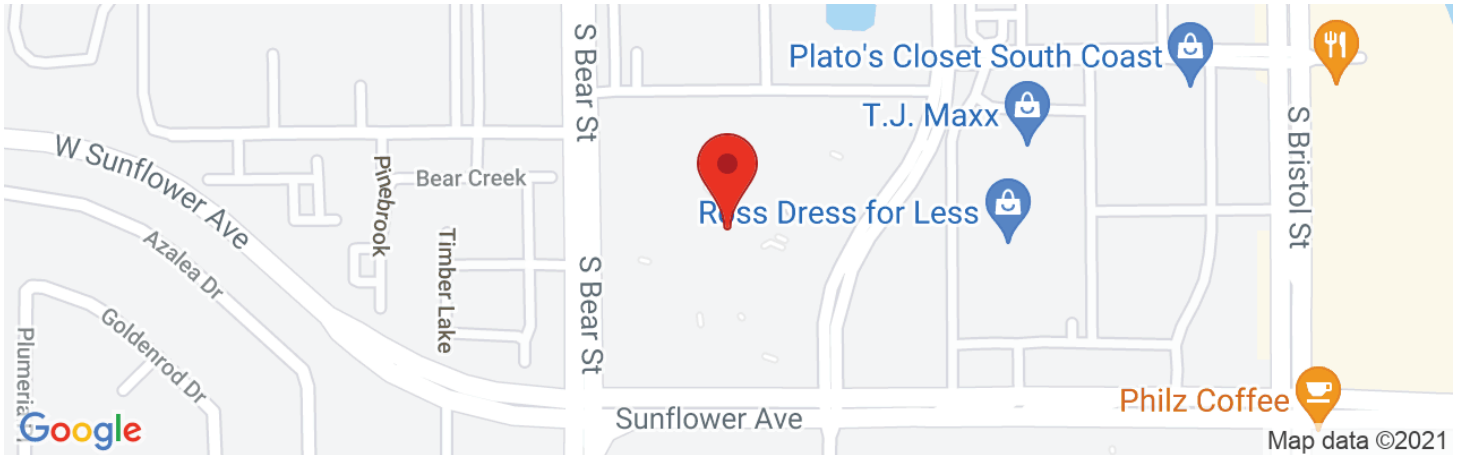
Date	4/21/2021, 2:18:40 PM
Design Code Reference Document	ASCE7-16
Risk Category	III
Site Class	D - Stiff Soil

Type	Value	Description
S_S	1.29	MCE_R ground motion. (for 0.2 second period)
S_1	0.463	MCE_R ground motion. (for 1.0s period)
S_{MS}	1.29	Site-modified spectral acceleration value
S_{M1}	null -See Section 11.4.8	Site-modified spectral acceleration value
S_{DS}	0.86	Numeric seismic design value at 0.2 second SA
S_{D1}	null -See Section 11.4.8	Numeric seismic design value at 1.0 second SA
