Storm Water Detention/Retention Structures – Annual Inspection Form

Basin/Property Owner: Baldwin Wallace College

Basin/Property Address: 325 Front St., Berea, Ohio 44017 (Adelbert St. Parking Lot)

I. Baldwin Wallace University: Adalbert Street Parking Lot

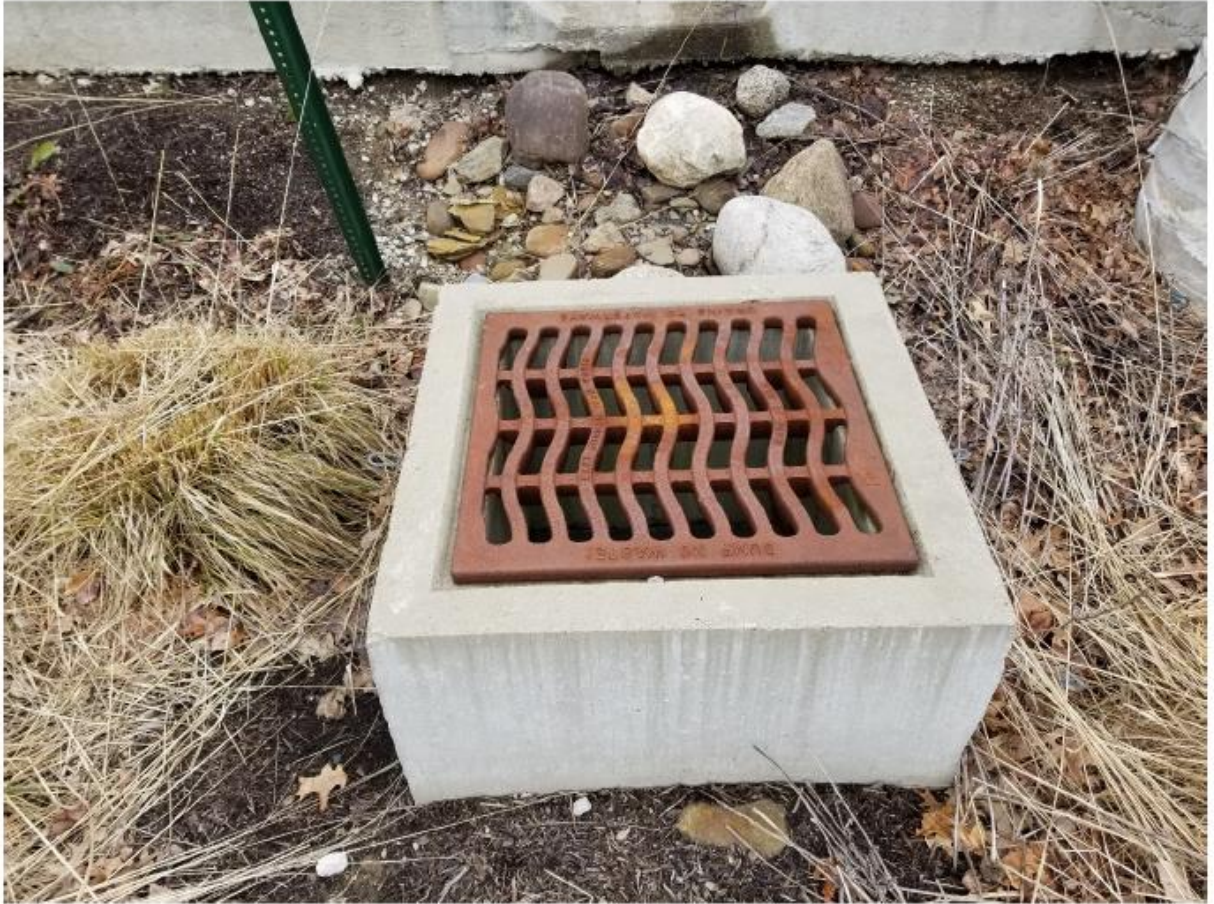
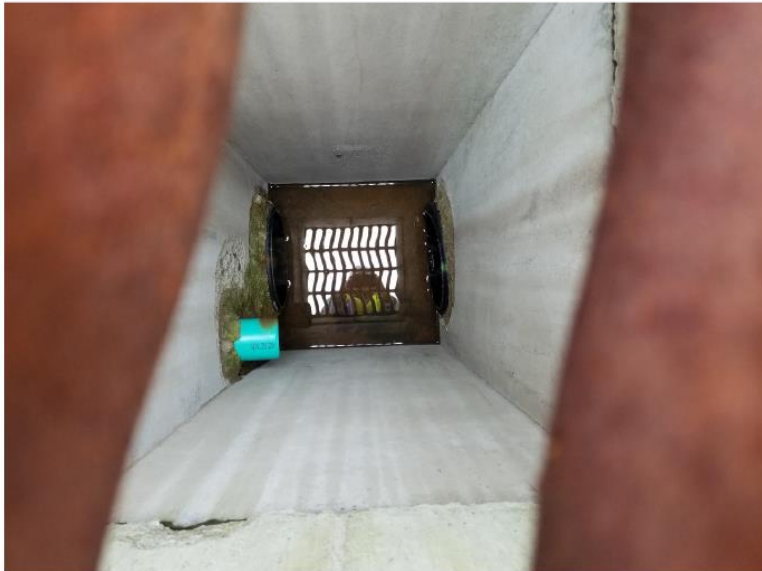
Bonds Administration Parking Lot

Newly Completed Bioswale Project (Completed 2017)
