HAVERFORD COLLEGE

Stormwater Master Plan Volume One January 17, 2020

STORMWATER MASTER PLAN

VOLUME ONE

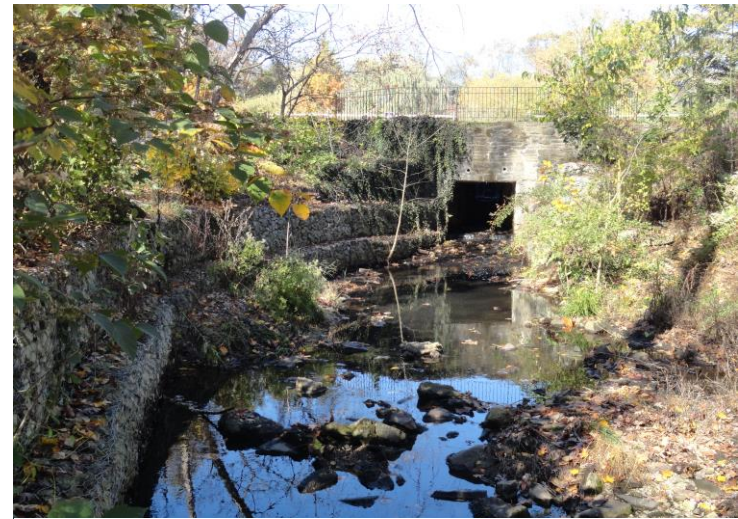
College Lane Culvert and Streambank Protection

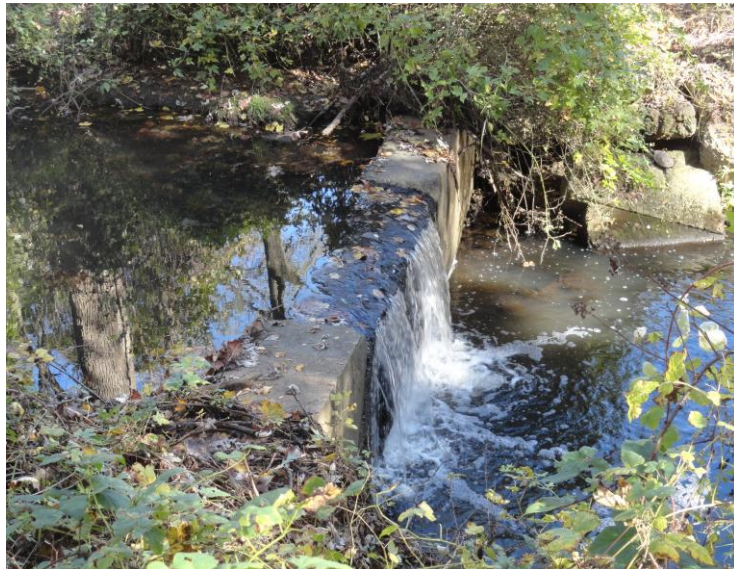
Concrete Weir in Stream Near Nature Trail

This low-head dam is an example of how human activities can fragment stream reaches, decrease natural resiliency, contribute to stream bank erosion, and impact the ability for fish and macroinvertebrates to reach spawning sites.

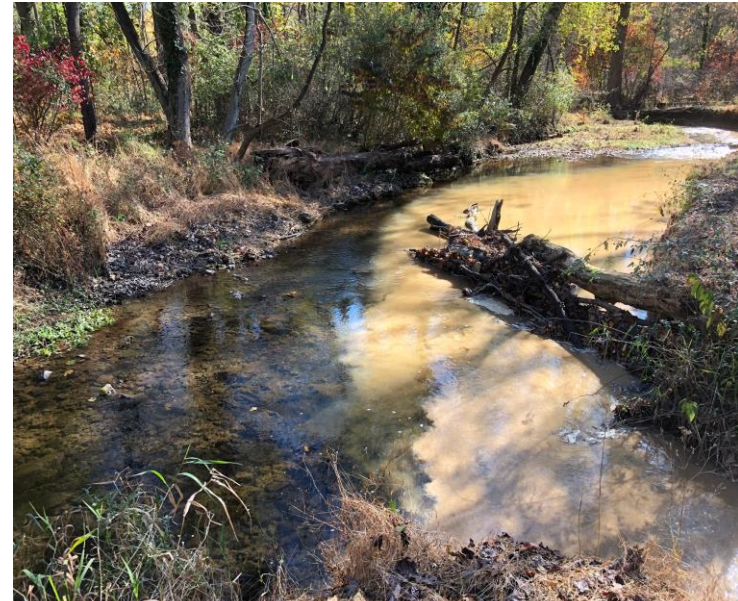
Example of sediment-laden discharge to stream

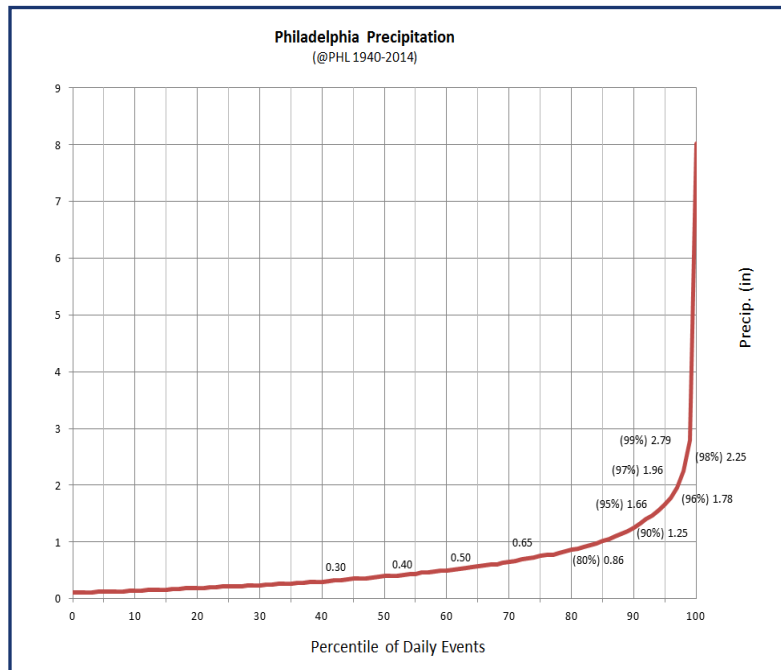
In relation to the percentile storm events referenced in the SITES credits, the 95th percentile storm event is the rainfall depth where 95 percent of all rainfalls (in a selected historical rainfall data set) are equal to or less than that depth. In order to determine the rainfall depth of the 95th percentile event, historical rainfall data must be analyzed so that the mutual relationships of all rain events of varying sizes can be understood (snow events and rainfalls less than 0.1 inches are excluded from the analysis). Haverford College is located in fairly close proximity to the Philadelphia airport, so historical rainfall data at the airport for a period of more than 70 years was analyzed. The statistical analysis finds that 95 percent of the historical storms at the

Philadelphia airport in the data set are less than 1.66 inches. Therefore, the 95th percentile storm event for Haverford College is defined as 1.66 inches of rainfall.

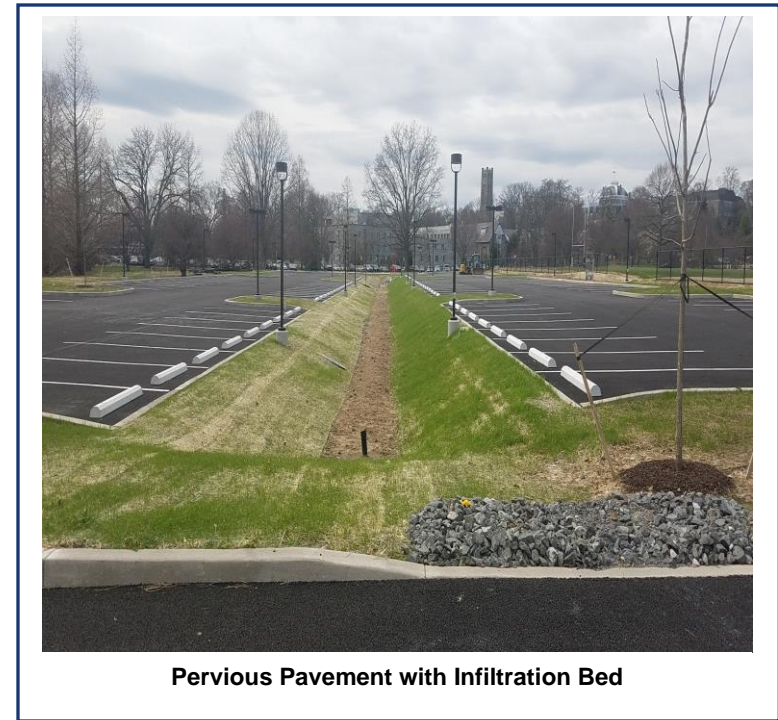
Pervious Pavement with Infiltration Bed – Sub-watersheds that have relatively large expanses of paved surfaces with slopes less than 4% that receive minimal heavy vehicle traffic are good candidates for this practice. Pervious pavement consists of a permeable surface course underlain by a uniformly-graded stone bed which provides temporary storage for peak rate control and infiltration. The surface course can consist of pervious asphalt, pervious concrete, or pervious structural pavers laid on a bed of crushed stone aggregated placed on uncompacted soil. The graded bottom of the infiltration bed should be level to maximize the storage volume for a given pavement area. Pervious pavement can provide excellent water quality improvement by trapping and filtering sediment and grit out of stormwater; it is critical to perform regular maintenance of the pervious pavement surface so that it does not become clogged by these materials. The flat infiltration bed area beneath the pavement and crushed stone volume may be terraced to accommodate locations where the combination of pavement area size and ground slope would result in large depths at the upgrade end of the bed.

Case Study: Pervious asphalt pavement was employed at a long term student parking lot at a private college in central Delaware County, PA. The entire student parking lot was paved with impervious pavement, which slopes inwards to a central bioretention basin. The impervious pavement has been operational since 2016 and no reports of issues have been received.

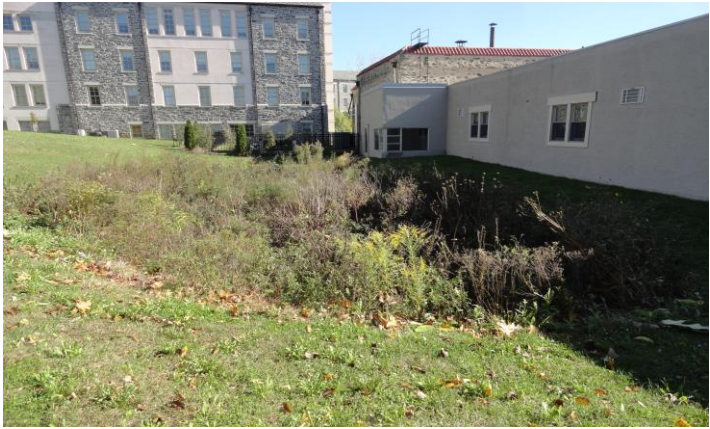
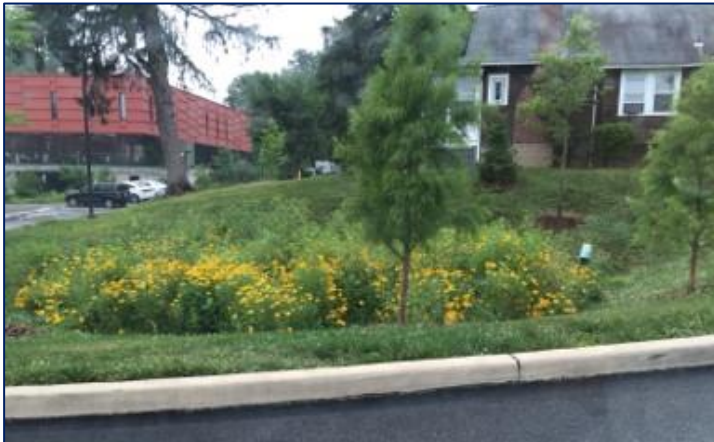
Bioretention – A method of treating stormwater in relatively small sub-watersheds by pooling water on the surface and encouraging filtering and settling of suspended soils and sediment at the soil / water interface. Bioretention techniques are used to accomplish water quality improvement and water quality reduction.

Case Study: While bioretention basins are employed frequently throughout the Philadelphia region, two specific bioretention basins are described below due to the similarity between their locations and the Haverford College campus. The bioretention basins in question are located at a private college in central Delaware County, PA, and became operational in 2014 and 2016, respectively. The first is the bioretention basin at the center of the student parking lot described in the “Pervious Pavement” section above. The

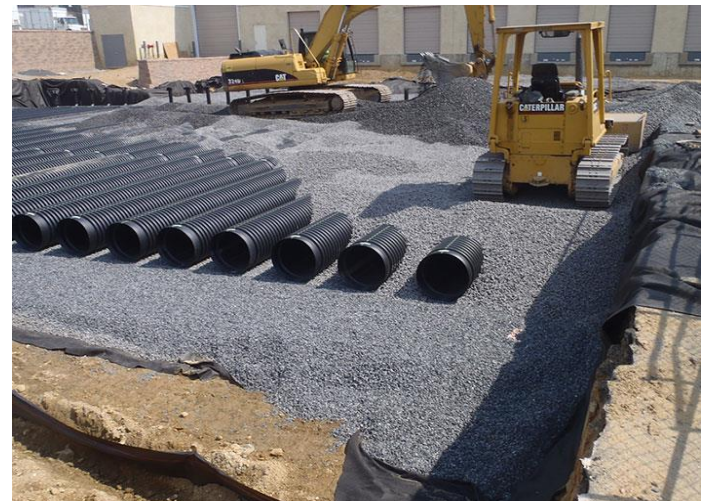
Subsurface Infiltration Bed – Generally consists of a perforated pipe system encased in a stone envelope buried beneath a landscape or paved surface. Subsurface infiltration features can stand alone as significant stormwater runoff volume, rate and quality control practices. They have the added benefit of full functionality year-round given that the infiltration surface is typically below the frost line. This BMP is recommended for sub-watersheds where soil conditions are expected to yield usable infiltration rates, and where competing interests make underground location of a BMP desirable so that land area can be used for multiple purposes. Subsurface infiltration beds can be combined with pervious pavement BMPs to reduce the storm sewer infrastructure required to deliver stormwater to the infiltration bed.

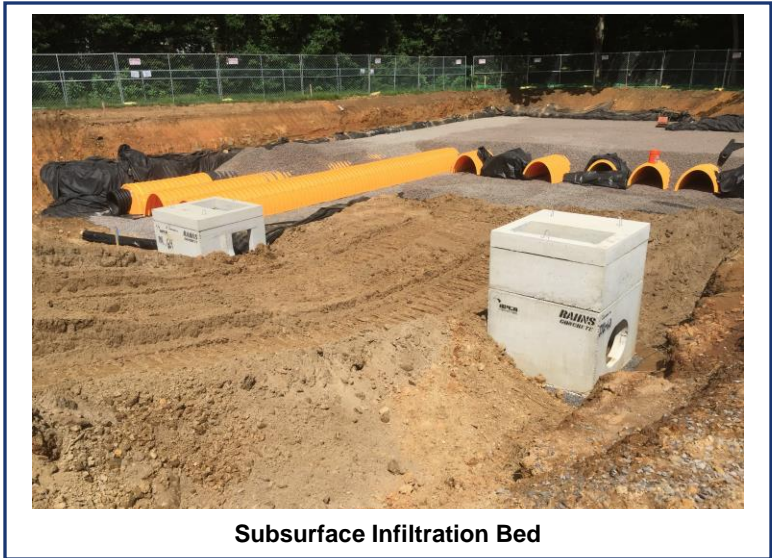
Case Study: While subsurface infiltration beds are employed frequently throughout the Philadelphia region, one specific infiltration bed is described below due to the similarity between its locations and the Haverford College campus. This particular infiltration bed was located in a

creative location upgrade of the majority of the site. Extensive soil testing located high permeability soils at a significant depth, which allowed the surrounding site area and a large portion of the proposed building roof to drain to the infiltration bed. The excellent soil infiltration rates allow for significant runoff volume reduction and groundwater recharge. This case study illustrates the importance of soil testing to locate the best locations to support infiltration.

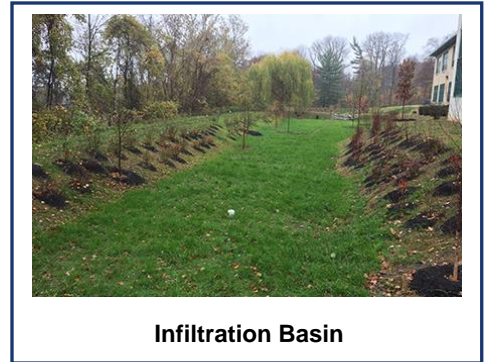
Case Study: Surface infiltration basins were constructed at the Chester County Public Safety Training Facility site in South Coatesville Borough, Chester County, PA. The training facility campus is similar to a college campus, although it has larger extents of impervious coverage which made the use of infiltration basins more appropriate than bioretention basins. The basins have been functioning since 2012 with no reported issues.

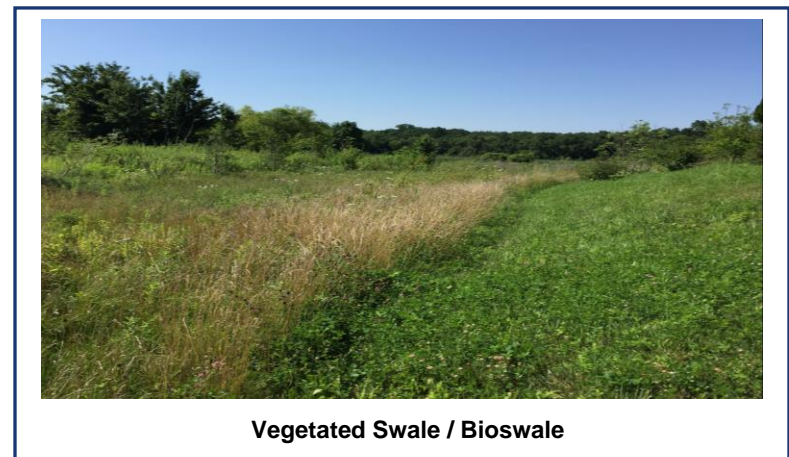
Vegetated Swale / Bioswale – A vegetated open channel that is designed to reduce runoff velocity, provide filtration, and in some cases, infiltrate runoff from adjacent impervious

surfaces. It is typically a broad, shallow, trapezoidal or parabolic channel, densely planted with a variety of trees, shrubs, and/or grasses. They provide an environmentally

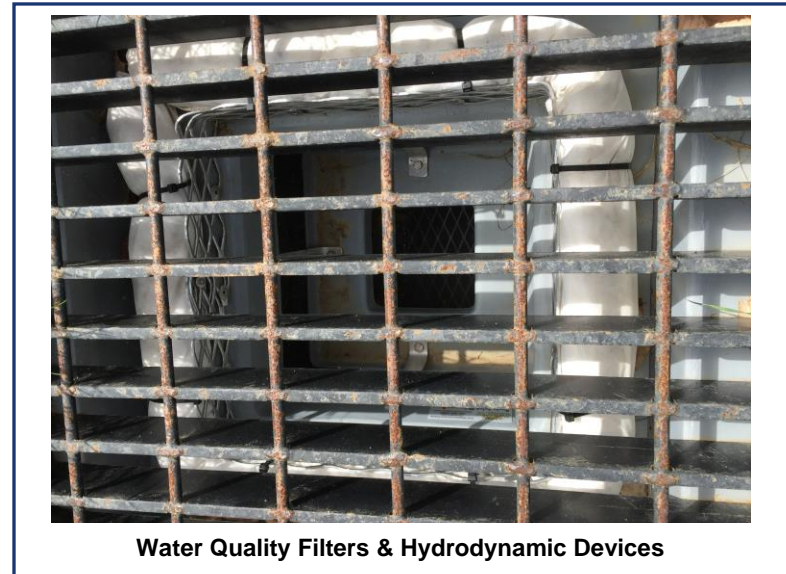
Water Quality Filters & Hydrodynamic Devices – Vary in size and function, but all utilize some form of settling and filtration to remove particulate pollutants from stormwater runoff. Water quality filters, catch basin inserts, and pre-cast vault hydrodynamic devices are commercially available and are recommended for sub-watersheds with existing storm sewer conveyance systems but that do not have adequate space for installation of basin or infiltration bed type BMPs. Water quality inserts can capture a great deal

Case Study: Water quality inserts were utilized at a private college in central Delaware County, PA to manage stormwater quality at drainage inlets located downgrade of the proposed stormwater management BMPs such as infiltration beds and bioretention basins. Due to topographic constraints, it was not feasible to provide water quality management without the use of the inserts.

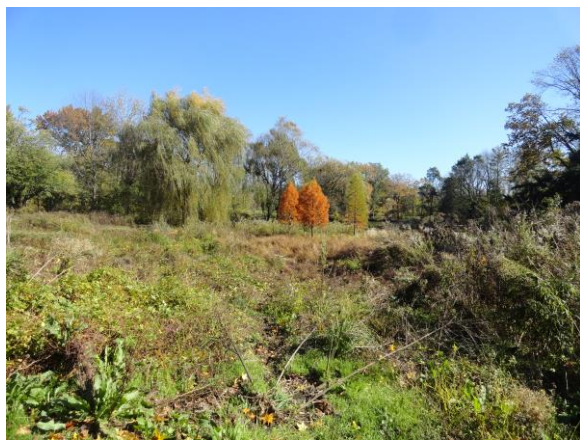
Riparian Buffer Restoration – Provides ecological and water quality benefits adjacent to streams, ponds and wetlands. Restoration of this ecological habitat is a responsive action to past activities that may have eliminated or reduced vegetation. Buffers are characterized by high species density, high species diversity, and high bio-productivity as a transition between aquatic and upland environments.

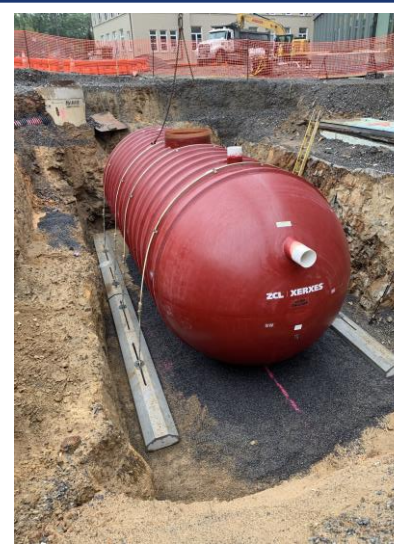
**Runoff Capture and Reuse /
Rainwater Harvesting**

Runoff Capture and Reuse / Rainwater Harvesting – This BMP is recommended for sub-watersheds that are to have buildings or significant building expansions constructed in the future. Rainwater harvesting systems typically collect roof runoff in a watertight underground cistern due to the reduced level of filtration that is required (compared to collecting runoff from the ground surface) and the ease of stormwater collection. Rainwater that is collected in cisterns in this manner is typically used to flush toilets or irrigate landscaping, which contributes to campus sustainability efforts by reducing public water consumption. The reuse of

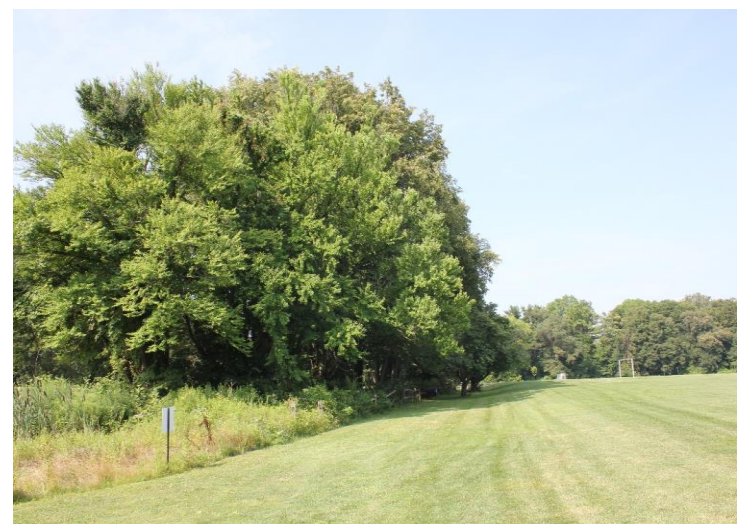
Existing Vegetated Swale Along the Athletic Field

Stormwater flows from the Featherbed and Class of 1995 Fields and adjacent upslope areas to the northeast through existing grass swales or on the road surface into the Haverfarm production plot. Even though the road along the northern side of the production area acts as a berm that holds back and collects water, this wet depression has limited capacity for larger amounts of water. When it reaches capacity, any additional rain overflows into and through the production area, causing both erosion of soil and unwanted saturation with potentially contaminated rain run-off.

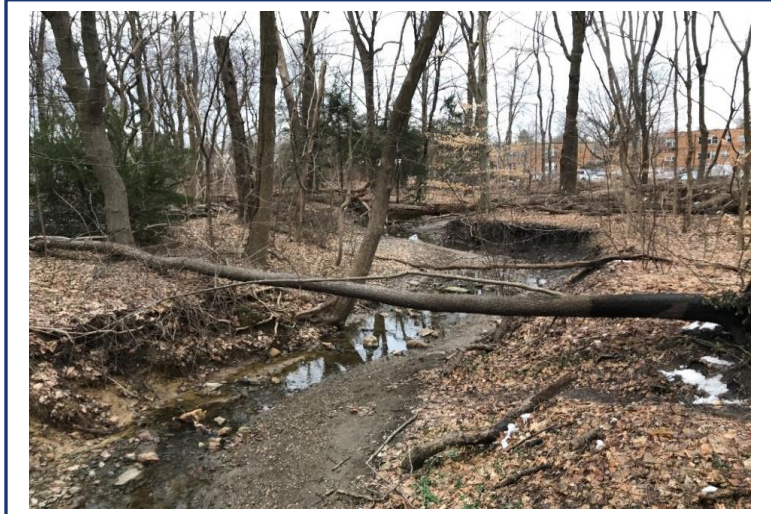
Upper Stream Channel (West of the Walking Bridge)

The stream channel and outfalls adjacent to Woods Road and Kim Hall in the southeast region of campus are severely eroded and contribute sediment to the downstream watershed. Flows from the central campus area reach this eroded channel via 18” and 24” stormwater pipe outfalls as well as localized overland flow. The areas below the pipe outfalls are steep and severely eroded; previous stabilization measures appear to have failed and provide minimal energy dissipation to prevent erosion. The following photograph depicts the stream channel above the walking bridge and the next photograph depicts the stream channel condition below the walking bridge.

The total stream and outfall channel length is approximately 800 feet. Average channel depth is approximately four (4) feet and average width is 15 feet. These channel dimensions are significantly larger than those predicted for a stable channel with a watershed of similar size. This channel can be described as “entrenched”, meaning that the vertical erosion has disconnected the stream channel from its historic floodplain. It can also be described as “over-widened”, meaning that the lateral erosion of the stream banks has resulted in a wide channel section relative to the average amount of flow. Because the stream is unable to access the floodplain during storm events, this entrenched and over-widened channel condition focuses most of the flowing water’s energy on the channel bed and banks. This degraded condition results in significant channel erosion as compared to a stream that can access the adjacent floodplain, which allows a reduction of erosive forces on the primary stream channel.

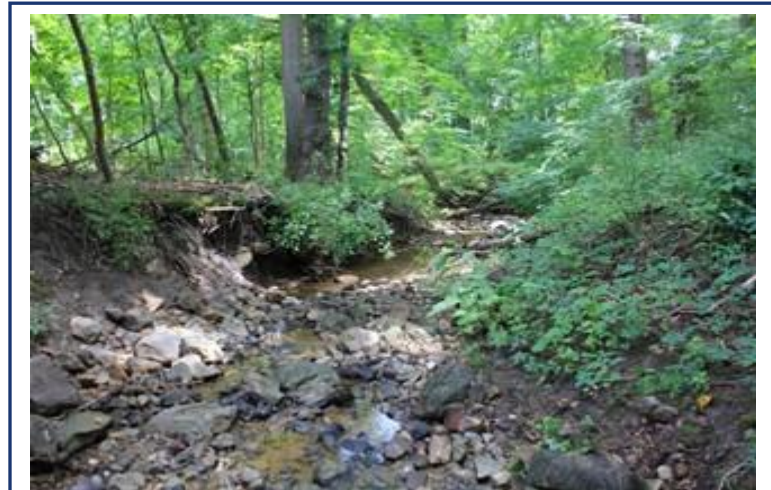
Upper Stream Channel (East of the Walking Bridge)

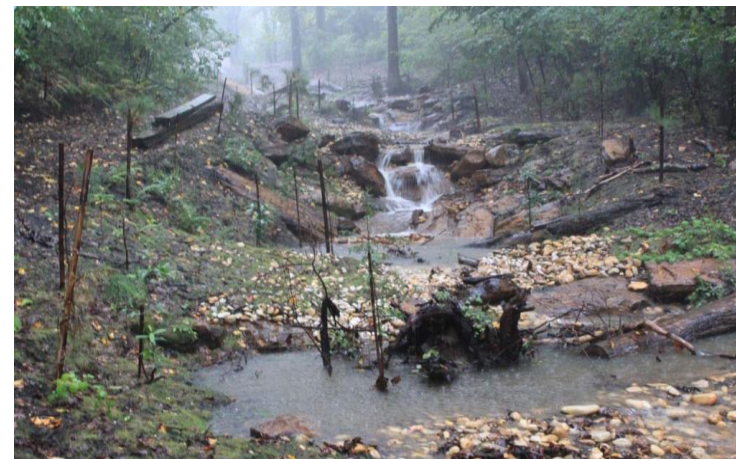
Example of a Completed Outfall and Stream Restoration Project – Photo Credit Biohabitats, Inc.

Stream restoration and outfall stabilization depicted in the next two (2) pictures is recommended to address channel and outfall erosion. The stabilization of the stormwater outfalls and restoration of the stream channel would offer several benefits including:

- Rebuild the outfall protections including installation of rock plunge pool energy dissipaters and raising the downstream channel inverts to reduce the amount of vertical drop at the pipe outfalls.
- Remove and replace the failing gabion basket wall which imbricated boulder wall protection.
- Restore upper reach (between outfalls and walking bridge) of stream channel by raising channel invert with step pool sequence in channel for vertical grade control. Grade banks to reduce slope and replant with native riparian vegetation. Install rock or wood toe protection as required for steeper bank areas.

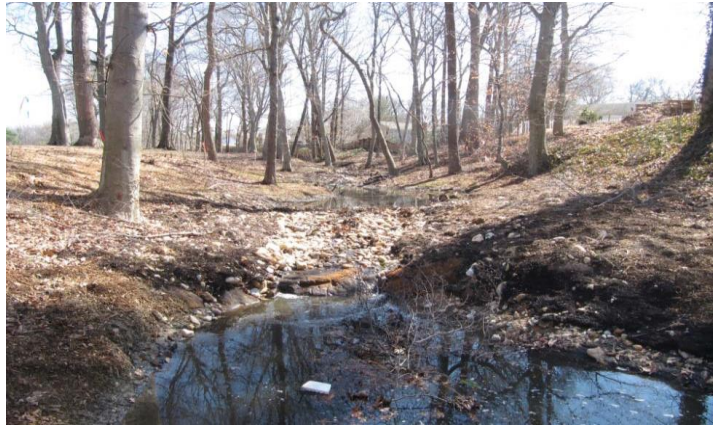
Example of a Completed Outfall and Stream Restoration Project – Photo Credit Biohabitats, Inc.

- Restore lower reach (between walking bridge and culvert entrance) by grading the banks and adding rock or wood bank toe protection. Grade banks to a stable slope and plant with native, riparian vegetation.

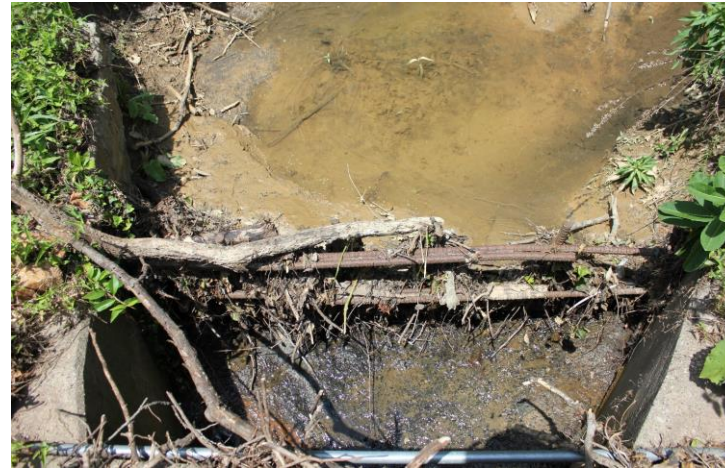
Partially Clogged Trash Screen Upstream of Culvert Entrance

Apartments site. The box culvert has adequate capacity, so only the 30" culvert from the upstream side of the Visitor's Parking Lot to the box culvert needs to be replaced. The existing 30" culvert has a vertical rebar trash screen immediately upstream of the culvert entrance that captures some debris before entering the culvert but also contributes to the clogging and reduction of capacity of the culvert.

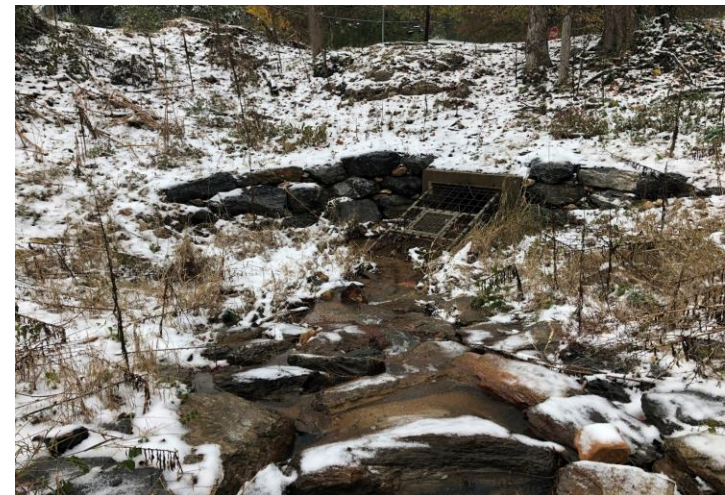
Wedge Shaped Debris Rack Installed Upstream of a Culvert Entrance

Replacing the existing culvert with a higher capacity culvert is the recommended solution to the flooding. Additional recommended enhancements include installing an improved trash/debris rack at the culvert entrance, a second trash/debris rack a few feet upstream of the culvert entrance to create a two-stage debris interception scheme, and grading a larger depositional area at the culvert entrance to reduce the concentration of sediment and debris at the entrance. Regarding the trash rack at the culvert entrance, a rack with more surface area would allow more debris to be captured before significant clogging or reduction in hydraulic capacity occurs. Also, trash racks with a wedge configuration typically maintain improved hydraulic capacity by encouraging settling upstream of the inlet at the front edge of the wedge.
