Estimation of Potential Esplanade Reserve Extent

Mangakootukutuku Stream

Prepared for Hamilton City Council Prepared by Tonkin & Taylor Ltd Date November 2019 Job Number 1011923.v2

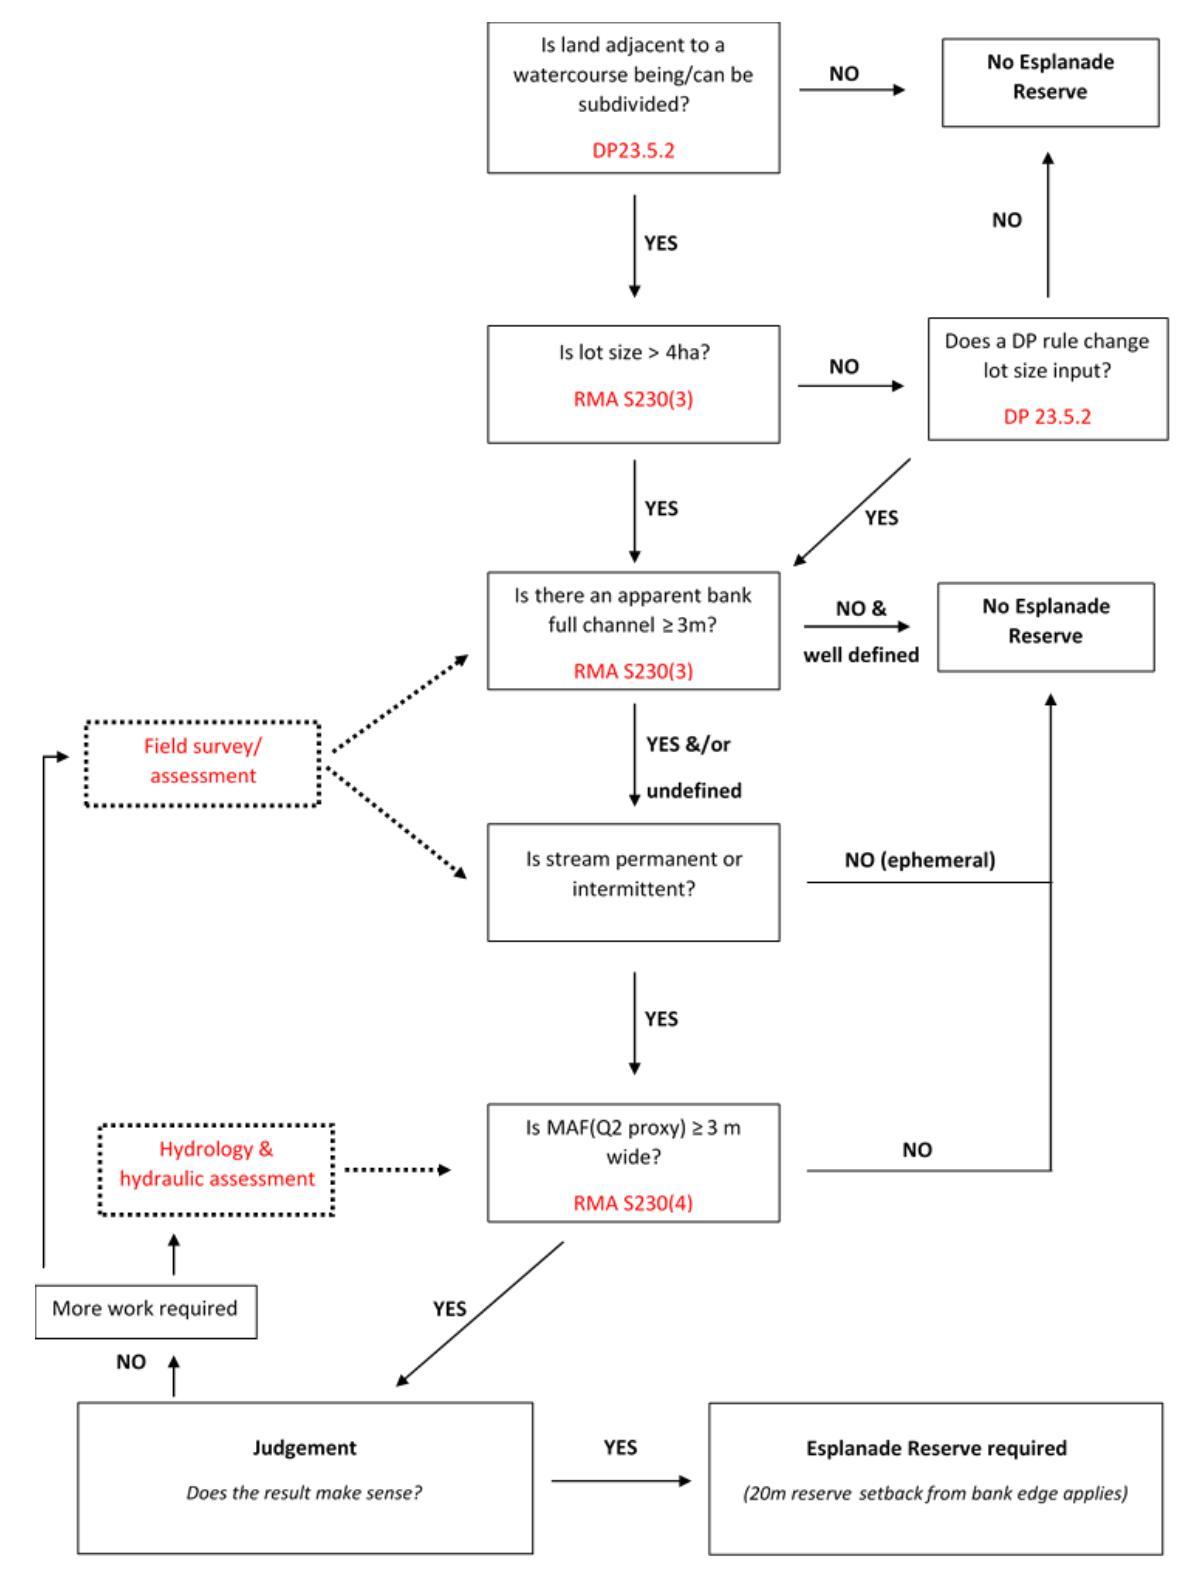
Figure 3.1: Process for identifying where an esplanade reserve would be required.

The process developed to identify the potential longitudinal extent of esplanade reserves is summarised in the flow chart presented in Figure 3.1. The process was developed so that it could be applied to streams in the local Hamilton area and not just the study area of interest in this report.

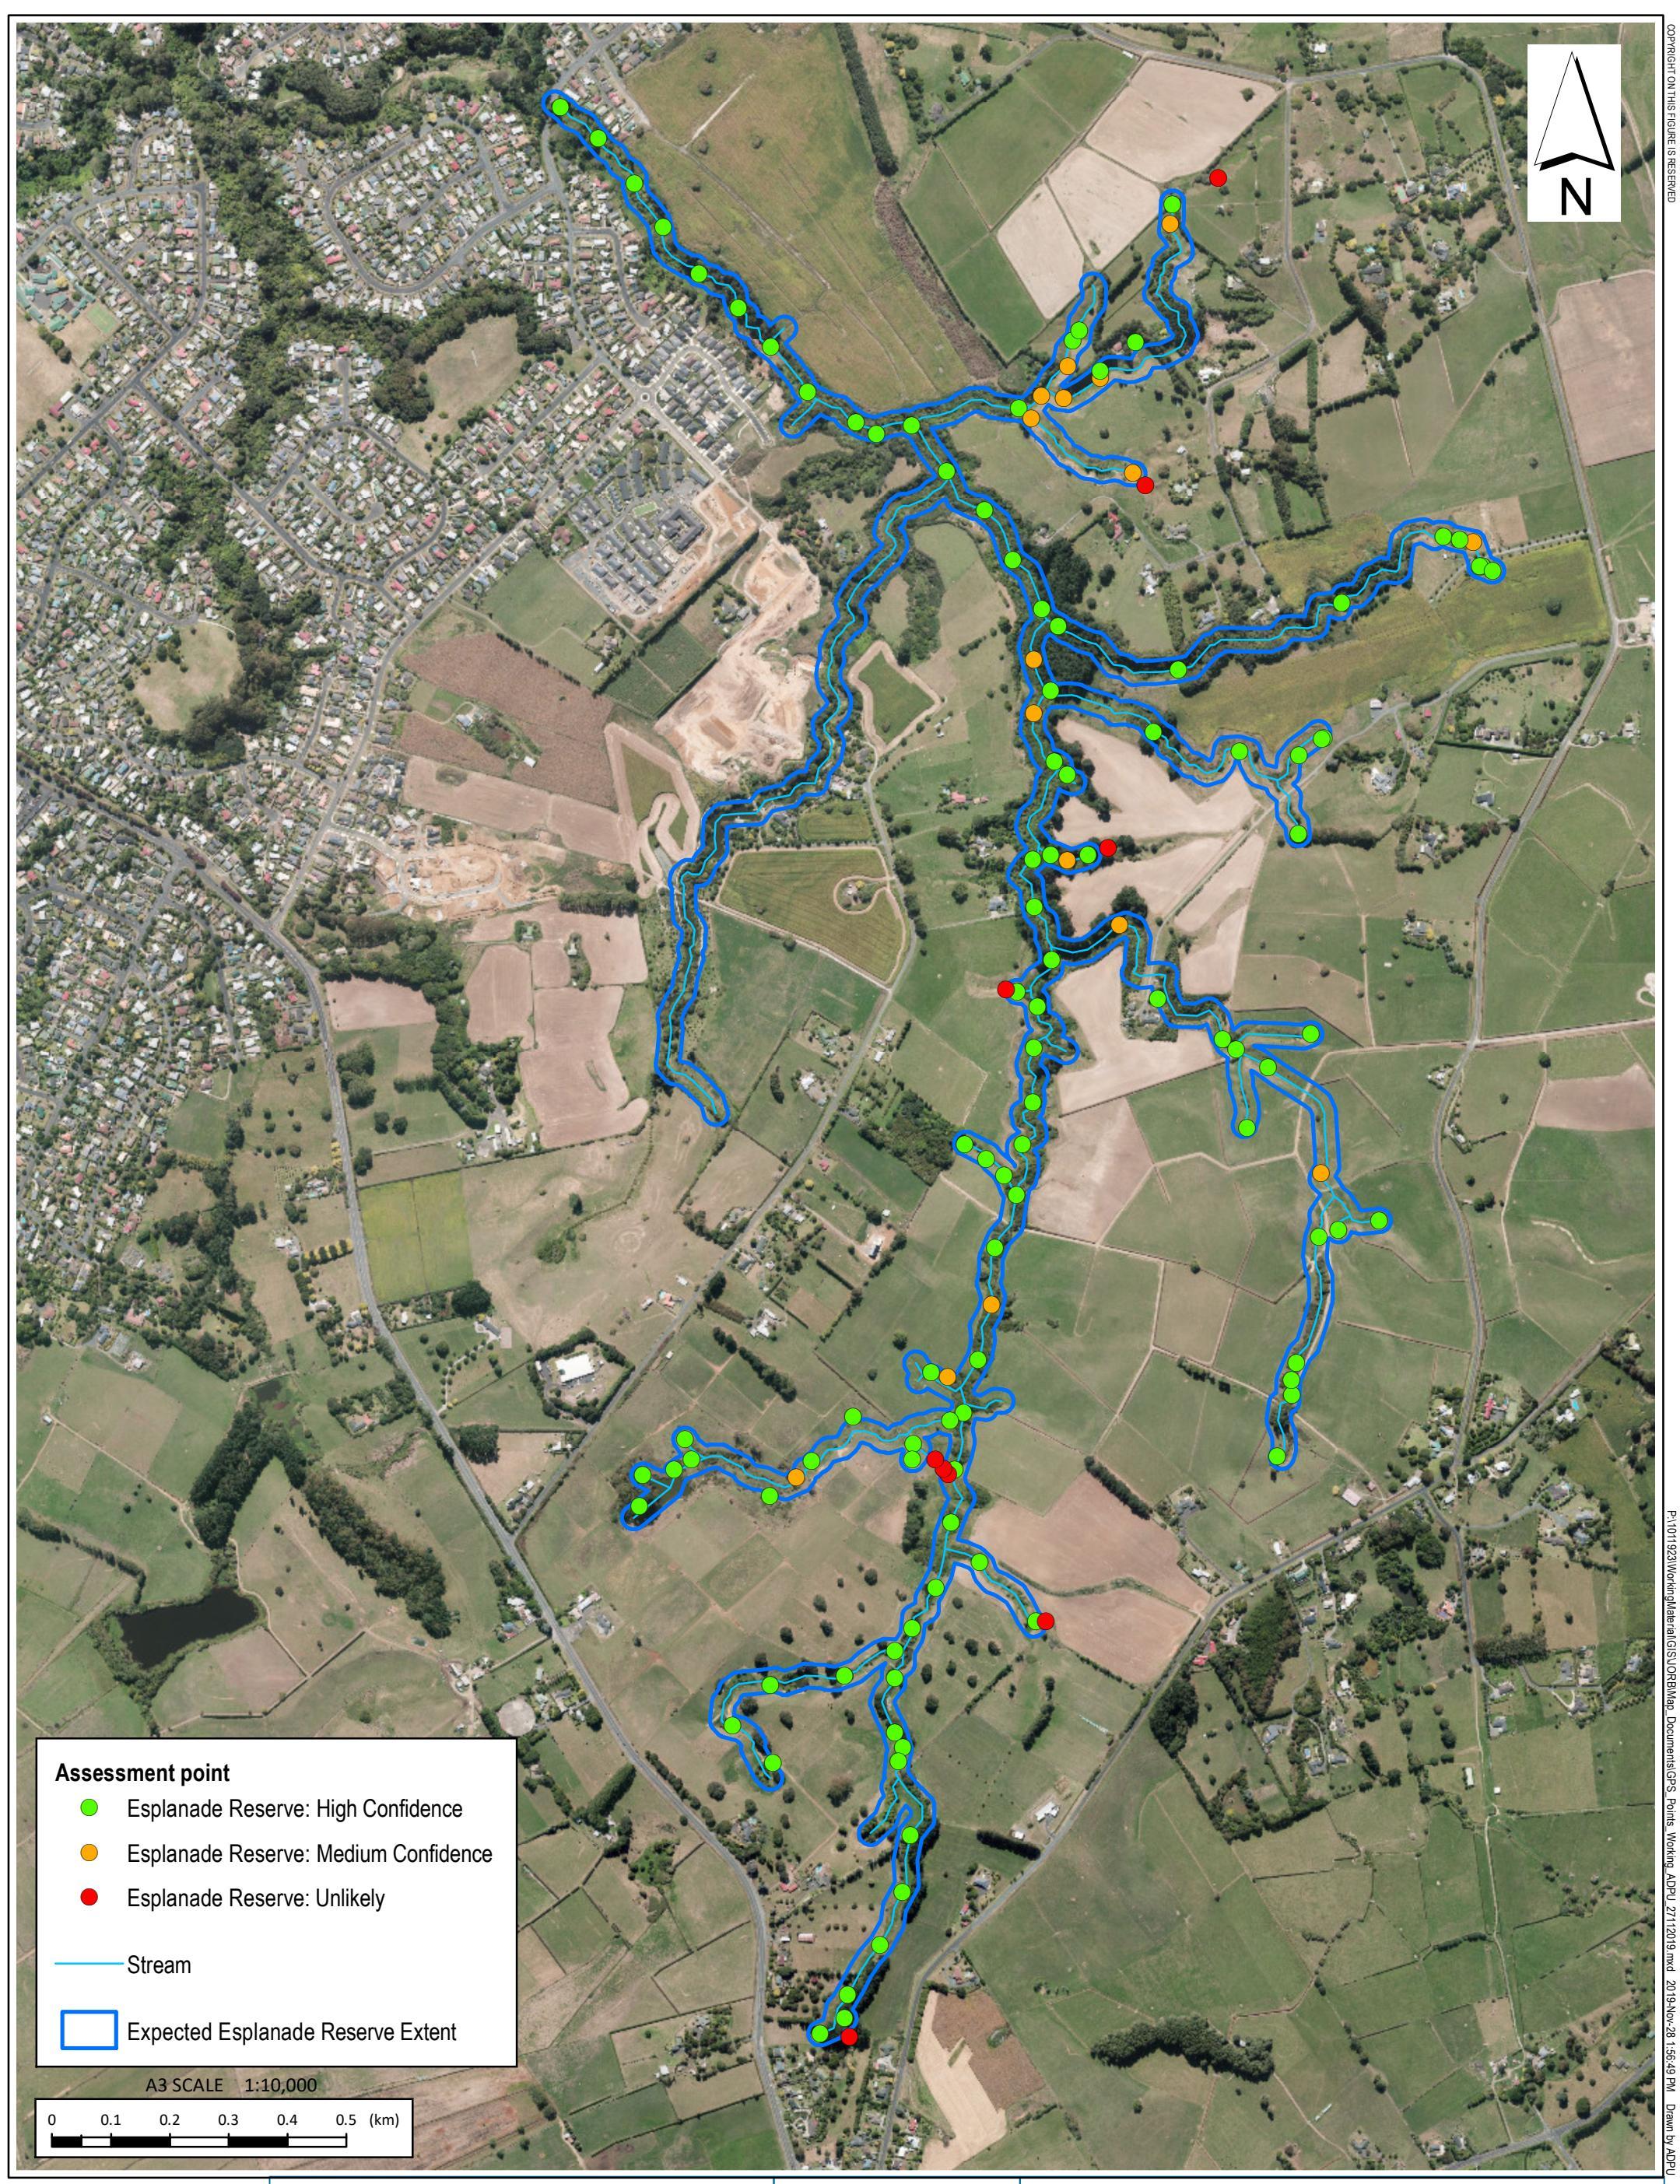
The flood level information and field assessment data were then used to identify whether, at each assessment point, an esplanade reserve would be triggered (Yes), not triggered (No), possibly triggered (Possible). The dataset was then re-mapped in ArcGIS to allow further checks of whether the results were logical in a spatial sense. This included checking all 'No' results as well as any 'Yes' results located upstream of 'No' results. An indicative esplanade reserve layer was then added to the digital map by plotting a 20 m buffer along the centre of the streamline. The results of the mapping are presented in Appendix A and provided in shapefile form.

NOTES:					PROJECT No.	101192	3	CLIENT	CLIENT HAMILTON CITY COUNCIL				
7666	Aerial imagery sourced from LINZ under CC4.0				DESIGNED DRAWN		NOV.19	PROJECT	HCC MANG	ΑΚΟΟΤΙ	IKUTUKU ESPLAN	ADE		
Toplin Toylor						CHECKED	MOLI	NOV.19 NOV.19	TITLE	SURVEY LO	CATION	S AND EXPECTED	ESPLANADE	
		First version	ADPU	MOLI	27/11/19	BNO	28/1	1/2019		RESERVE E	XTENT			
Exceptional thinking together	REV	DESCRIPTION	GIS	СНК	DATE	APPROVED	D	ATE	SCALE (A3)	1:10,000	FIG No.	FIGURE 1.	REV ()

Field data was exported to an excel spreadsheet where it was checked before being imported to ArcGIS. Cross-section points were overlaid with the two-year flood flow extent layer to determine whether the flow would exceed 3 m within the vicinity of the survey point. The flood layer consists of 2 x 2 m cells so it was necessary to apply category based on the following levels of certainty:

- ≤1 cell = No, flood flow levels not exceeding 3 m
- 2 cells = Possible that flow levels exceed 3 m
- >2 cells = Yes, flood flow levels exceeding 3 m
