# ROTOKAURI NORTH SHA

GEOTECHNICAL ASSESSMENT REPORT

PROJECT NO: HD631 GREEN SEED CONSULTANTS LIMITED REFERENCE: PGR/PC 25 OCTOBER 2018

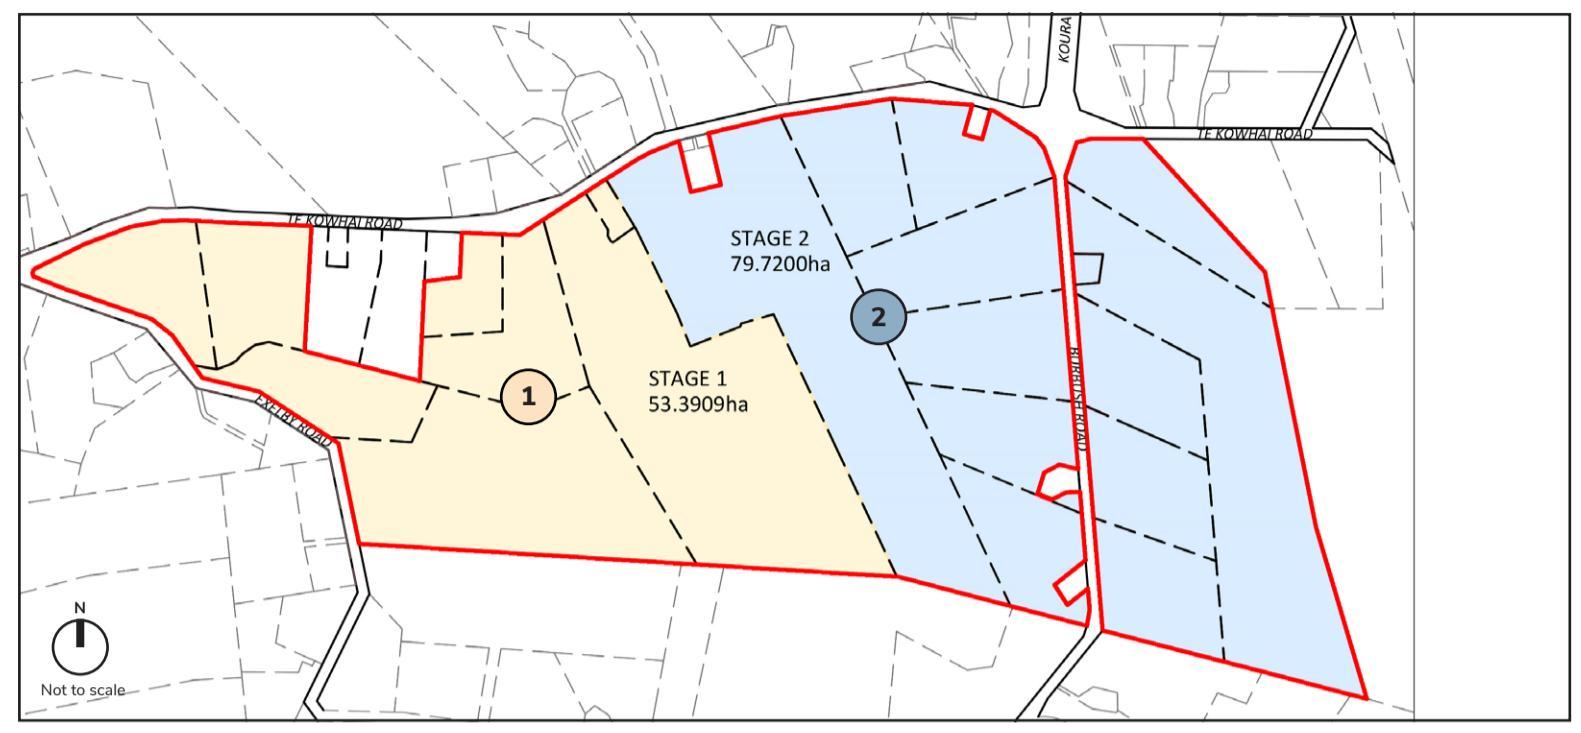
**ROTOKAURI NORTH SHA AREA (Figure 1)**

Stages 1 and 2 sought as an SHA. Total of 133.1109ha.

Figure 1: Rotokauri North SHA area

The site is located at the north west extent of Hamilton City and consists of a total area of approximately 133 ha. It is bounded by the Te Kowhai Road (SH39) to the north, greenfields to the east and south and Exelby Road to the west. Burbush Road runs north to south through the eastern portion of the site. A plan showing the extent of the site is included in Appendix A.

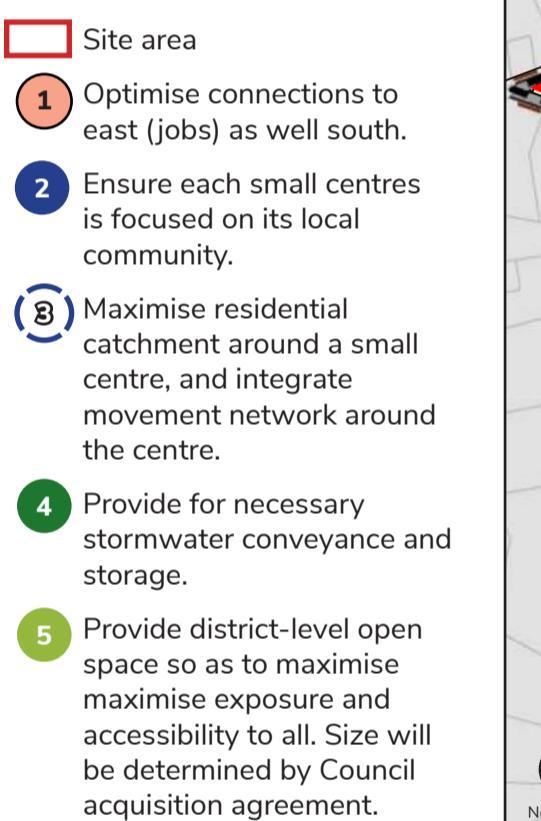
## **ROTOKAURI NORTH SHA CONCEPT (Figure 2)**

Ensure sensitive slopes can

be appreciated as landscape

Figure 1: Key structuring elements of Rotokauri North SHA concept

The proposed development consists of two stages, Stage 1 in the western portion of site covering an area of approximately 53 ha and Stage 2 in the eastern portion of site which is approximately 80 ha. The proposed development concept and staging plans are included in Appendix B.

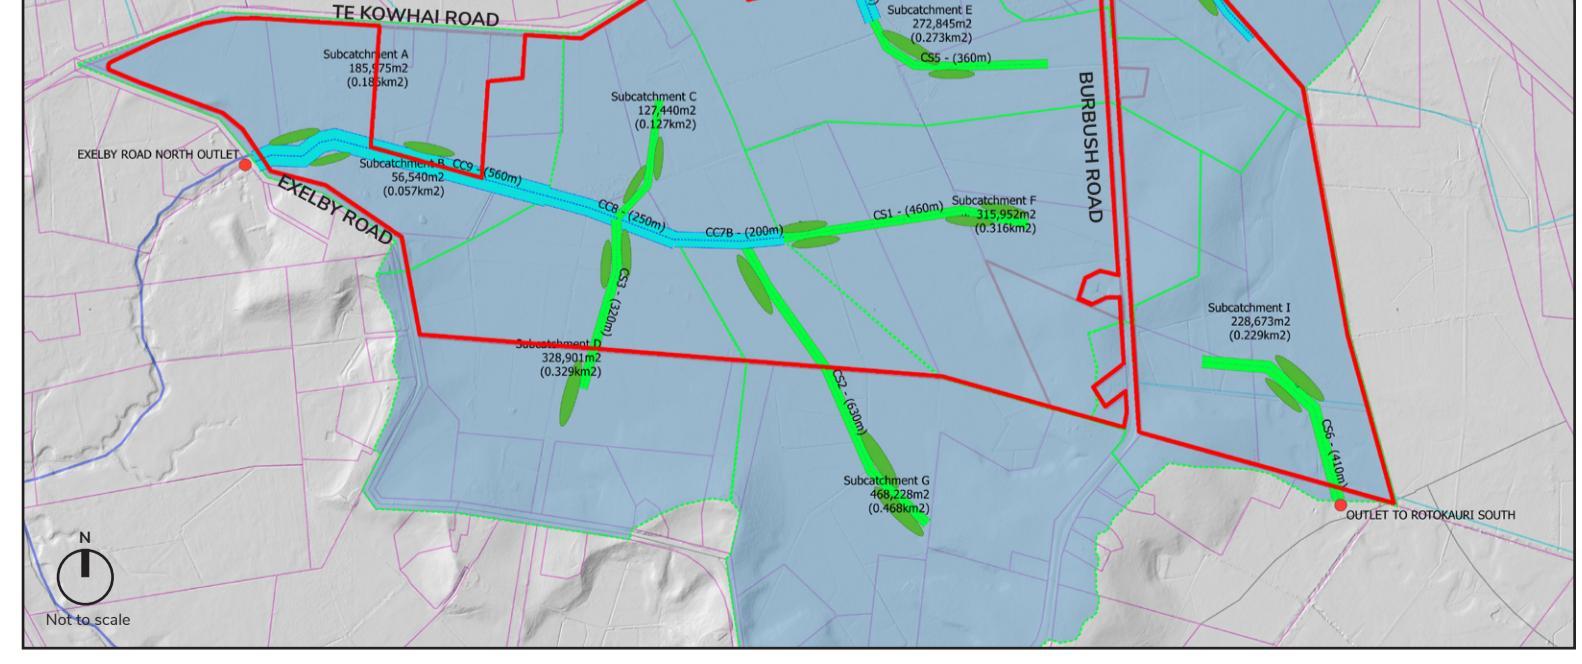
## **ROTOKAURI NORTH SHA OPTIONS FOR STORMWATER (Figure 3)**

Floodway basin (conveyance and flood storage)

Swale (conveyance only)

Figure 3: Rotokauri North SHA options for stormwater Source: CKL Stormwater Solutions

Development plans show stormwater swales throughout the site which are likely to be excavated up to 2.0 m below current ground levels. Given the near surface soils have been identified as liquefiable, the formation of these swales is likely to create a lateral spreading hazard.
