INSTRUCTION SHEET FOR SET #7.1115 NISSAN MAXIMA

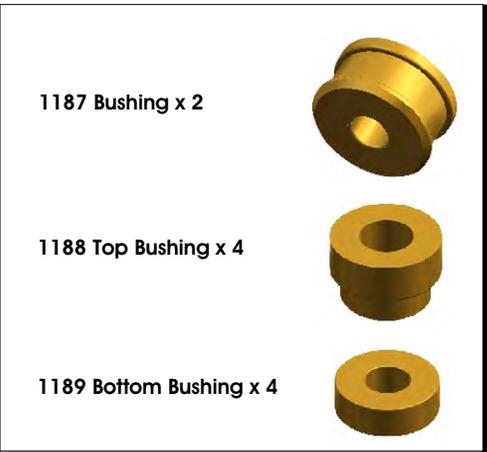
PIC 1

- Carefully unclip center trim panel. **Pic 1**
- Unsnap the shift boot from the trim panel and set to side.
- Remove screws for the center console and remove console. **Pic 2**
- Remove four nuts for plastic shifter bracket, now remove shifter Banjo bushing.
- Don't forget to also replace the banjo bushing out in the engine bay. **Pic3**

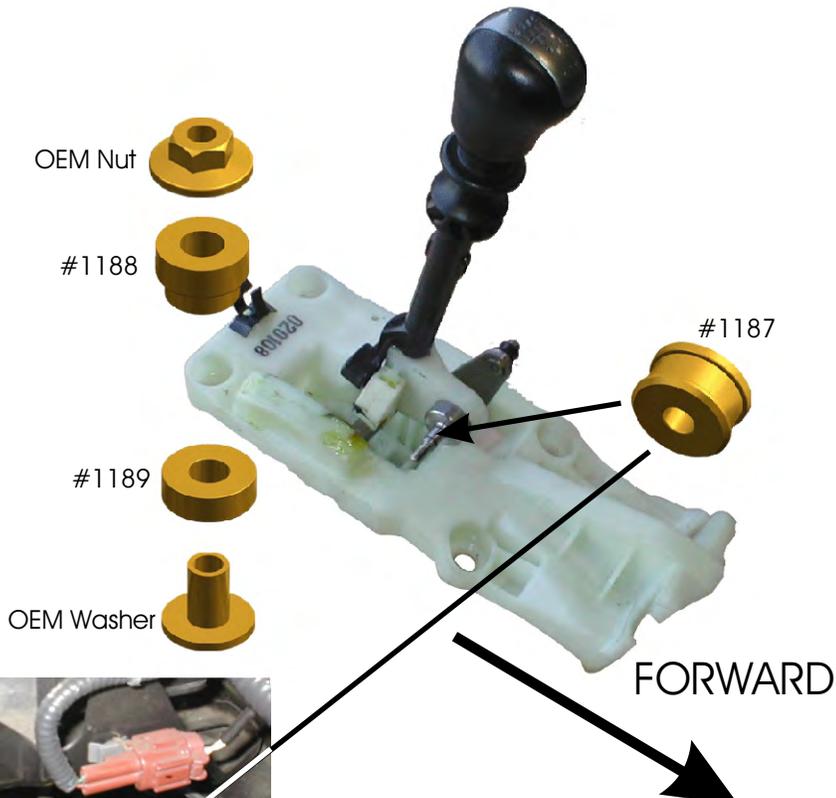
- Place the shifter bushings as per diagram below. First place the existing OEM washer down over the stud at four positions. Now place our **#1189** bushing over the OEM sleeve. Now set the shifter bracket down over the studs. Push our **#1188** bushing down into the bracket and now use the OEM nut to tighten bracket down. Install the banjo bushing for the main shifter cable at both the shifter location and out in the engine bay. **Pic 3** NOTE: To ease install, push **#1187** in with tapered side first.
