P/N: 303002L

TJ AUTO (3 speed) ATLAS II SHIFTER

SHIFTER INSTALLATION (2sp and 4sp main case)

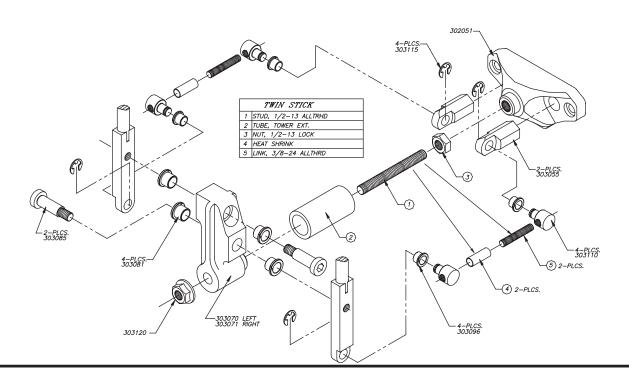
- 1. Install the shifter base to the face of the Atlas using the three S.H.C.S. 3/8"-16 x 1". These bolts have a sealant patch that will prevent leakage on the threads. This should be done before the Atlas is installed into the vehicle.

- 2. Install 1/2"-13 all-thread and jam nut to the shifter base.
- 3. Slide the shifter tower along the all-thread stud until the shifter arms are at the center of your stock floor cutout.

- 4. Measure between the tower and the base to obtain the correct extension tube length.
- 5. Remove the tower and install the extension tube.
- 6. Assemble the shift handles to the shift tower.

- 7. Install the shift tower assembly to the extension tube using the lock nut on 1/2"-13 all-thread to secure.
- 8. Install the brass shift rod ends to the Atlas shift rods. Teflon tape should be used on the threaded portion of the shift rod.

- 9. With the Atlas in neutral and the shift handles parallel with the shift tower, measure the distance for the linkage rods.
- 10. Connect the shift buttons and heat shrink tubing to the 3/8"-24 all-thread at the distance measured. Make sure that the all-thread is flush with the outside edge of the shift button. Cut all-thread if necessary.

- 11. Assemble the linkage rods to the shift handle and brass portion of the shift rod and verify the shift handles are parallel to the tower.
- 12. Install the e-clips to retain the buttons to the mating parts.

- 13. Make sure the brass shift rod ends are not too tight. They should be finger tight.
- 14. Modify the floorboard if necessary.
- 15. Install the rubber boot and boot ring to the floorboard. (Note: On some twin stick configurations, the boot ring may need to be cut in order to fit around the Atlas twin sticks).

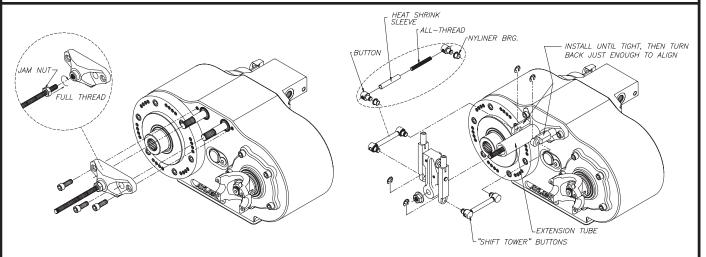
addressed. One of the most common difficulties we hear is that "my unit isn't shifting fully into one of the gear ratios". Incorrect adjustment of the shift handles to the linkage rods is normally the cause. With both shift rods in neutral, the linkage rod (connected to the shift handles) must be parallel with the aluminum shift tower. Refer to the photo left.

Another concern that we've heard is that "my Atlas seems to be hard to shift". This problem could be one of two areas. The brass shift rod ends that the shifter linkage rods connect to are too tight, causing a binding effect on the shifter linkage. The brass shift rod ends should be installed until tight, then loosened enough to align to the shifter button.

The last of the most common dilemmas we hear is that "the shifter linkage came apart while in operation". The area in question is the all-thread linkage rods. These rods fit into the two shift buttons. To prevent the all-thread from unscrewing out of the shift buttons, a portion of the heat shrink tubing should have been installed (o-rings on a TJ automatic). The heat shrink tubing or o-rings act as a jam nut to prevent the all-thread from unscrewing. DO NOT use a jam nut on these linkage rods because it will cause binding of the shifter linkage.
