100 Football pitch Project

Football Ground: HA. Muraidhoo

Site visit report – supporting information

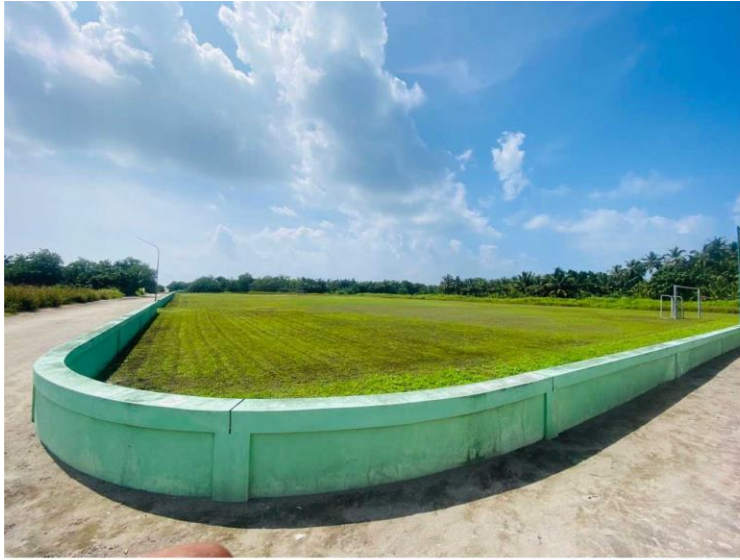
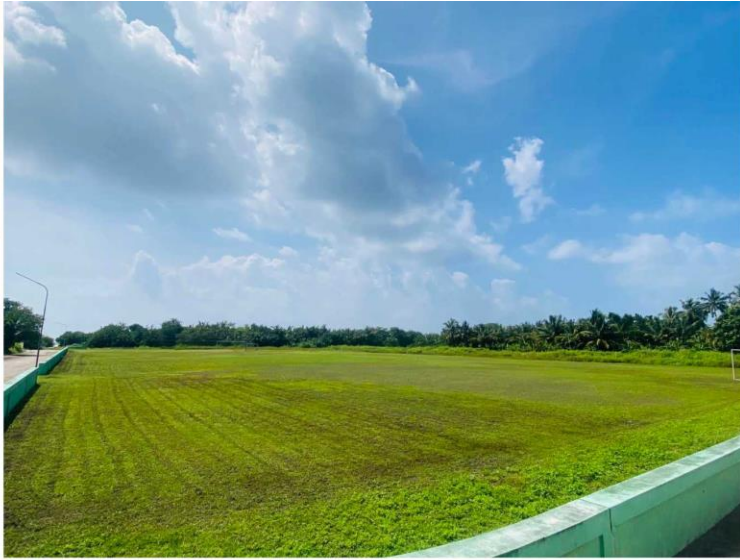
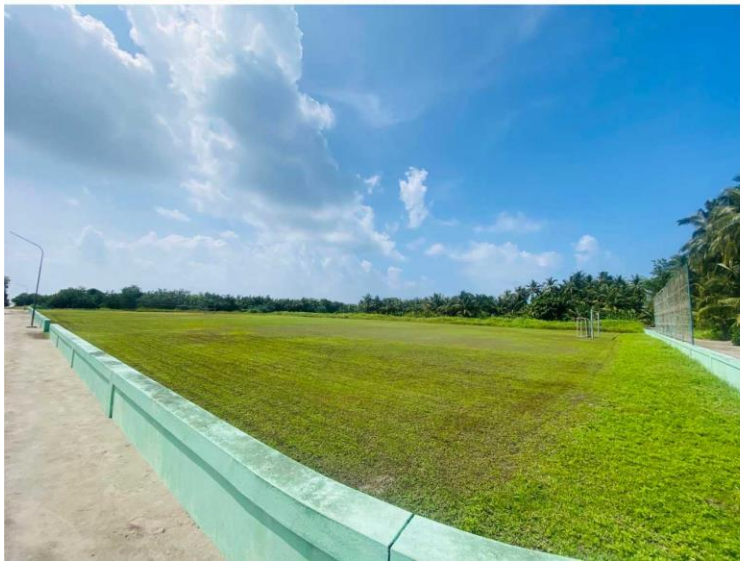
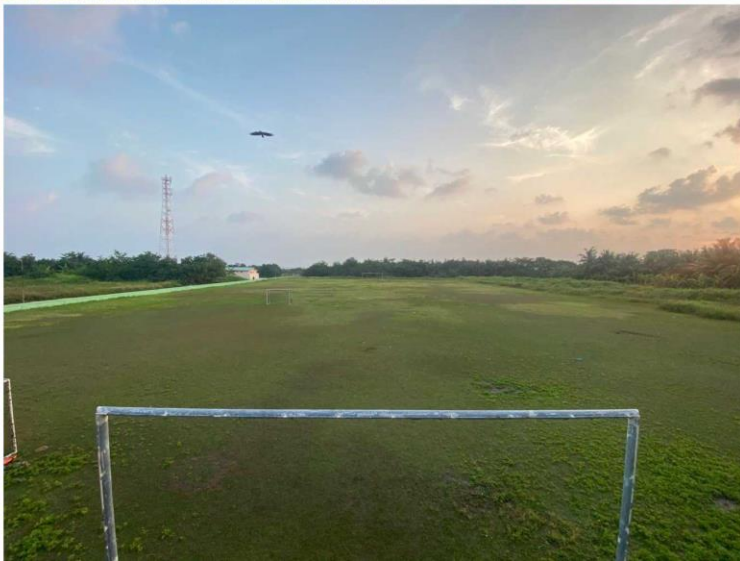
Site photos

| <p>Ground Conditions: Proposed site is located due South / of the island; 4 trial holes were made. Allocated area covered with grass generally flat. It was noticed that +/- 300 mm of top layer is fine silt with rock (well compacted) like hold water, but infiltrate. According to the council existing pitch area is resurfaced 3-4 years back. Top layer will need to be scraped to achieve uniform compaction. +/- 200mm for slope is available in the island.</p> | |
| Topography | <p>Surface is full of grass and level about a football pitch area.</p> |

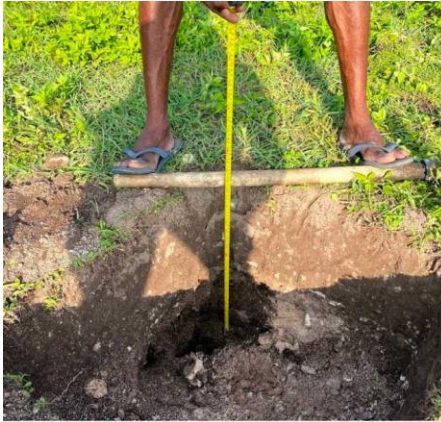
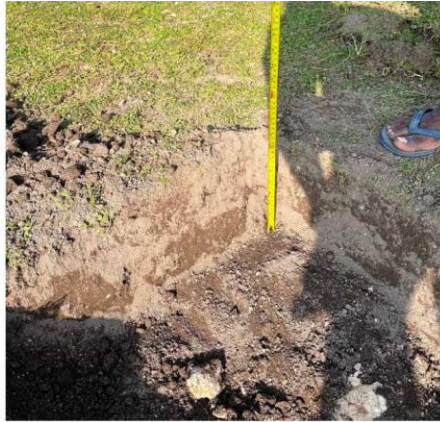
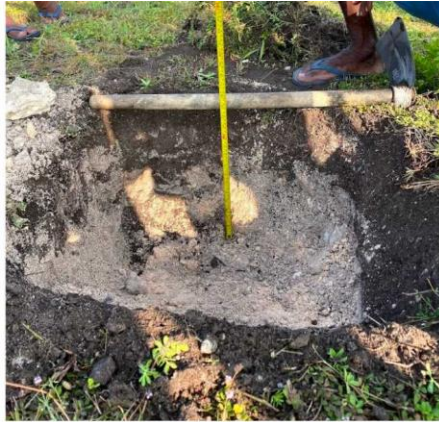
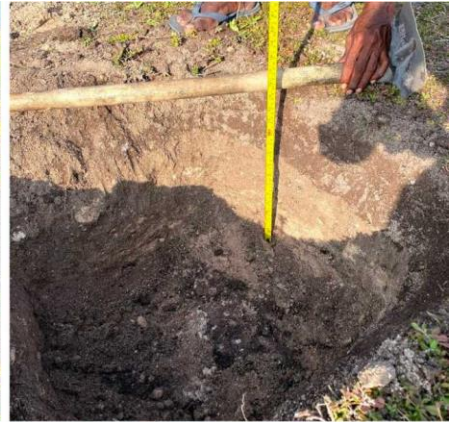
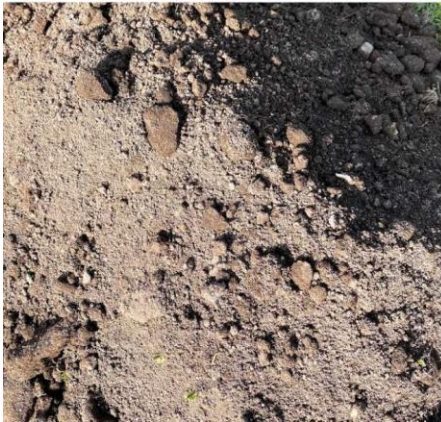
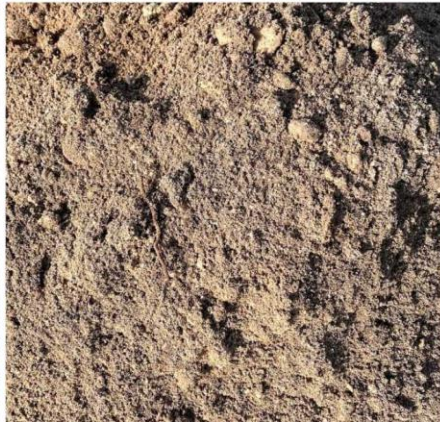
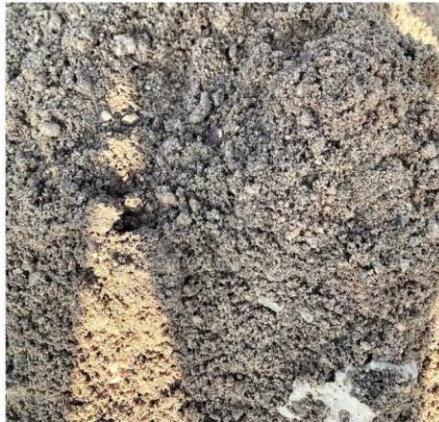
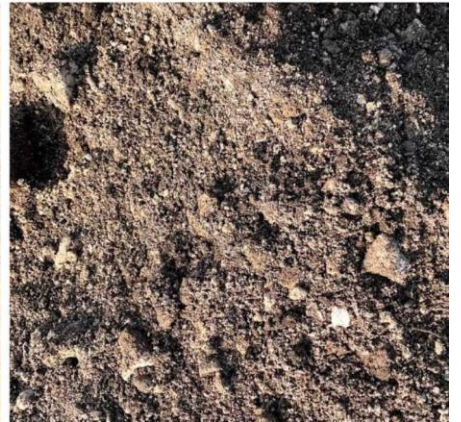
Trial Holes

| Groundwater evidence | <p>Location is due South of the island, no evidence of water in ant trial holes made. According to the council evidence of water may find from 3-4 ft deep.</p> |
