Report: 141/001

## 100 Football pitch Project

Football Ground Thaa. Madifushi
Site visit report – supporting information

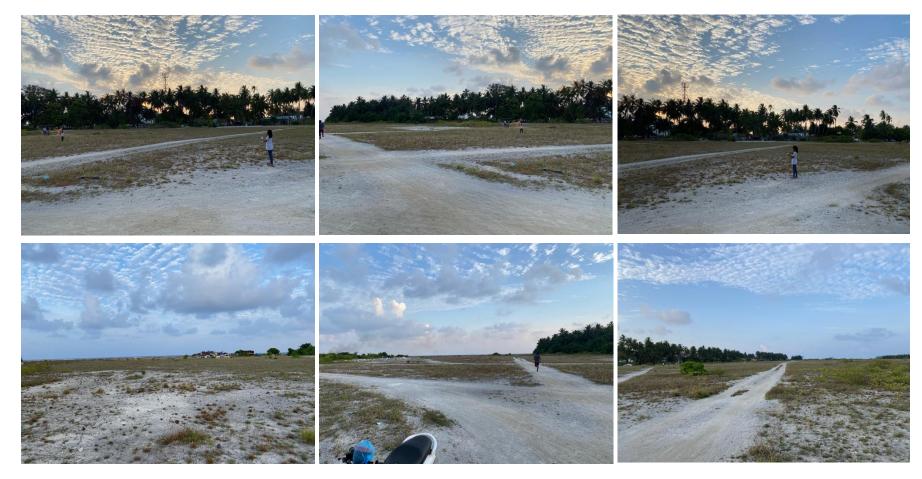
## Site Photo

- No benchmark identified, for the groundbreaking and defining footprint of the football pitch, a thorough survey is important.
- Waste management area next to the football pitch plot.
- Power supply or electrical and water outlet available
