Report: 141/001

100 Football pitch Project

Football Ground GA. Dhevvadhoo Site visit report – supporting information.

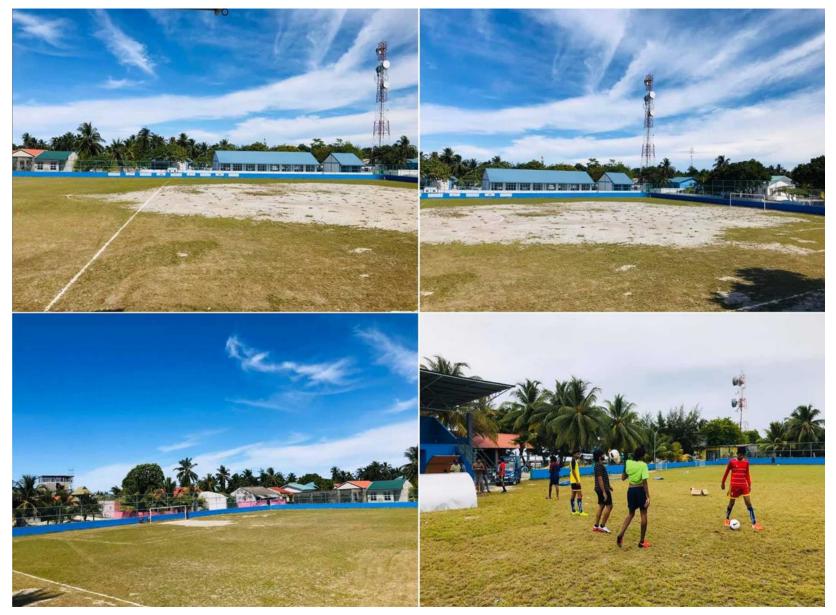
Site Photo

Scope of the Project	Design and construction of fu	Design and construction of full-size football Artificial turf pitch					
	Category of pitch requirement		FIFA Recommende	ed			
	Level of competition and activity requirement	vities &	National Level				
Proposed usage	Level of play		National Level				
	Intensity of play per week / ye	36 hrs /week					
Field orientation	North / South						
Proposed filed dimensions	$\frac{1}{2} \mathbf{w} + \mathbf{e} = \frac{1}{2} \mathbf{w} + \mathbf{e} $		1				
		Length		Width			
	Field size	100m		64m			
	Run – off area	North	South	West	East		
		3m	3m	2.5m	2.5m		
	Total Green area (synthetic)	106m x	: 69m				
Spectator Area	Pavilion with some level of functional rooms						
Fencing	Existing facility/ Structure has full boundary wall and fence

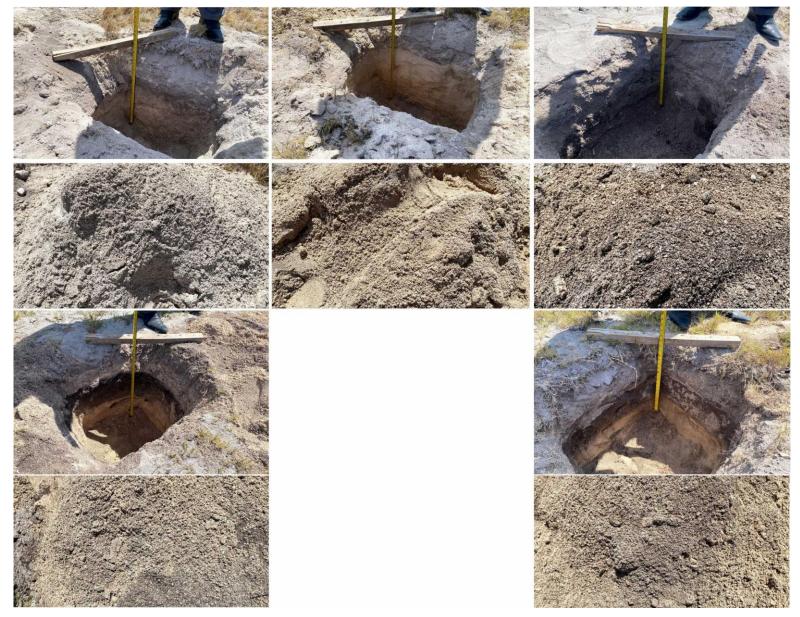
Trial Holes

Ground Conditions: Proposed site is in East of the island; 5 trail holes were made. Noticed +/- 200 mm of rootzone and silt reclaim covered with patches of grass, top layer needs removing of the grass patches and scrap. Backfilling with the sand scrapped

Groundwater evidence	Location is the heart of the island, according to the represents on site water is likely more than 3 feet deep
Topography	Old surface with patches of grass, with +/- 200mm of rootzone, ground area likely lower than outside
Drain Outlet	No public sewerage pipe or system in place, drainage must be designed with enough soak pits to flush excess water.
Existing Service & sports lighting	Small pavilion with functional rooms and seating space, no flood lights
Disposal of Spoil	All removed spoil sand needs to be removed in accordance with council instruction.

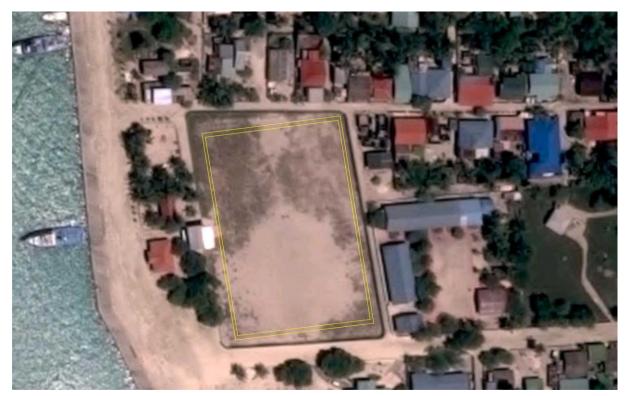
PROPOSED INDICATIVE LAYOUT

Construction Detail: Proposed site is not in a regular shape; footprint must be laid to maximize space. Sand use must be maximized					
Site access	Proposed site is accessible from all 4 sides, however distance from harbor will make it easy for the transportation of materials (allocated site is in from of the harbor				
Site Compound	It is located on East of the island, no infrastructure from the harbor to the site. Existing pavilion				
Best time of the year to construct	No significant time of the year				
Working restriction	Νο				
Drainage	Subbase will be designed with gutter and soak pit to drain the excess water.				
Provision for new functional extension	Proposed site is smaller for a full pitch project, Existing pavilion maybe extended in the space available on sides.				
Maintenance equipment requirement	ТВС				
Sports equipment	TBC				
sports equipment
