# 100 Football pitch Project

Report: 141/001

**Football Ground AA. Bodufulhadhoo**  
Site visit report – supporting information.

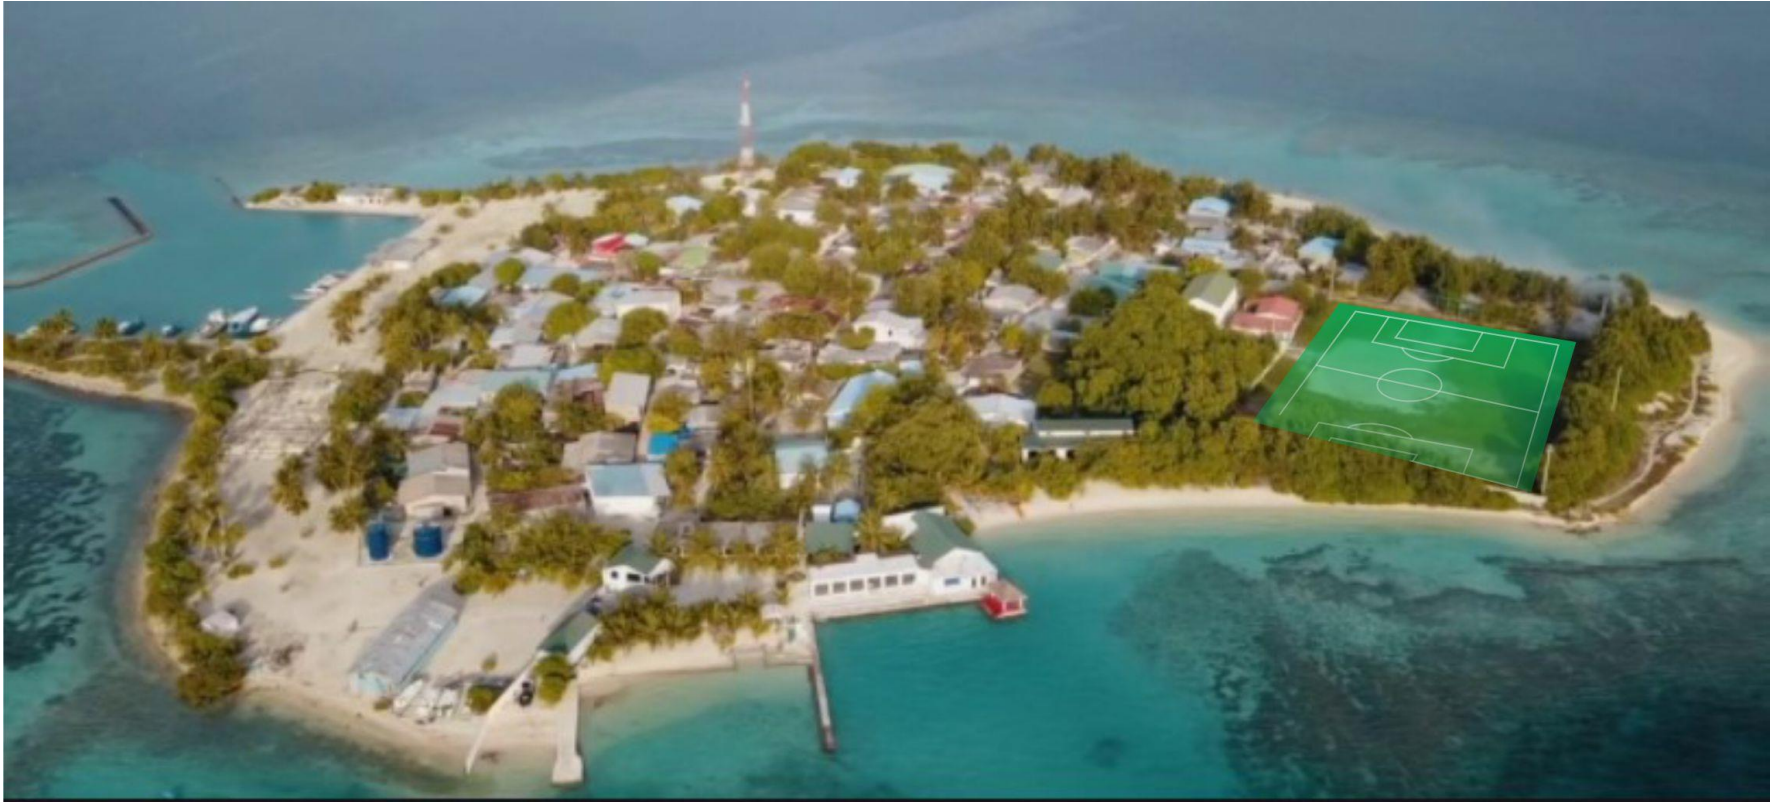
#### **PROPOSED INDICATIVE LAYOUT**

Footprint of the football pitch is suggested to be placed in a way to make room for the other sports courts on the East side.  
footprint of the pitch according to the concept by council.
