Report: 141/001

100 Football pitch Project

Football Ground Thaa. Madifushi
Site visit report – supporting information

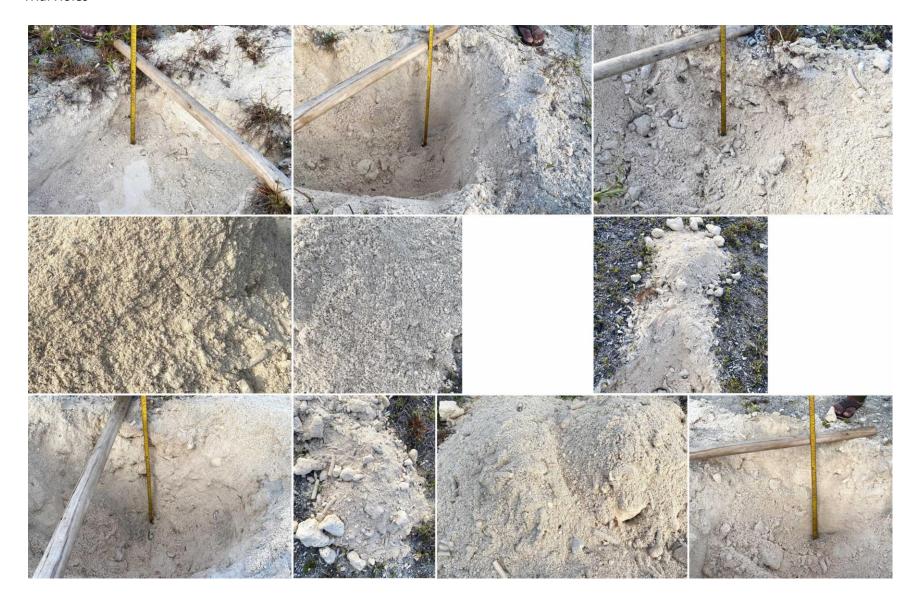
Trial Holes

-	South / East of the island; 5 trail holes were made. Noticed +/- 300 mm of reclaim with coral and up layer needs removing of the grass patches and scrap. Backfilling need sieving and use the small
Groundwater evidence	Location is the heart of the island, according to the represents on site water is likely more than 3 feet deep
Topography	Old surface with patches of grass and uneven terrain.
Drain Outlet	No public sewerage pipe or system in place, drainage must be designed with enough soak pits to flush excess water.
Existing Service & sports lighting	No existing service area
Disposal of Spoil	All removed spoil sand needs to be removed in accordance with council instruction.

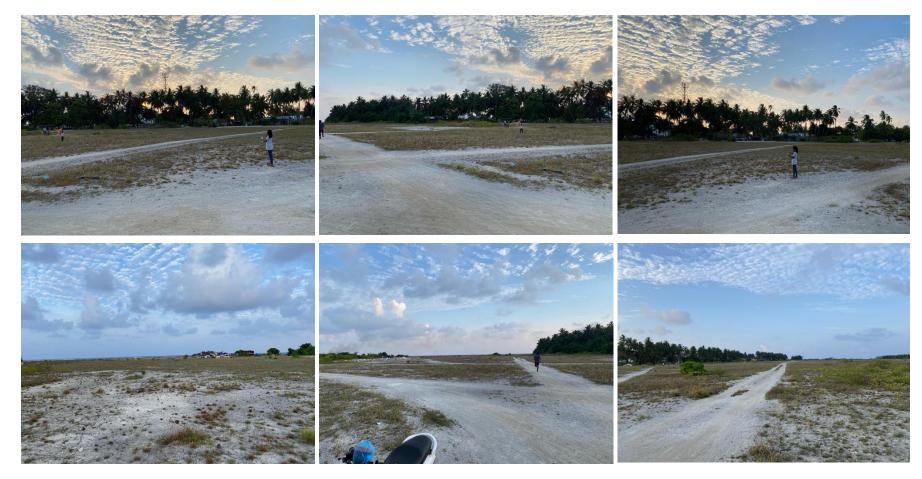
Site Photo

- No benchmark identified, for the groundbreaking and defining footprint of the football pitch, a thorough survey is important.
- Waste management area next to the football pitch plot.
- Power supply or electrical and water outlet available

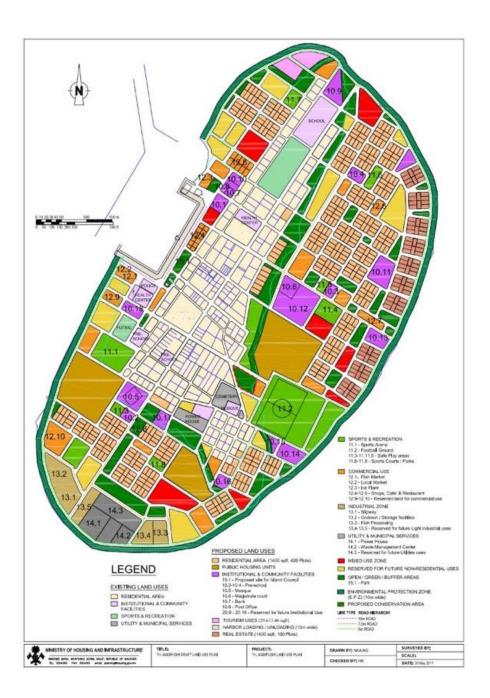
PROPOSED INDICATIVE LAYOUT

wide strip of land from the allocated for other purpose on the East side of the football pitch area.
