100 Football pitch Project

Football Ground Sh. Kanditheemu
Site visit report – supporting information.

| Date of visit | 10 th March 2021 | |
| Site address | Proposed New Football Ground | |

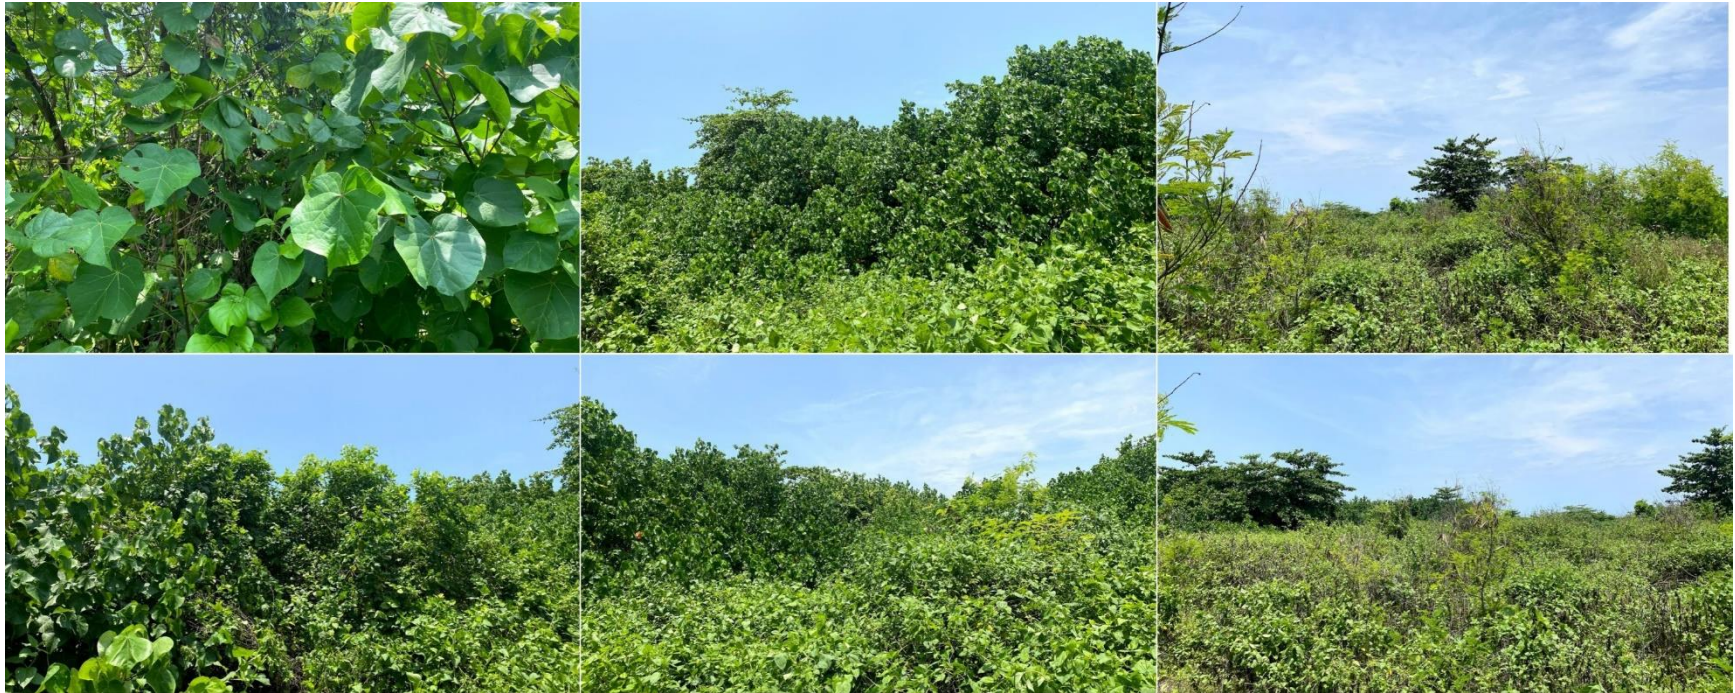
Site Photo

| <p>Ground Conditions: Proposed site is in the south / West side of the island; 4 trial holes were made. Noticed +/- 200 mm of rootzone and silt, fully covered with bushes (tress and heavily grown grass), site needs removing trees and grass. Backfilling with the sand scrapped, if available (during construction) avoid using the scrapped silt,</p> | |
| <p>Topography</p> | <p>Plot allocated is new location with bushes. Uneven terrain and silt sand.</p> |

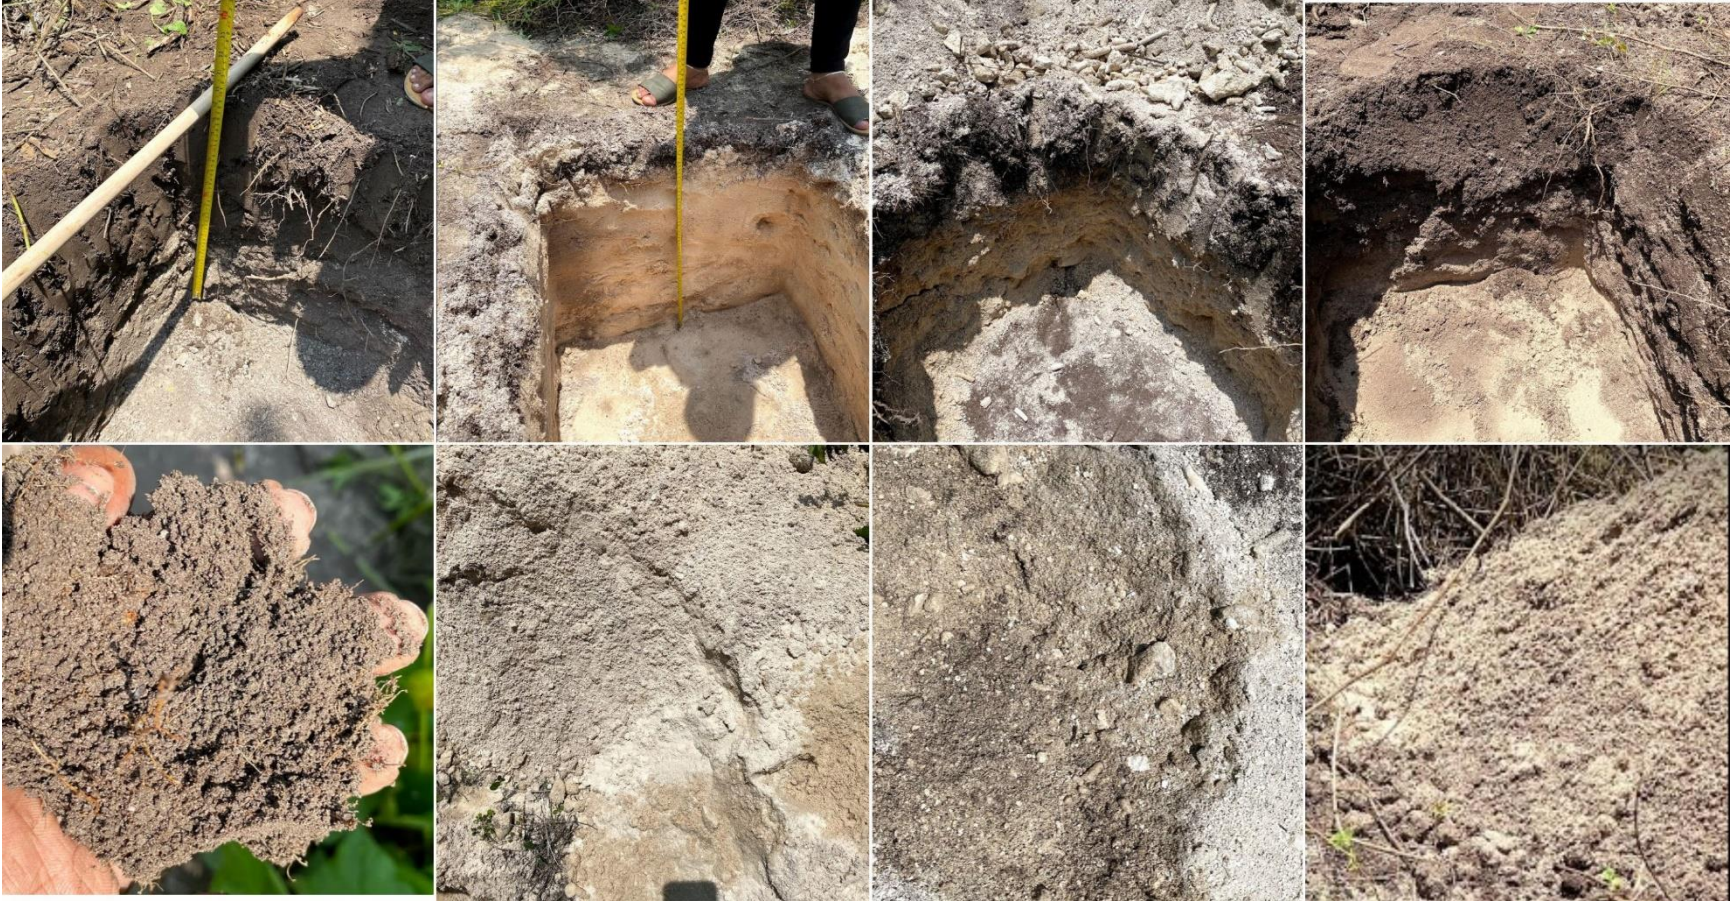
Trial Holes

| <p>Groundwater evidence</p> | <p>Location is South / West of the island, no water found in the trial holes</p> |

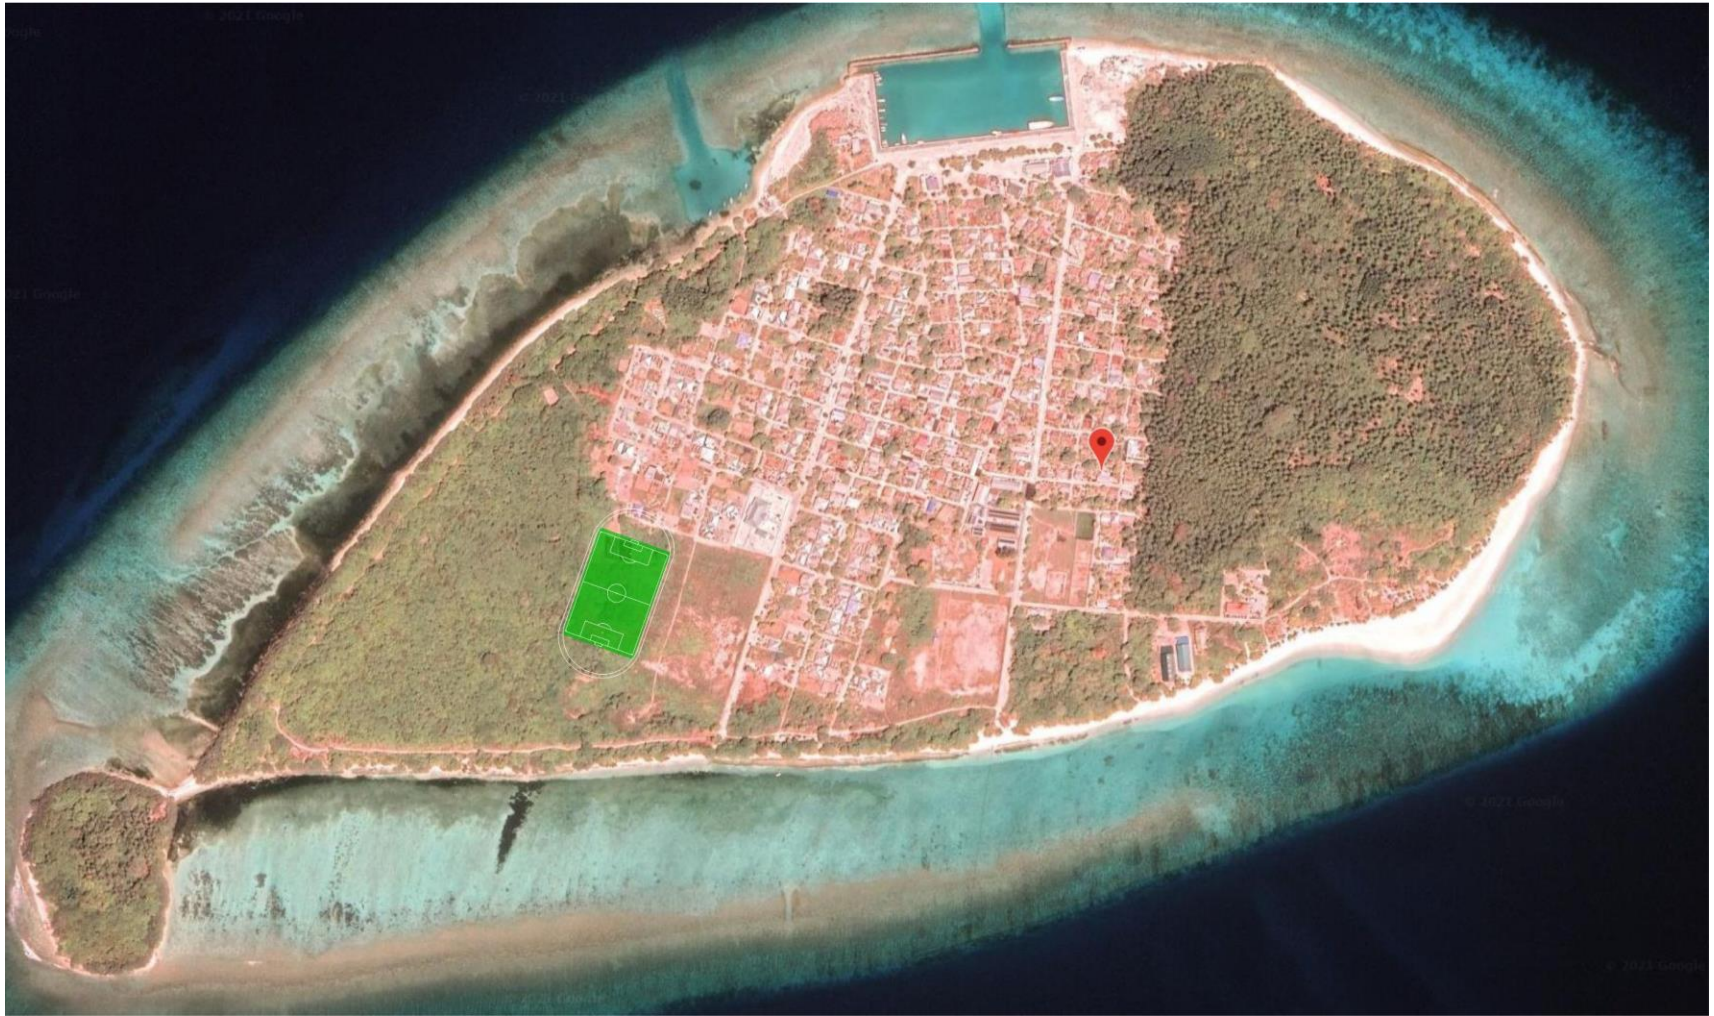
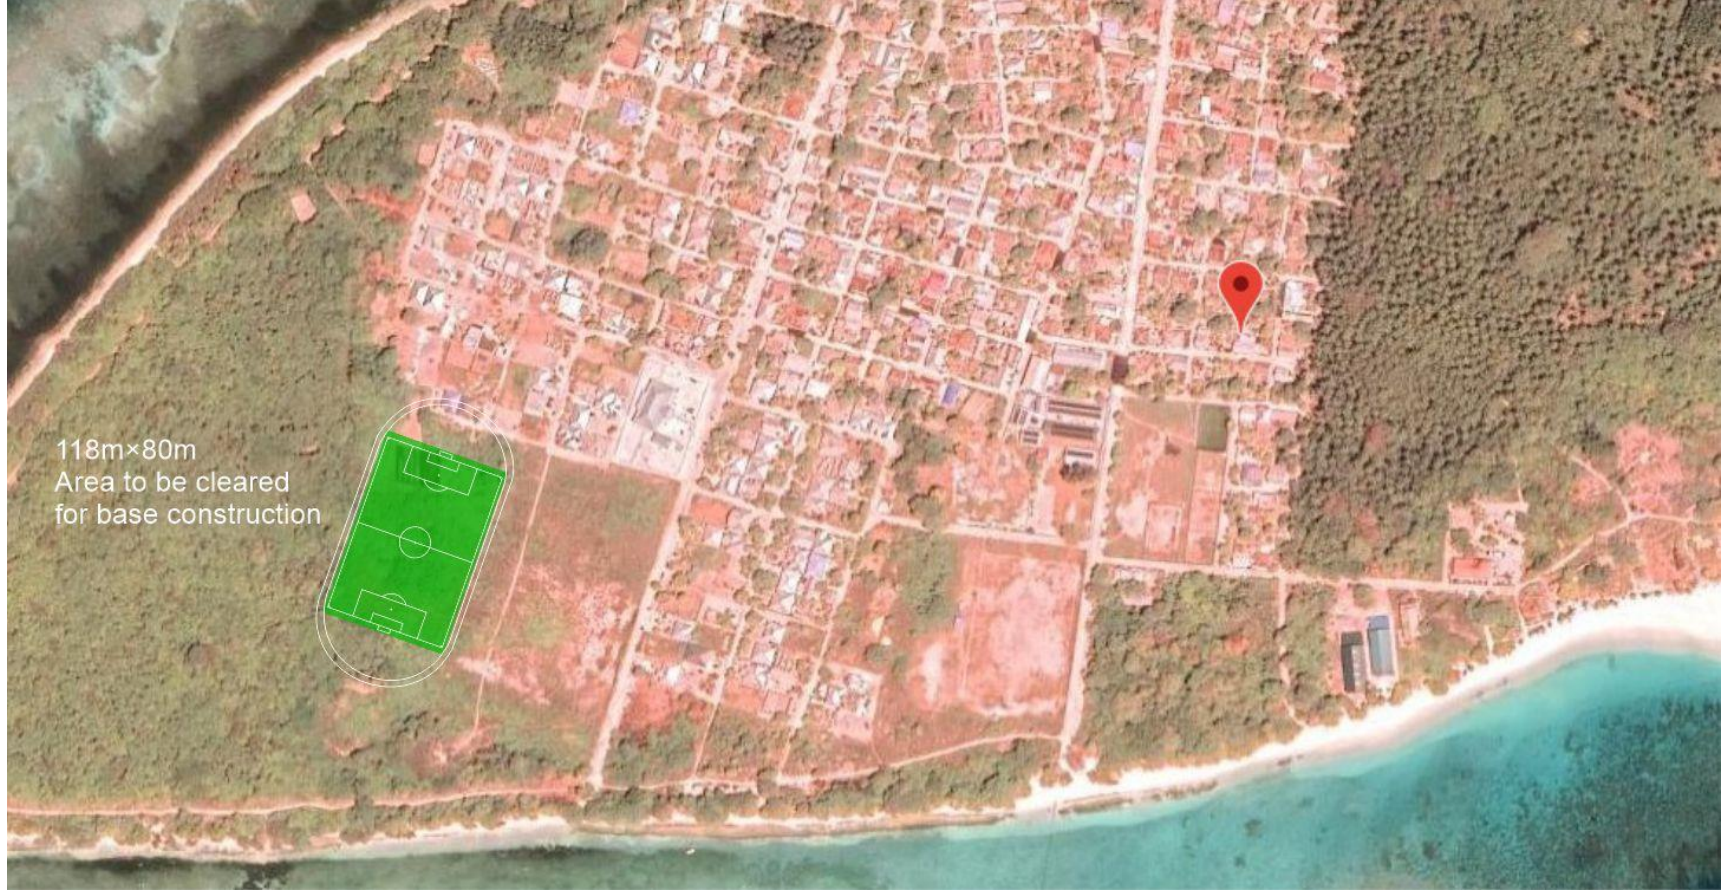
PROPOSED INDICATIVE LAYOUT

118m×80m
Area to be cleared
for base construction
