**REVIEW OF
AGEING PROCESSES AND THEIR INFLUENCE ON SAFETY
AND PERFORMANCE OF
WYLFA NUCLEAR POWER STATION**

CLIENT: GREENPEACE UK

REPORT REF N^o R3049-A1

14 MARCH 2001

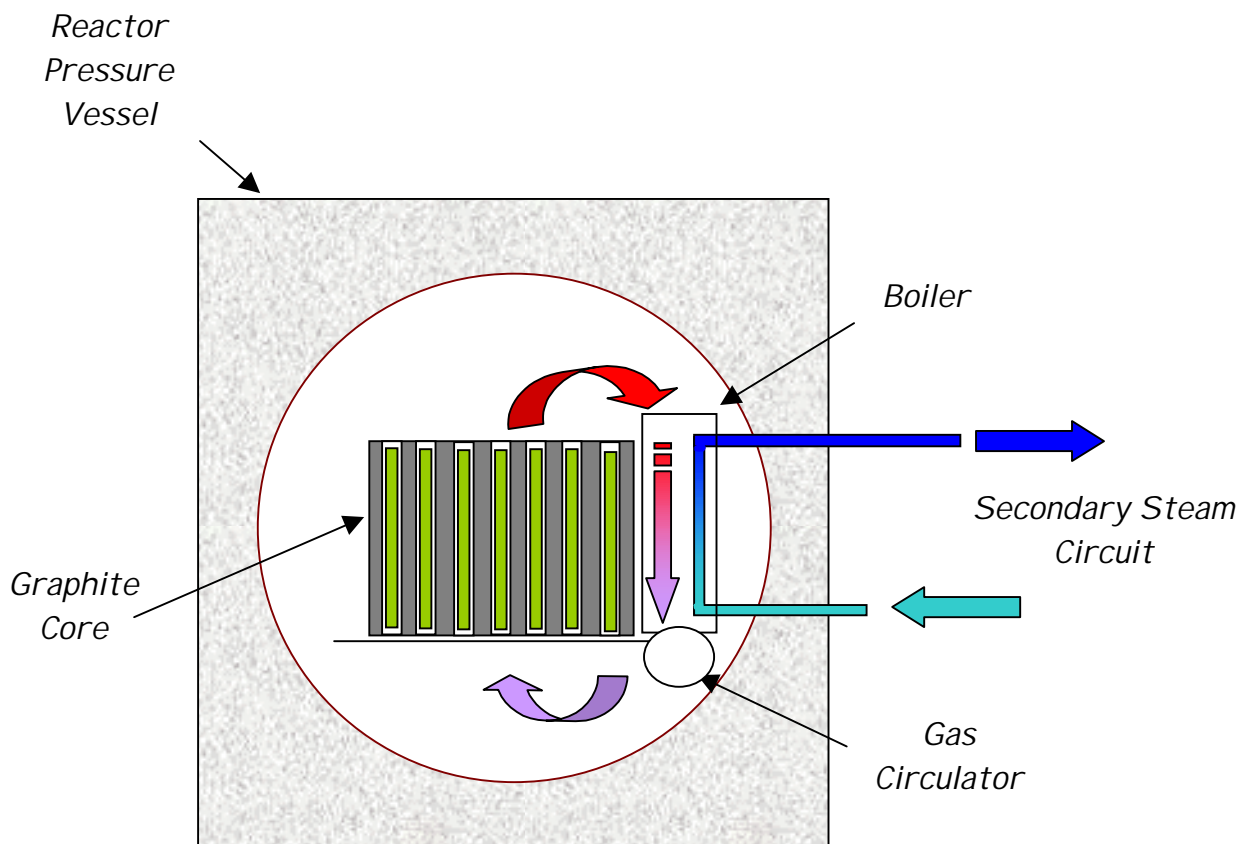
FIGURE 1 – MAGNOX REACTOR CIRCUIT

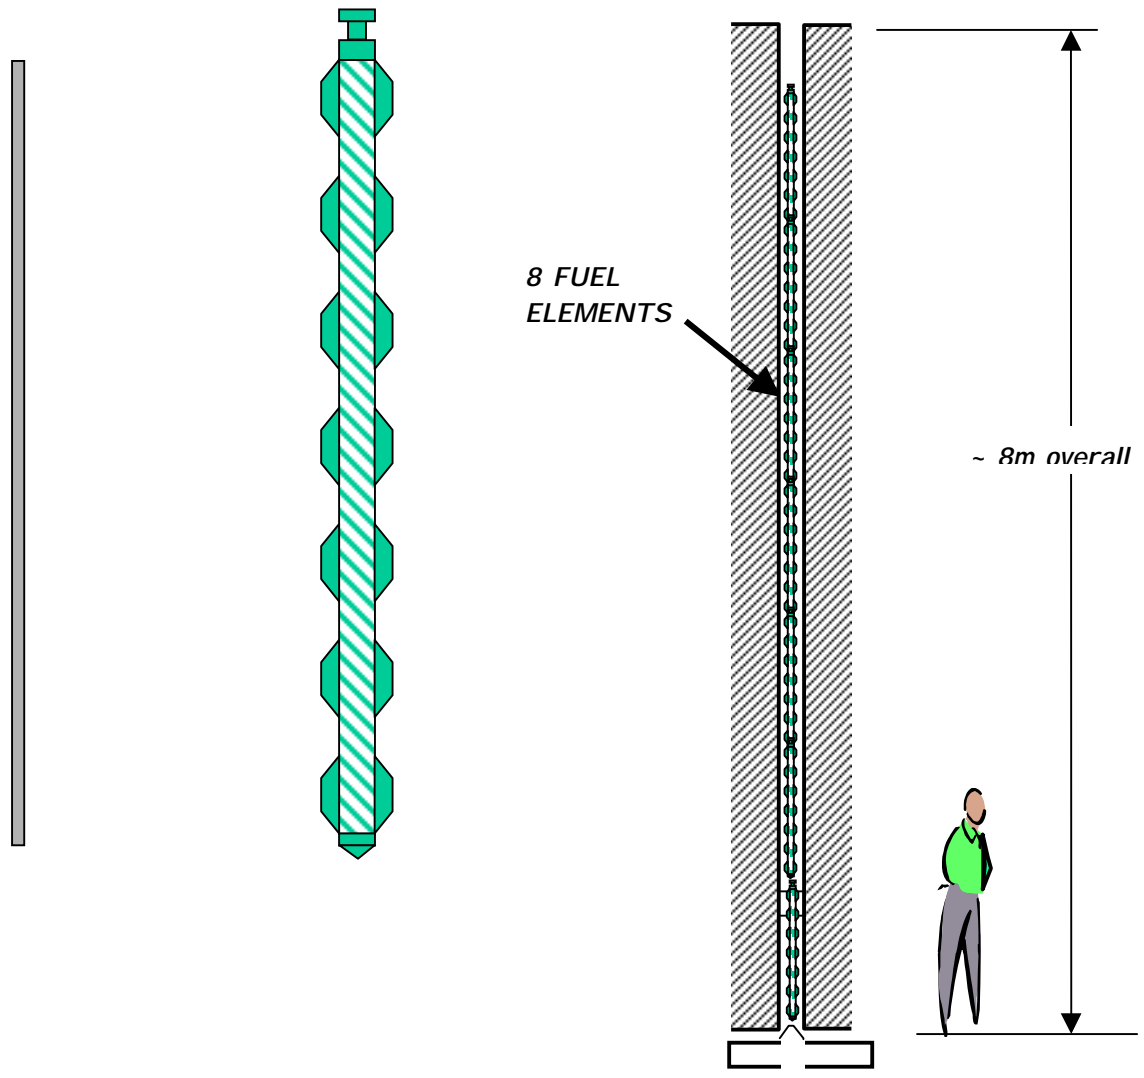
FUEL ROD

FUEL ELEMENT

FUEL CHANNEL

FIGURE 2 - MAGNOX FUEL SYSTEM

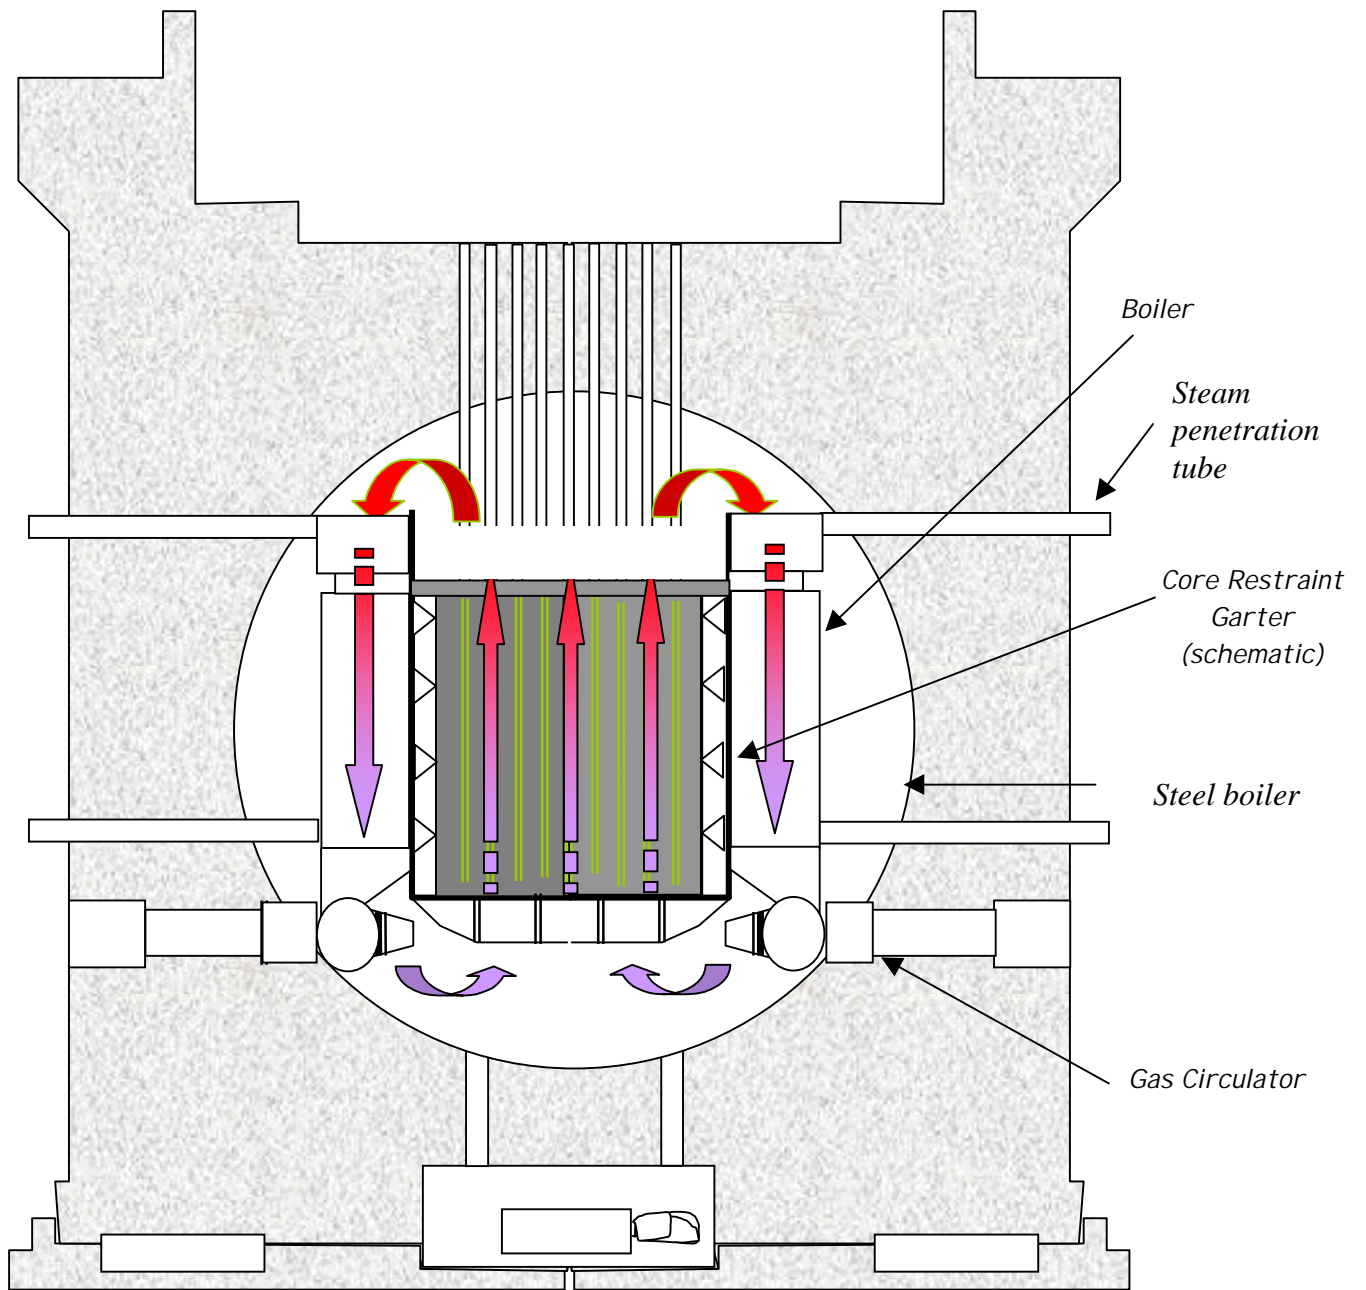
**FIGURE 4 - CROSS SECTION OF MAGNOX REACTOR PRESSURE VESSEL
- Reinforced Concrete**

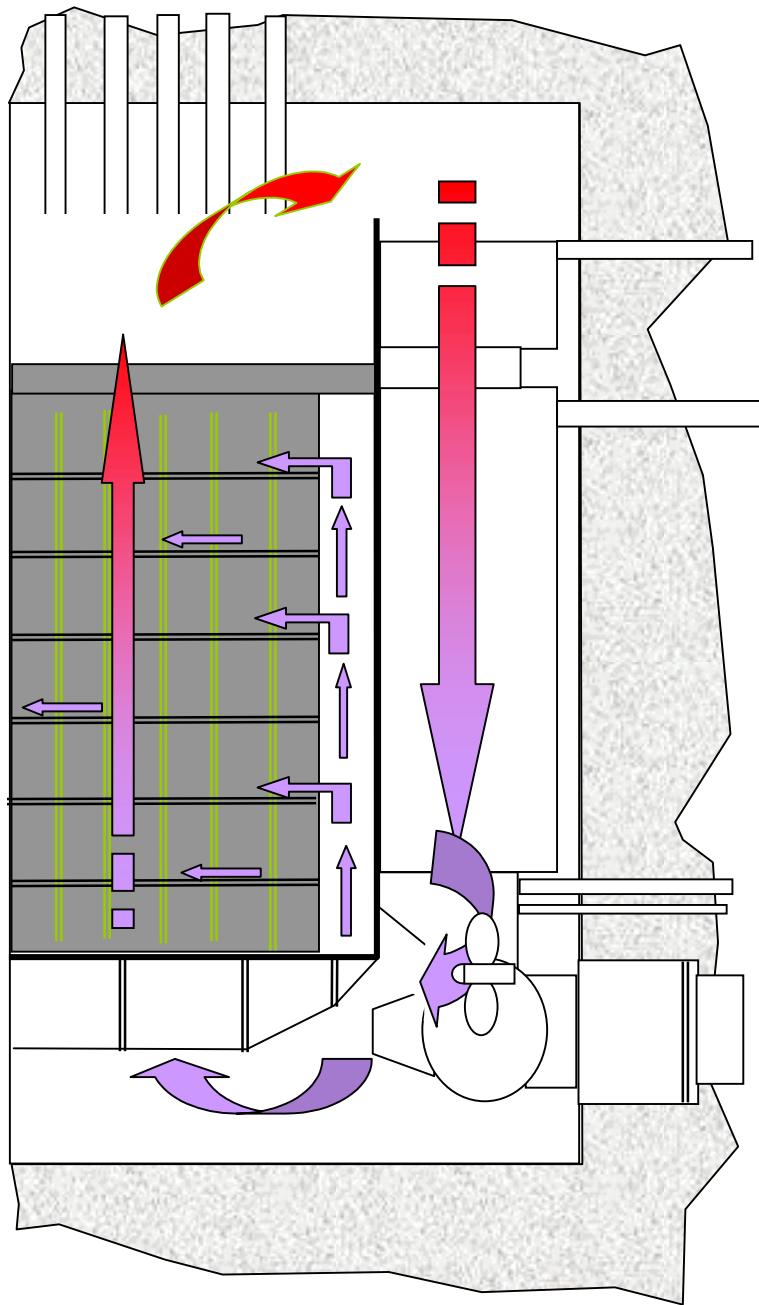
FIGURE 5 - OLDBURY/WYLFA SECONDARY AND INTERBRICK FLOWS

The interbrick flow passages serve the important fault condition function of providing coolant gas to any starved fuel channel – about 15 to 20% of the total gas flow makes up the interbrick flow. Of course, interbrick flows will only establish when there is a pressure differential from one channel to another but, for a containment boundary failure above the core (ie several standpipe failing), once that the reactor circuit has fully depressurised circulation is weak and pressure differential low.

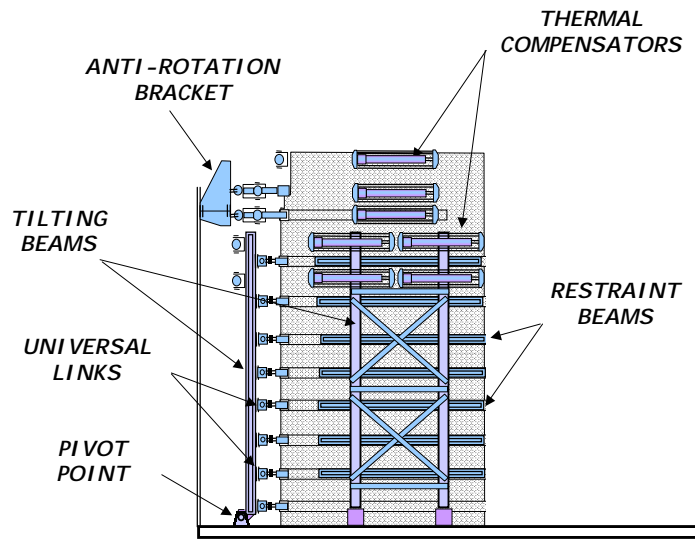
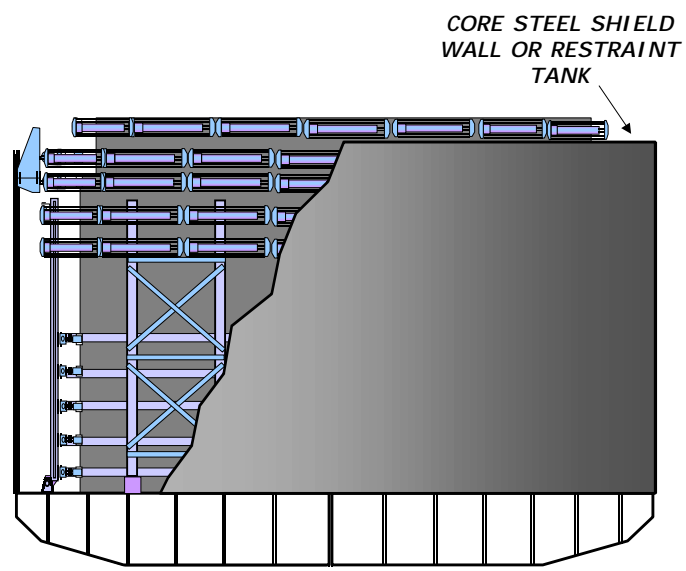
FIGURE 6 - CORE GARTER RESTRAINT SYSTEM (SCHEMATIC)

Age-related factors relating to the garter include corrosion of the components and hence loss of strength; seizure of moving parts by the growth of oxide films (rust) and carbon dust (in the coils of the thermal compensators) so a lowering of the capacity to absorb shock loading; fatigue and creep relating to its loading and movement over the years of operation; and irradiation embrittlement which will influence its fracture mechanics performance.

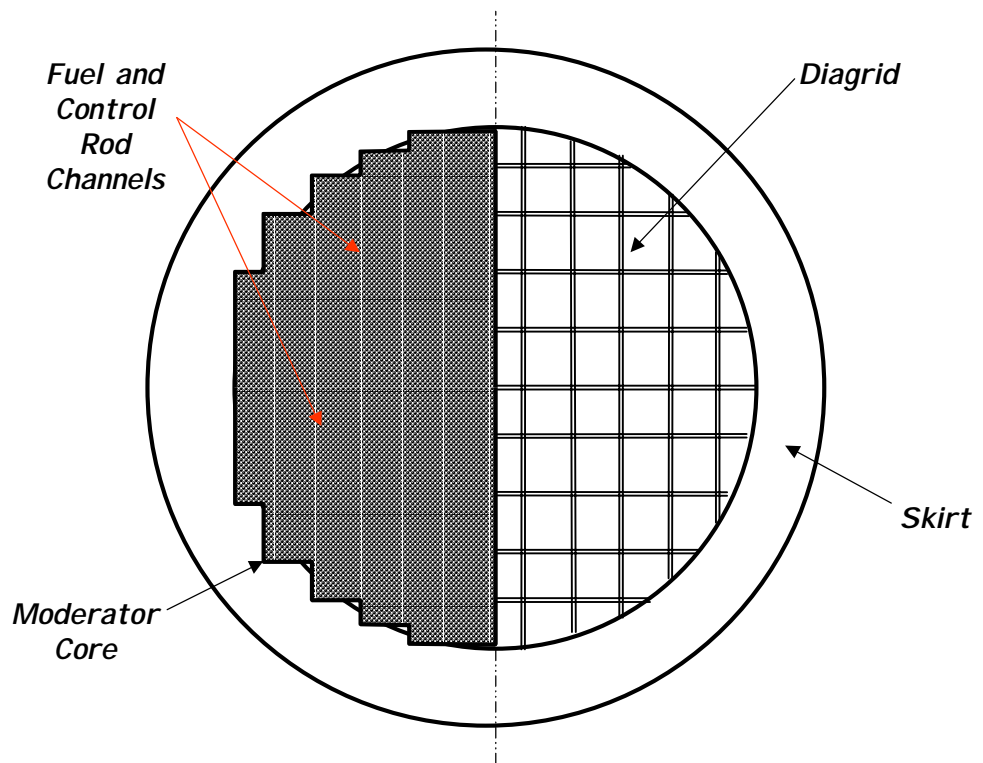
FIGURE 7 - CORE FUEL AND CONTROL CHANNELS (SCHEMATIC)

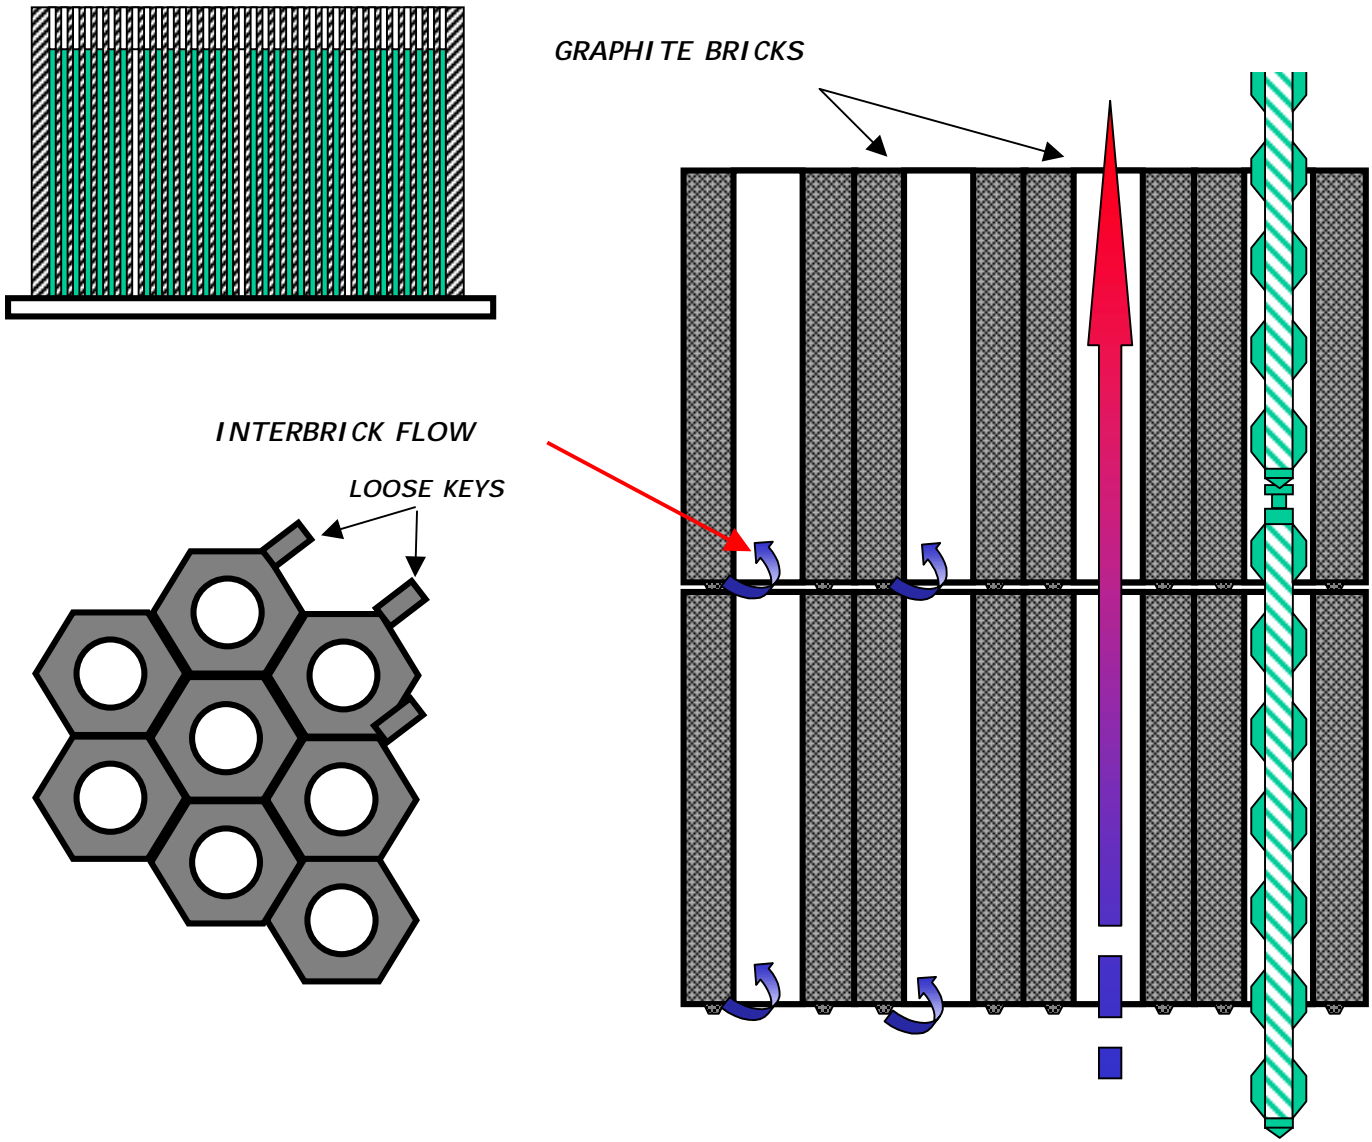
FIGURE 8 - INTERBRICK FLOWS – STEEL PRESSURE VESSEL TYPES

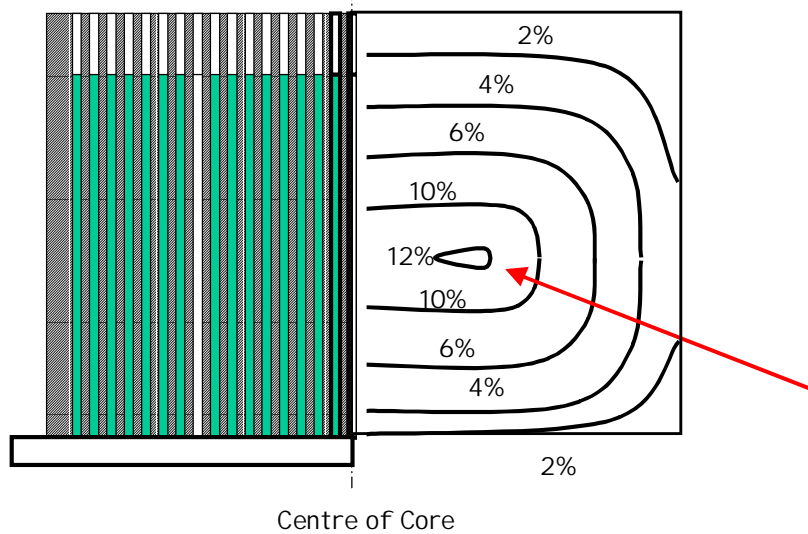
Greatest weight loss in region of highest γ flux - so greatest deposit of dust in area of highest heat source of core - total weight loss could be as high as 27% by end of life (48% at channel walls)

Data:- Oldbury at 18 years

FIGURE 9 - RADIOLYTIC CORROSION OF THE GRAPHITE CORE

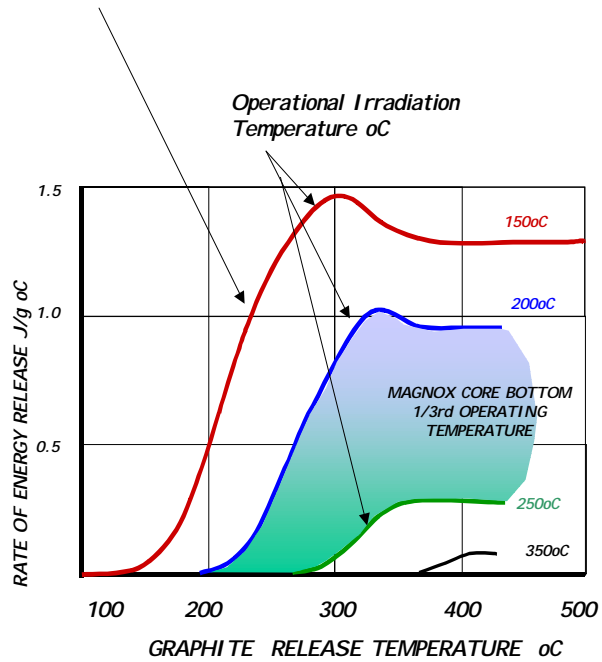
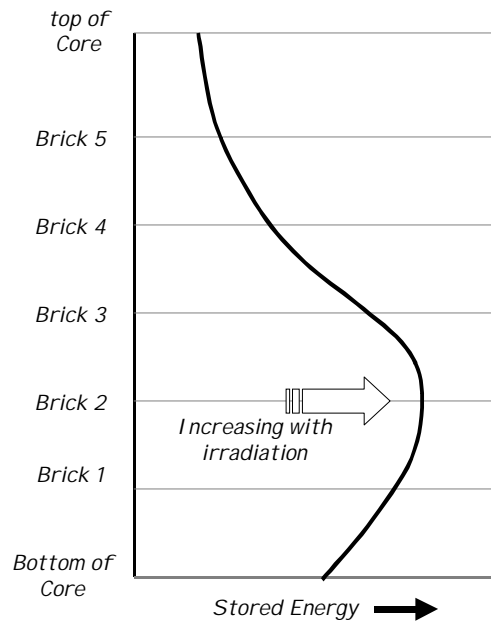
TOTAL WIGNER N BOTTOM
1/3rd OF CORE

$$2.1E3 \times 3800 \times 1000 \times 1000 / 3 = 2.66E12J$$

DURATION OF WIGNER RELEASE

$$740 / 40 = \sim 18 \text{ hours}$$

FIGURE 10 - WIGNER STORED ENERGY AVAILABILITY

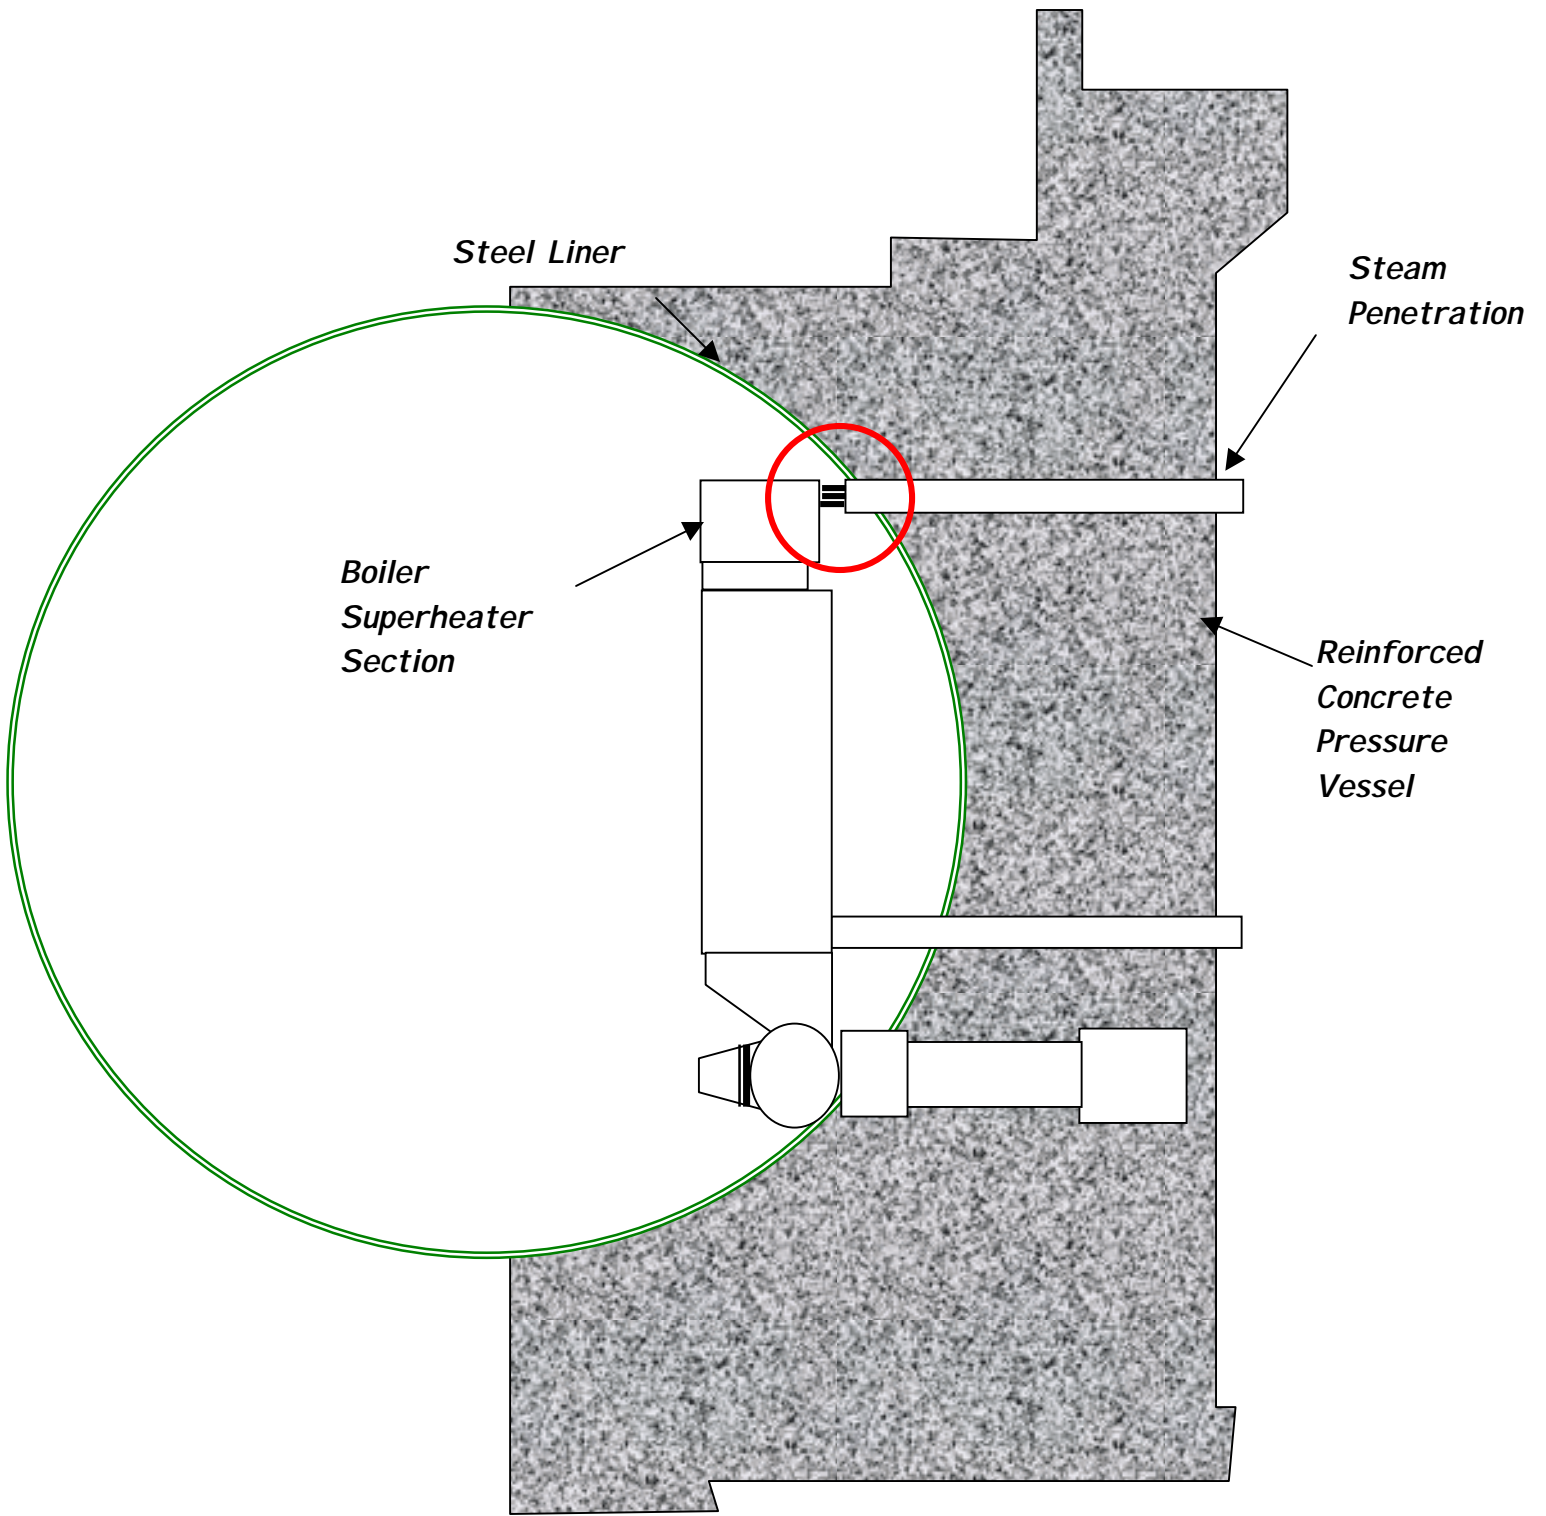
FIGURE 11: SUPERHEATER HEADER PENETRATION

Although details of the actual cracking are not available it is probable that the weld cracking is on the restraint plate that anchors the six or so superheater tailpipes as these are gathered together to pass into the reactor pressure vessel wall penetration.

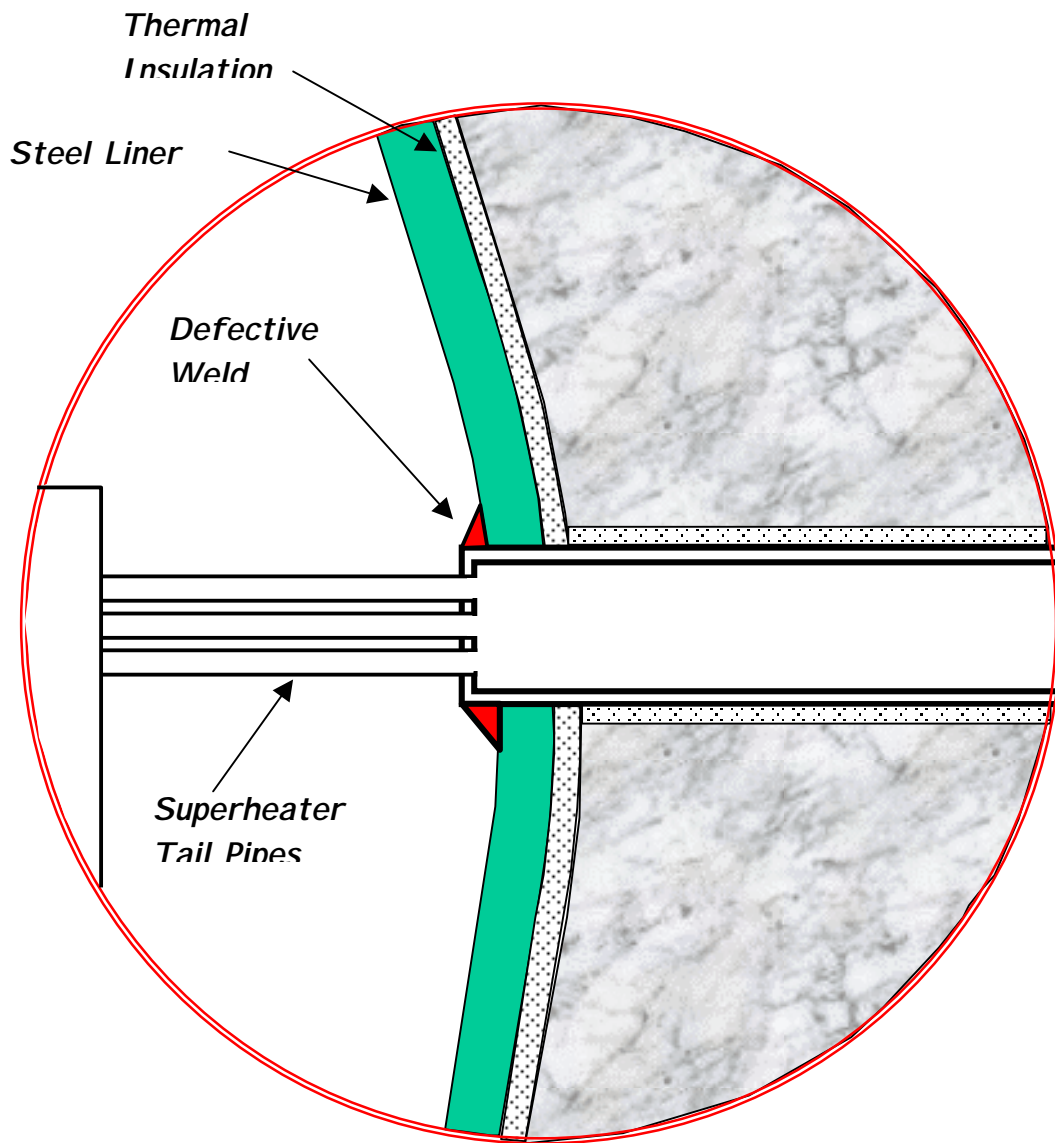
FIGURE 12 SUPERHEATER WELDING

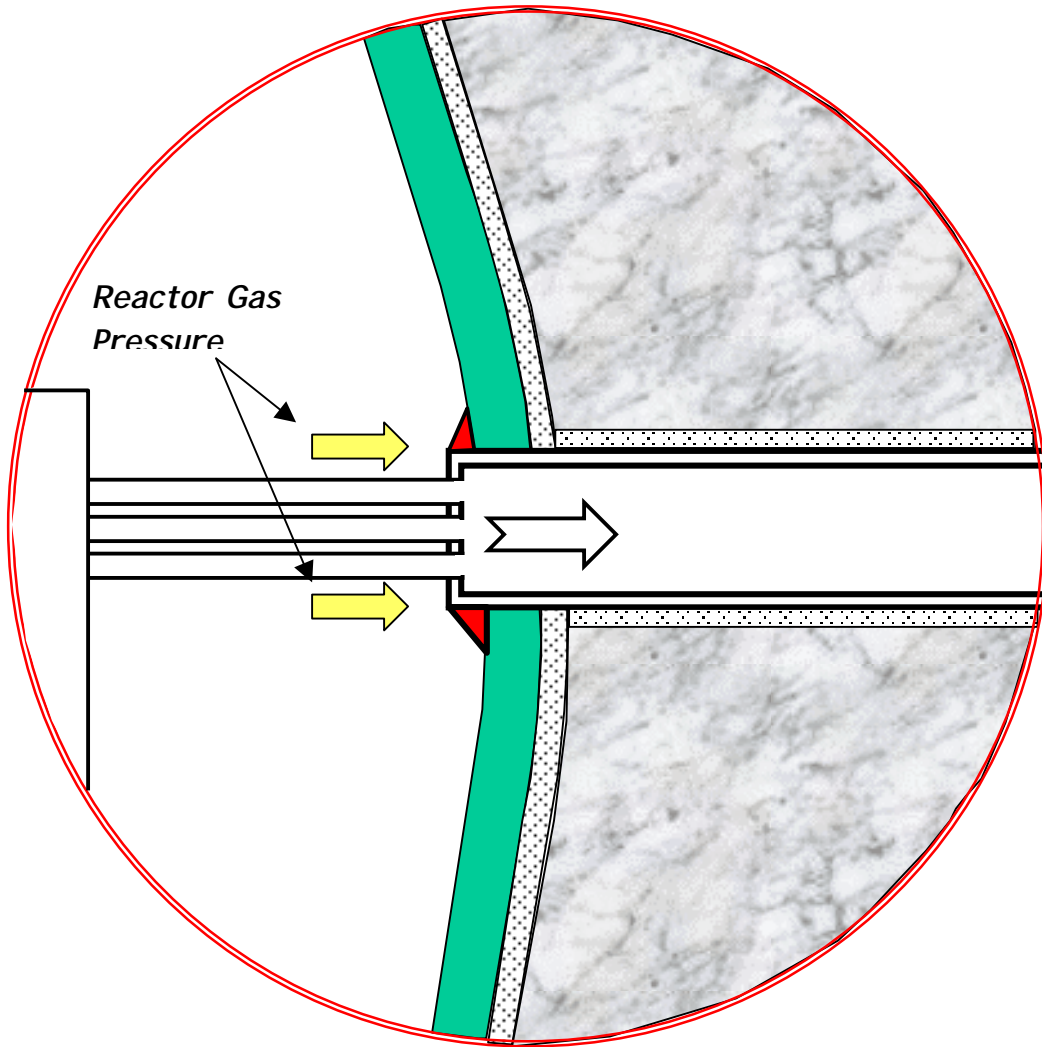
FIGURE 13 PRESSURES ON SUPERHEATER HEADER

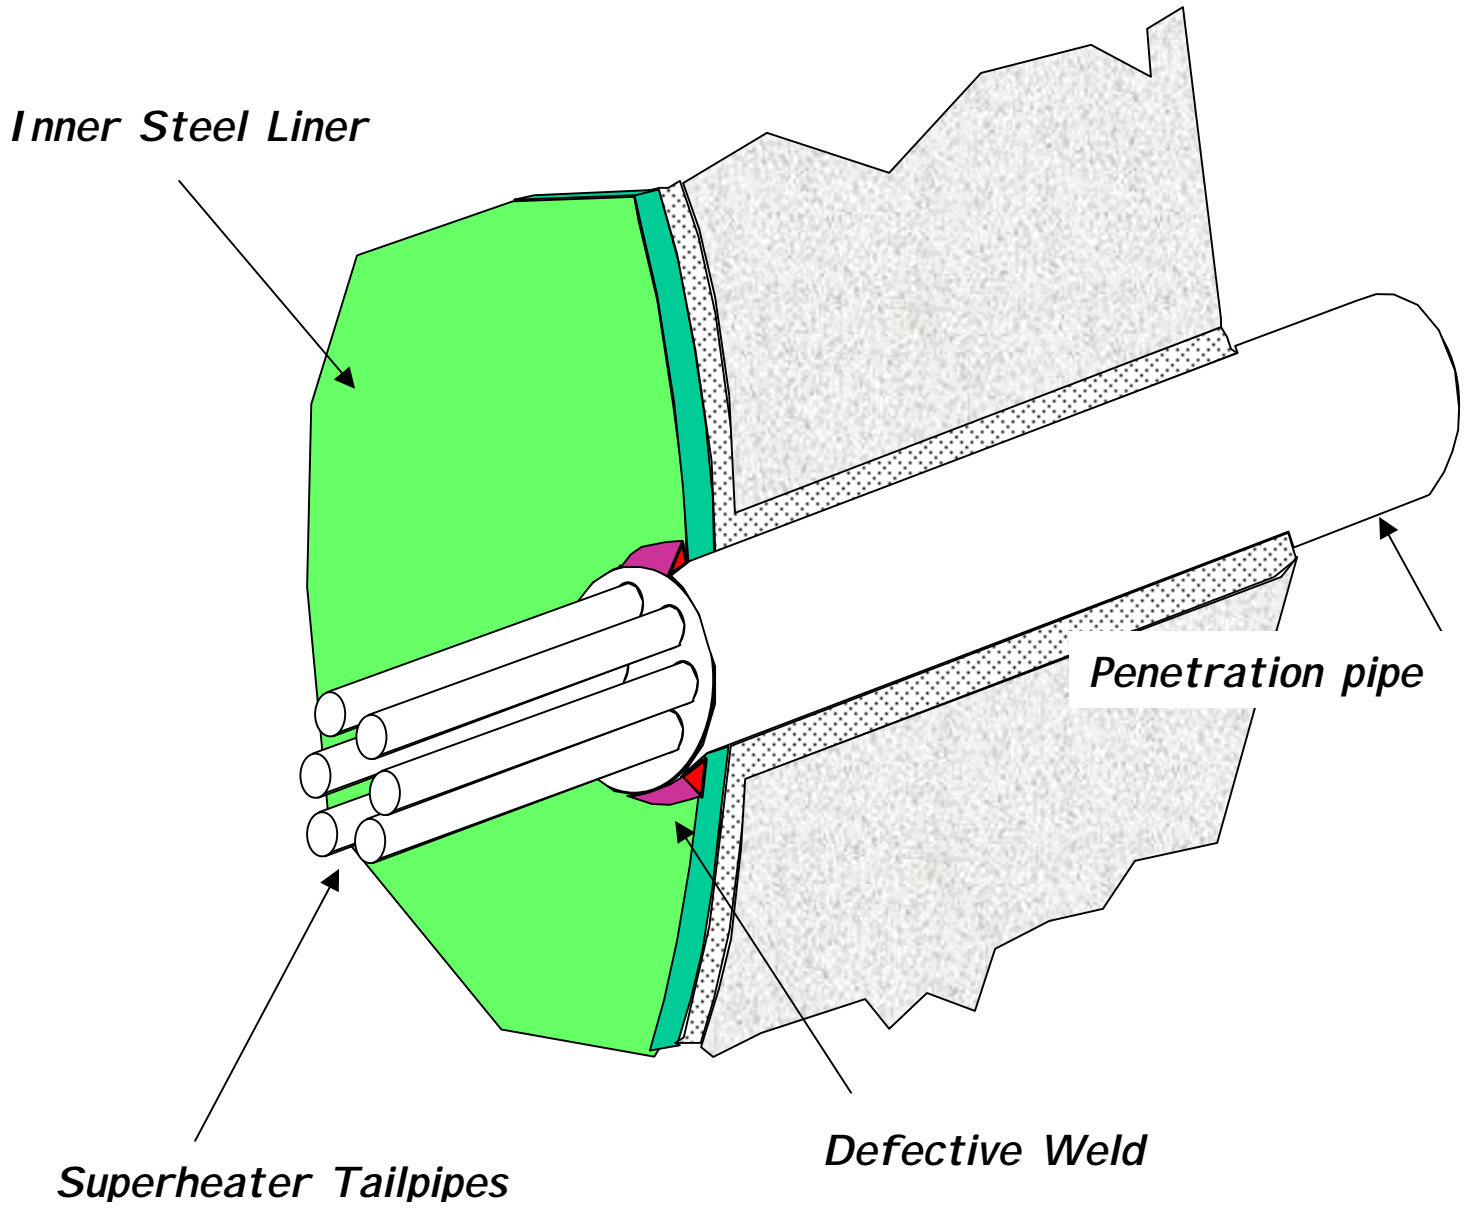
FIGURE 14 SUPERHEATER TAILPIPES AND DEFECTIVE WELD

During a routine inspection of one of Wylfa's reactor in April 2000 weld cracks were discovered at some of the thirty two locations where the steam superheater tails pass into the reactor pressure vessel penetration. As a result the second reactor at Wylfa was closed and both reactors have remained closed since that time.

The potential failure scenario for this defect is whereby the restraint fails and the superheater tailpipes physically displace, triggering a simultaneous failure of a number of tailpipes, ejection of superheated steam from the high-pressure boiler circuit and ingress into the reactor pressure vessel.²⁰
