**FORGOTTEN DOUBLE-J STENT: A CASE REPORT**Dr. Ramesh Kaundal<sup>1</sup>, Dr. D. K. Verma<sup>2</sup>, Dr. Puneet Mahajan<sup>2</sup> and Dr. Mukesh Kumar<sup>3\*</sup><sup>1</sup>MS General Surgery, Medical Officer, Civil Hospital Theog (HP).<sup>2</sup>Professor, Department of General Surgery, IGMC Shimla (HP).<sup>3</sup>MS General Surgery, Medical Officer, Regional Hospital Bilaspur (HP).**\*Corresponding Author: Dr. Mukesh Kumar**

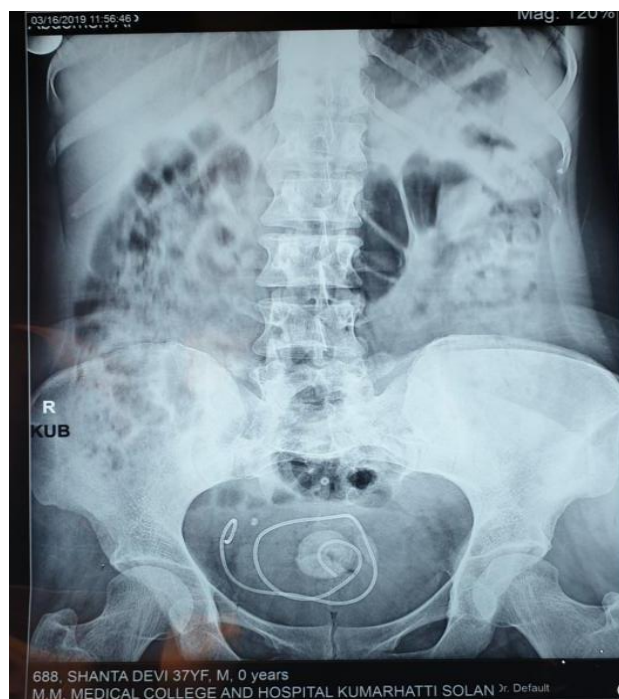
**Fig 1: X-ray KUB showing DJ stent in urinary bladder and vesical Calculi.**

On examination general physical examination was within normal limits. Patient was afebrile. Pulse was 94 per minute and blood pressure was 112/74 mm of Hg. Per abdominal examination was within normal limits. Scar of previous surgery was present. Rest of the systemic examination was normal. Routine blood investigations were within normal limits. On urine routine examination multiple pus cells were present and on urine culture growth of Klebsiella was present. On ultrasound KUB right kidney showed presence of gross hydronephrosis with dilated ureter. Left kidney was normal. DJ stent had migrated into the urinary bladder. Echogenic densities were present in relation to the DJ stent suggestive of vesical calculi. X-ray KUB was suggestive of DJ stent in the urinary bladder and associated vesical calculi. (Fig1).

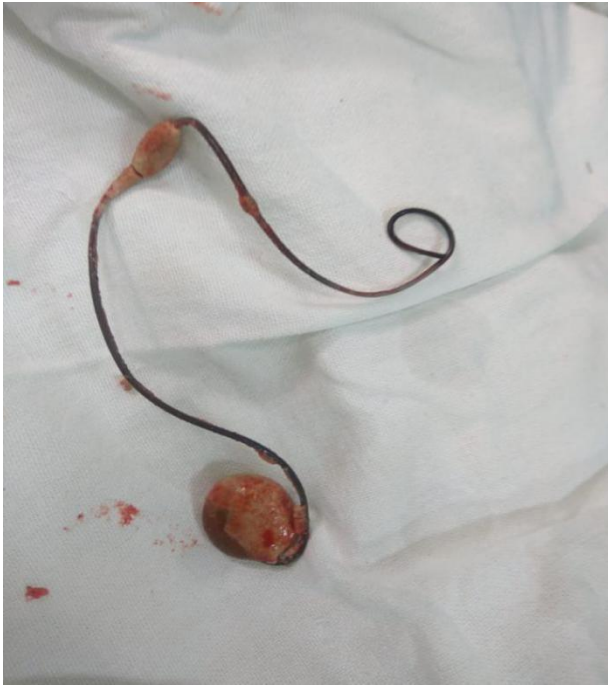
**Fig 2: Retrieved DJ Stent along with calculi.**

The patient was not aware of the DJ stent placed in her ureter during her previous surgery. The patient was hospitalized, given antibiotic treatment and was planned for cystolithotomy and DJ stent removal. On opening the urinary bladder, DJ stent was impacted in the urinary bladder and two calculi were present in relation to the DJ stent. DJ stent and the calculi were extracted (Fig 2). Drain was kept in the retropubic space of retzius.

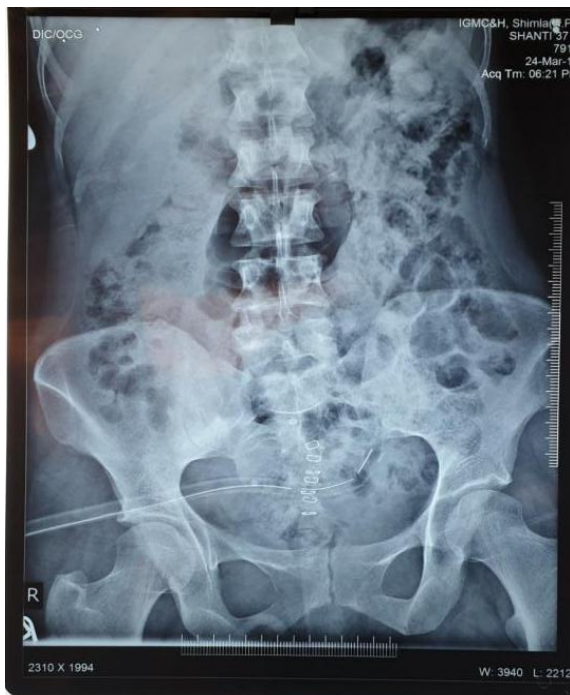
**Fig 3: Post-operative X-ray KUB with Drain in situ.**
