MUDHEN LAKE REHABILITATION DISTRICT MEETING

MEMORANDUM

Site: Mud Hen Lake

Re: Feasibility Study

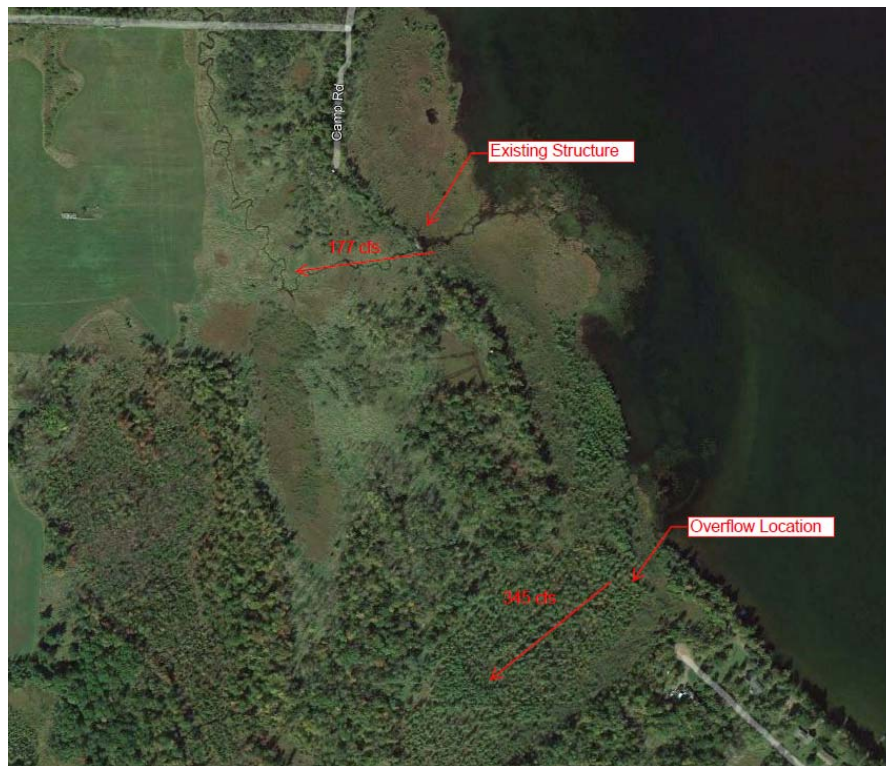
The study found that more flow exits Mudhen lake to the south through a wetland complex than goes through the existing structure. See Figure 1 below.

Before moving forward with any options, the Lake District needs to review permitting options with the DNR. Our model shows that the structure the DNR required removed, increased the 100 year flood elevation by 0.11 feet. We found that replacing the existing structure is likely not permissible under Chapter 31 as a dam (not functioning as a dam), but a permit should be pursued for a water control structure under Chapter 30. This will require a detailed study to determine how wide and what elevation the overflow should be design to. The next step to would be to share these findings with the WDNR and discuss permit options under Chapter 30.
