*Terra Vigilis Environmental Services Group*

Lake Beulah Wave Impact Study

Phase 3 Final Report

Prepared for the Lake Beulah Management District

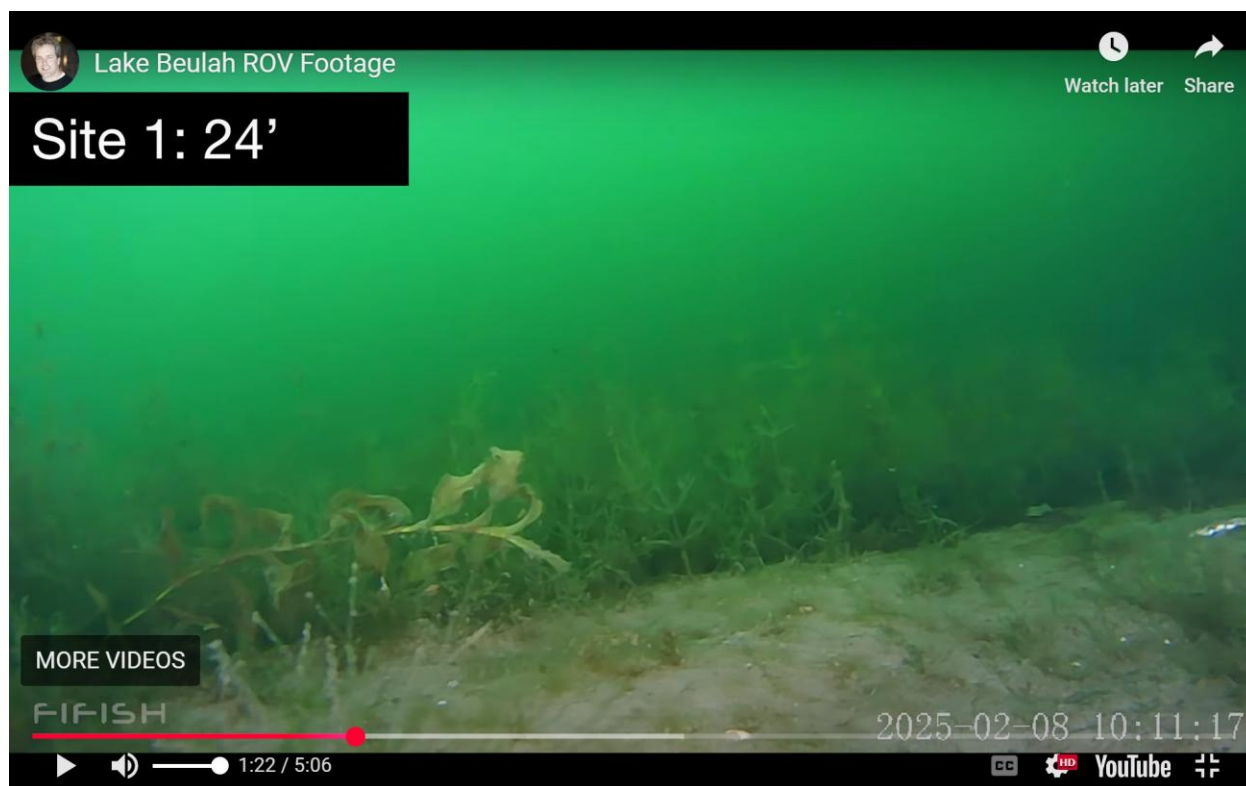
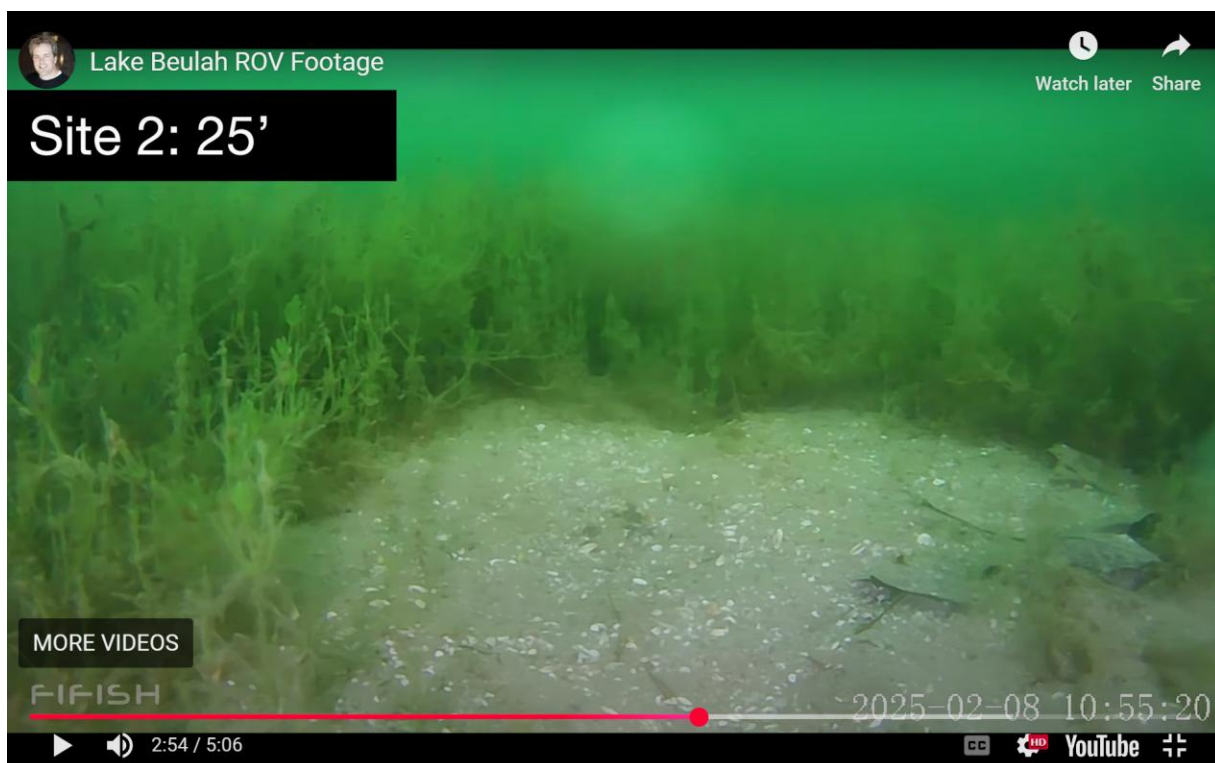
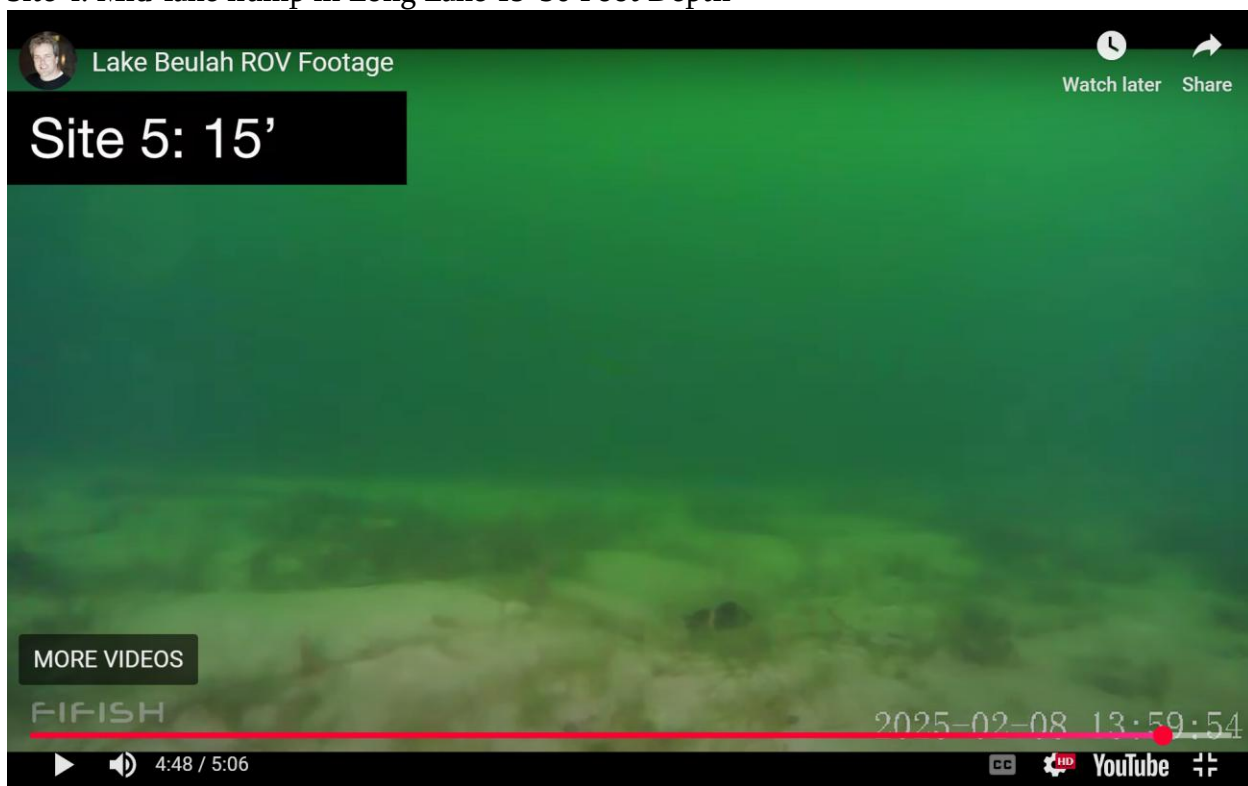
The Phase 1 Lake Beulah lake bottom survey results were gathered on 8 February 2025. A winter ice tent structure was erected at the pre-selected sites chosen by the LBMD authority. (See Figure 6) Multiple sites were used to gather lake bottom data imagery with a commercial submersible ROVER vehicle operated by a TVES professional commercial drone pilot using virtual FPV (First Person View) goggles and computer consoles as shown in the methodologies section. Clear evidence of substantial lake bottom disruption is revealed in these images. Of significance, the aquatic plant damage is extensive and notable for plant loss in large areas of the survey. Plant survey data provided to TVES by the LBMD establishes that these areas are heavily populated by several aquatic plant species including Cabbage (Broad-leaf Pondweed), Coontail and Chara. (See Figure 11)

[Figure 11 Phase 1 Video Survey of Lake Bottom at Sites 1-5](#)

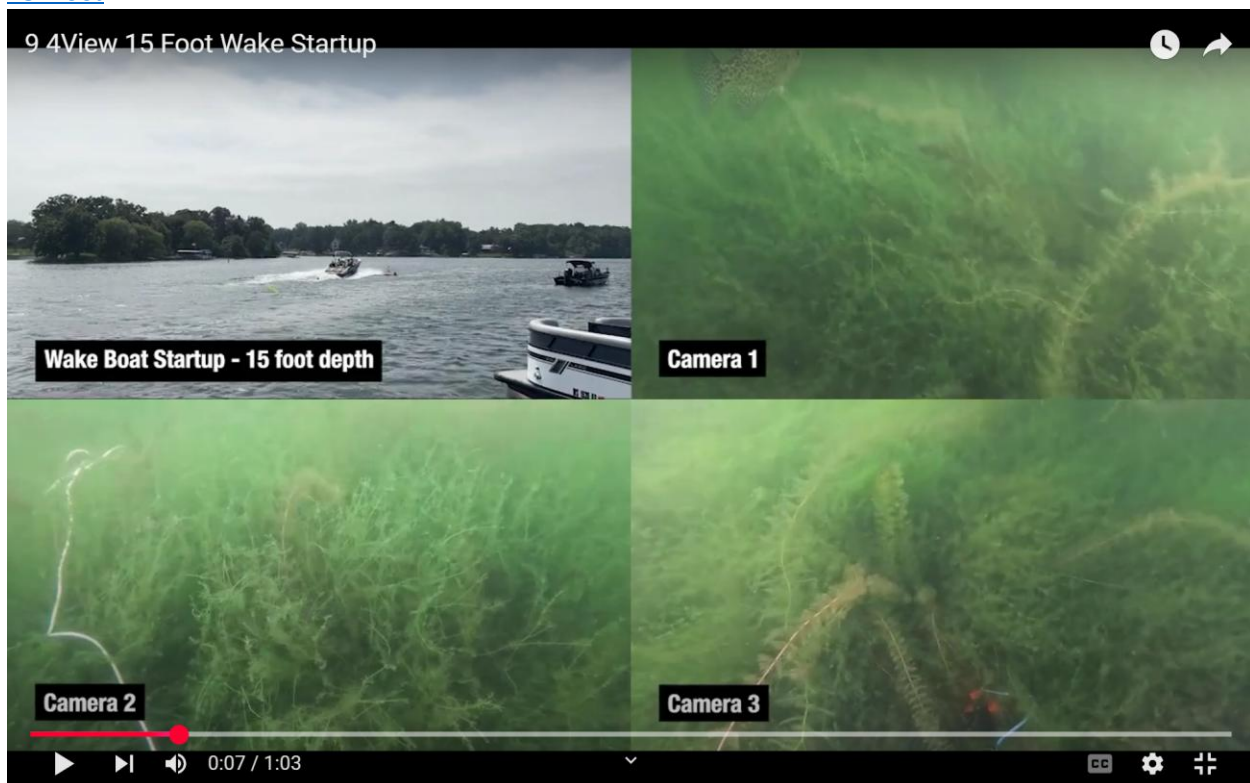
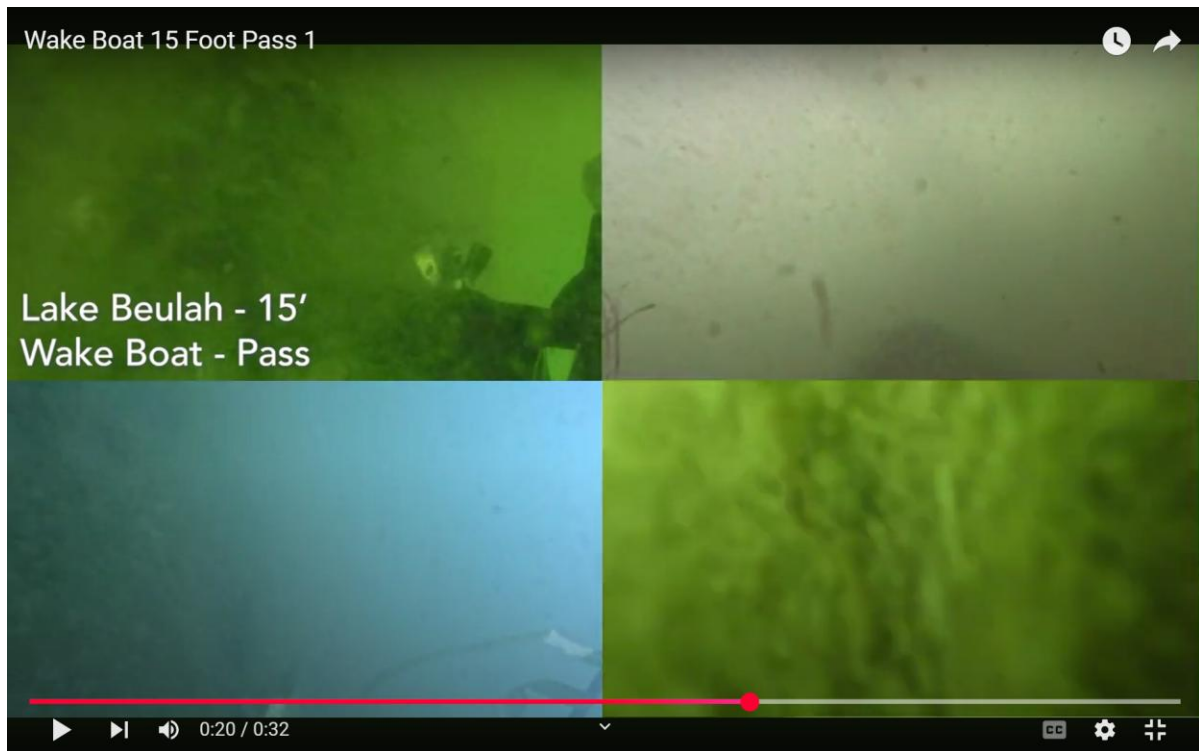
Phase 2 subsurface waves and propeller downwash test results reflect comparative data on subsurface impacts effected by a wake boat in surf mode and a planing water ski boat. Figures 12-15 reveal impacts to the lake bottom (sediment and plant disturbance) in both 15', 21' depths by wake boat in surf mode operations both for start-up and buoy pass (at operational speed) testing conditions. Minimal apparent impact is shown at 25' depth (a site with marl lake bottom and devoid of plant habitat). See Figures 16-17. Figures 18-19 do not reveal planing water ski boat impacts to the lake bottom at depths of 15 feet or greater. In the Phase 2 study, sediment disruption was not apparent at 25-foot depth due to several factors including: hard marl lake bottom at Site C, and propeller downwash angle and energy from the wake boat obtained and used for the Phase 2 study.

[Fig. 12 Phase 2 Subsurface Waves and Propeller Downwash Impacts of Wake Boat Startup at 15 Feet](#)

[Fig. 12A Phase 3 Subsurface Waves and Propeller Downwash Impacts of Wake Boat Startup at 15 Feet](#)

[Figure 13 Phase 2 Subsurface Waves and Propeller Downwash Impacts of Wake Boat Pass at 15 Feet](#)

[Figure 14 Phase 2 Wake Boat Startup at 21 Feet](#)

[Figure 15 Phase 2 Wake Boat Pass at 21 Feet](#)

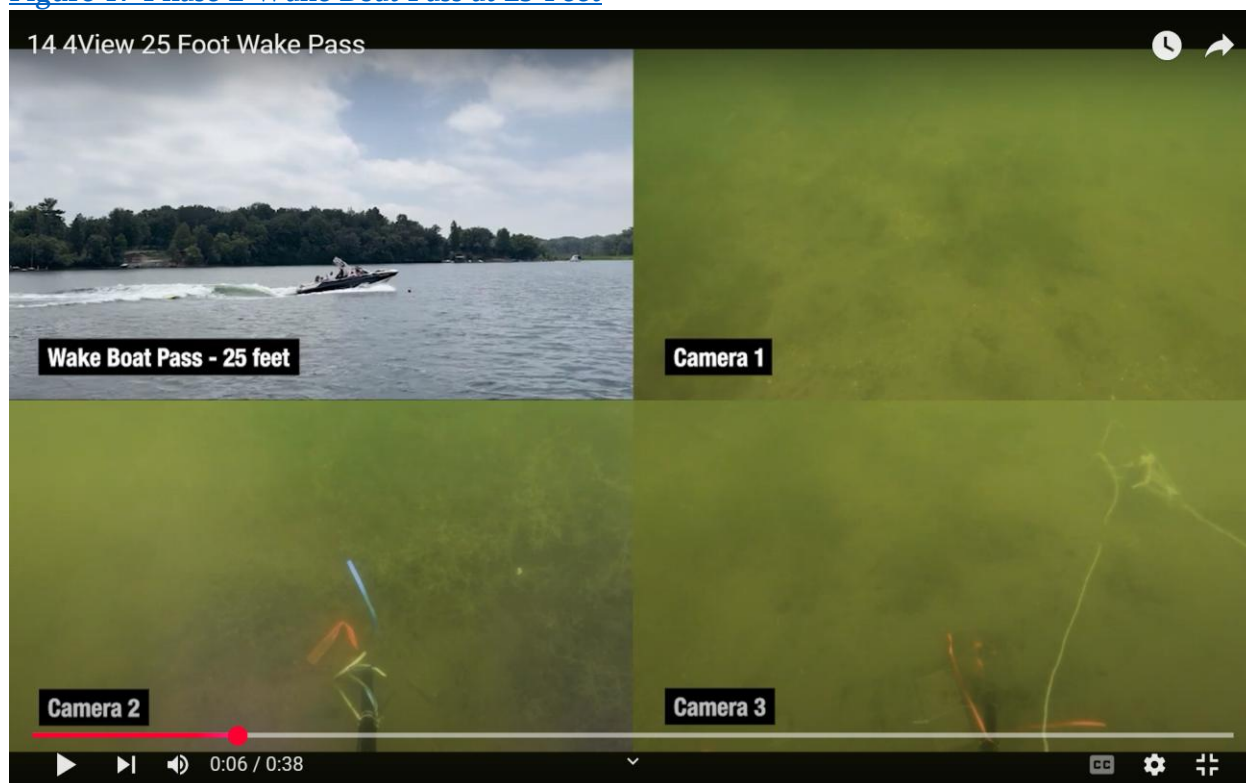
In the Phase 3 study with a more representative Wake boat in surf mode with a larger water displacement (weight) and larger engine (430hp), sediment movement was observed at 25-foot depth. Similar findings of sediment disturbance and redistribution at 26-foot water depth at Lake Waramaug (TV-ES study) can be attributed to the presence of deep penetrating subsurface waves from the wake boat in surf mode and the presence of fine silt sediment on the lake bottom.

The TV-ES In-lake studies at Lake Waramaug and Lake Beulah provide videos at 26' and 25' respectively showing fine sediment (dark silt) moving onto and off the gray brick used to anchor the camera tripod. Fine silt needs a water velocity less than 0.3ft/sec to move it. The SAFL Phase 2 report describes and confirms that water movement caused by bow/stern waves and transverse waves go even deeper than from propwash, and the sequence of when they occur relative to the boat passing overhead are confirmed by the videos. In previous reports all of those hydrodynamic effects were typically classified just as propeller downwash, however with the videos and the vessel displacement hydrodynamics explanation, there is now a better understanding and appreciation of the various and specific hydrodynamic effects that each cause sediment movement at those depths (i.e. bow/stern waves and transverse waves in addition to and separate from propeller downwash).

[Figure 16 Phase 2 Wake Boat Start-up at 25 Feet](#)

[Figure 17 Phase 2 Wake Boat Pass at 25 Feet](#)

[Figure 17A Phase 3 Wake Boat Pass at 25 Feet](#)

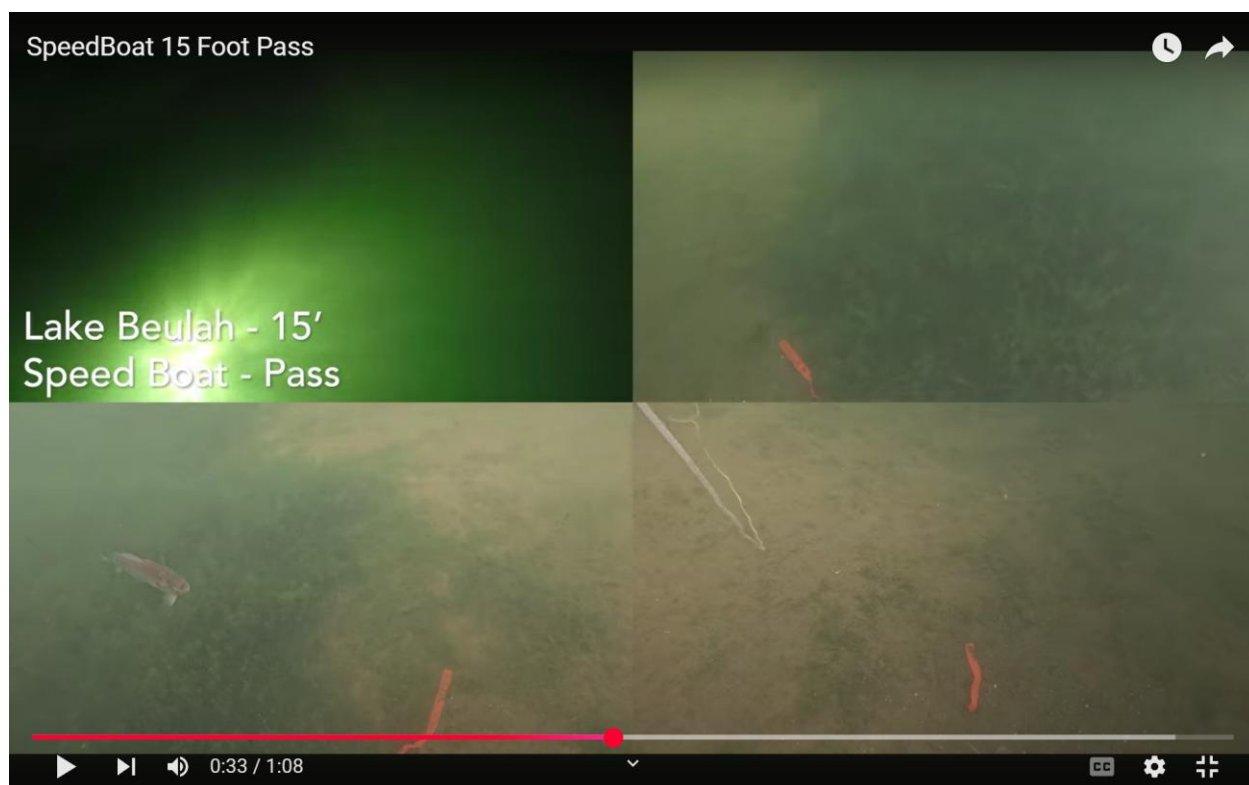
[Figure 18 Phase 2 Speed Boat Startup at 15 Feet](#)

[Figure 19 Phase 2 Speed Boat Pass at 15 Feet](#)

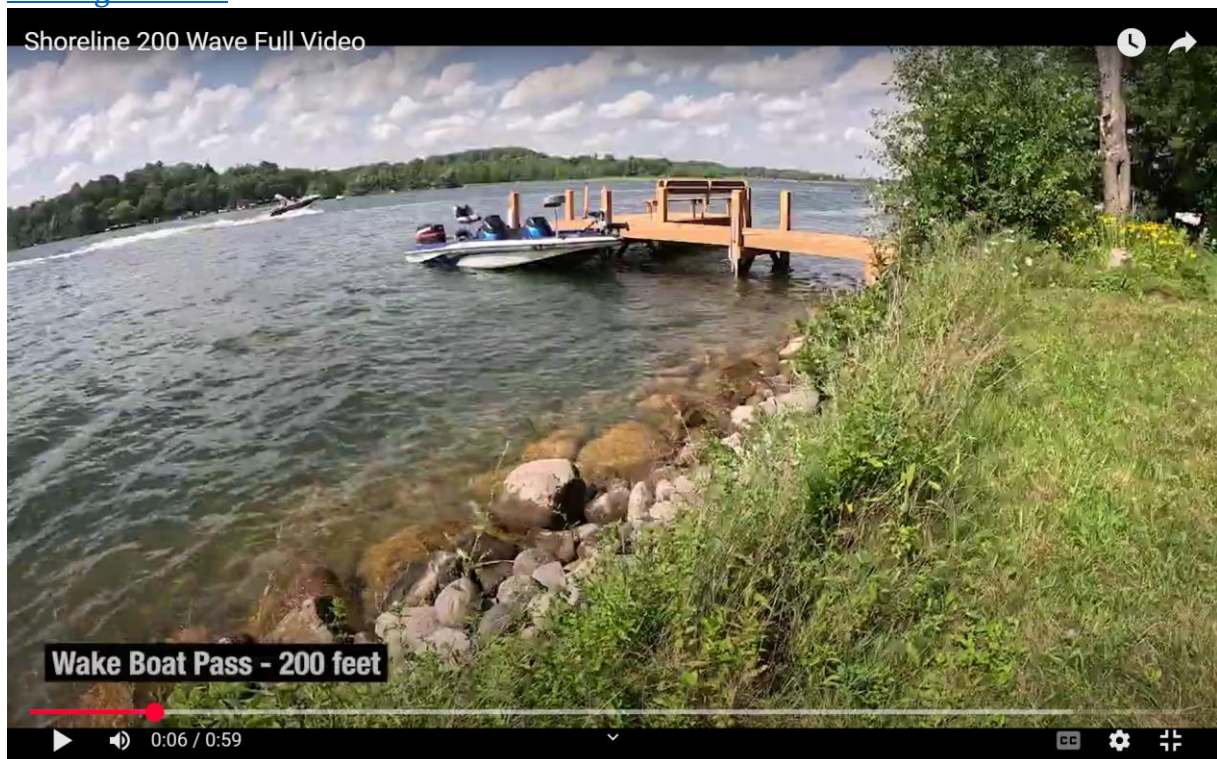
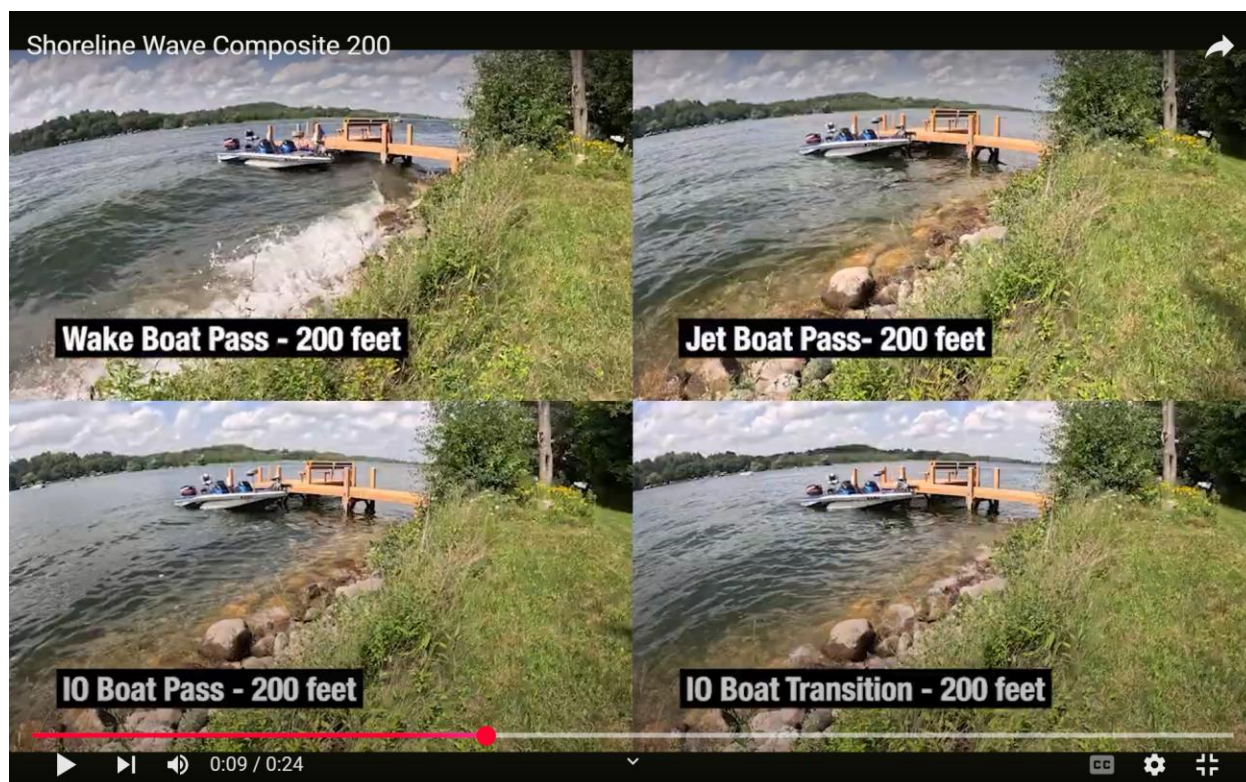
[Figure 20 Phase 2 Waves Generated 200 Feet from Shoreline of Wake Boat in Surf Mode vs. Planing Ski Boat](#)

[Fig 20A Phase 3 Waves Generated 200 feet from Shoreline with Wake Boat in Surf Mode](#)

Figure 20B Phase 3 Comparison of Waves generated 200 feet from Shoreline

Wave Heights on average were at least 2X as high for Wake Boats in Surf Mode compared to planing Boats at the same 200-foot distance from shore.

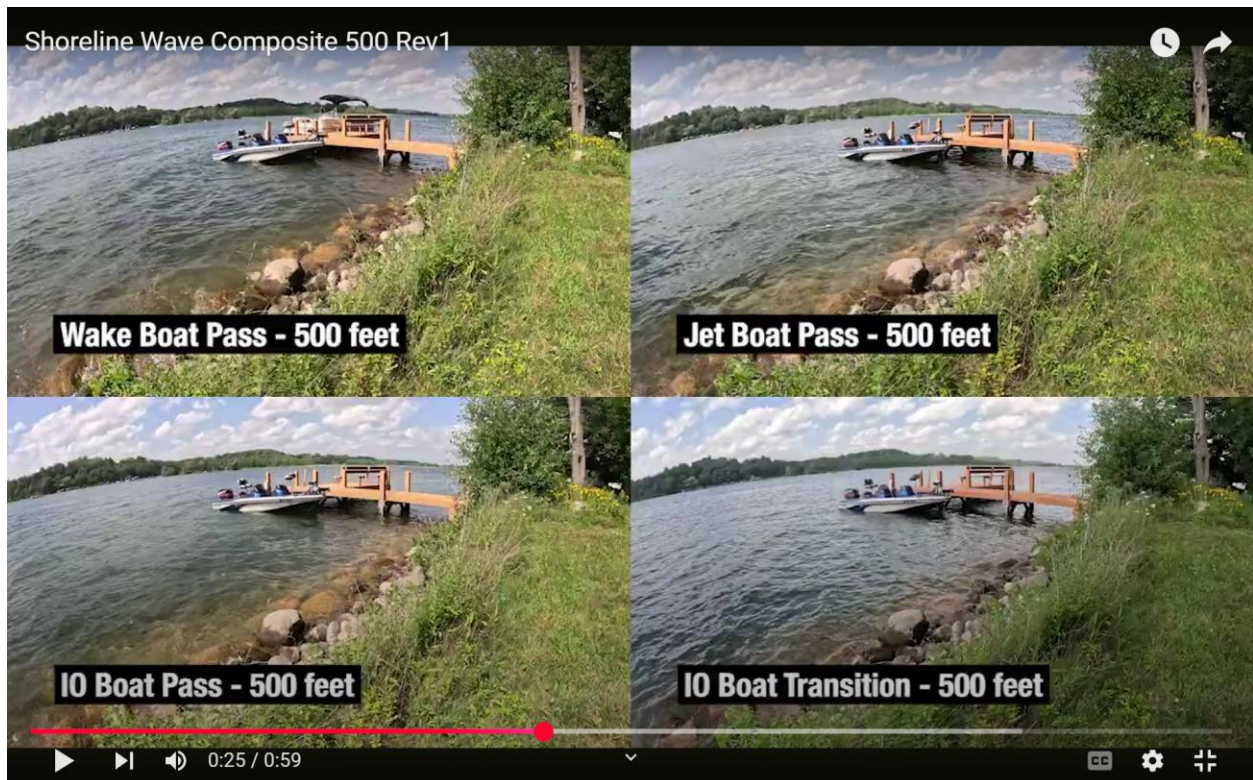
Figure 23: Phase 3 Comparison of Waves Generated 500 feet from Shoreline

Figure 23A: Phase 3 Comparison of Wake Boat in Surf Mode at 500 feet versus Other boats at 200 feet
