**SLOPE EROSION CONTROL AT SHAH ALAM, SELANGOR, MALAYSIA**  
**SHAH ALAM, SELANGOR, MALAYSIA**

Slope Protection

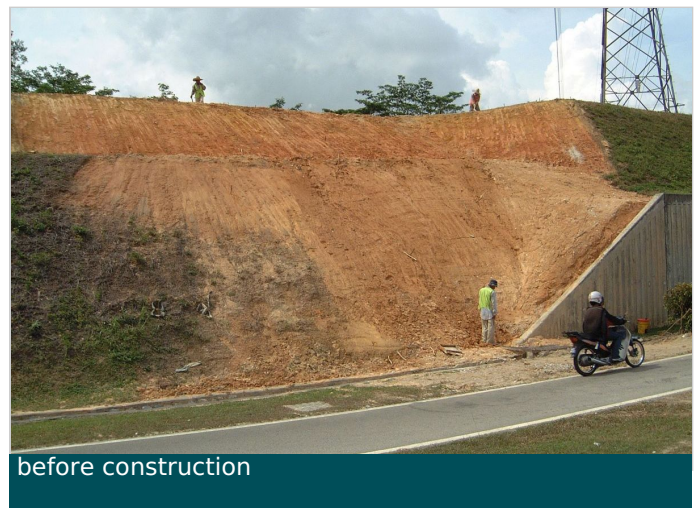
Prolonged and intensified rainfalls severely eroded and caused a shallow slip failure of a steep slope exceeding 50° angle. The affected area was just next to Federal Highway Batu Tiga Toll Plaza, a highly trafficked area. In addition to the alarming condition, an electric pylon is standing near the failing slope. The client cum concessionaire, Projek Lebuhraya Utara - Selatan (PLUS) Bhd had instructed immediate measures to rectify the problem and the consultant was tasked to come up with an economical and pro-environmental solution

before construction

The common remedy adopted by most engineers for this type of problem would be the use of rubble pitching but this was not recommended by the consultant because it does not harmonize aesthetically with the existing vegetated surroundings. Recognizing the elements to satisfy, we proposed Reinforced Enkamat as it has the capability to control erosion, whilst acting as turf reinforcement mat. Fundamentally, Reinforced Enkamat was chosen as the best solution because it enhances the growth of vegetation and prevents surface erosion. Technically or aesthetically, it is a combination that works.

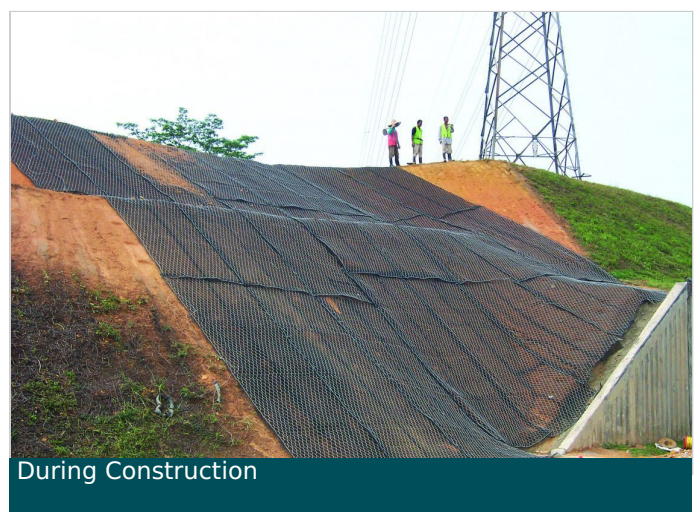
During Construction

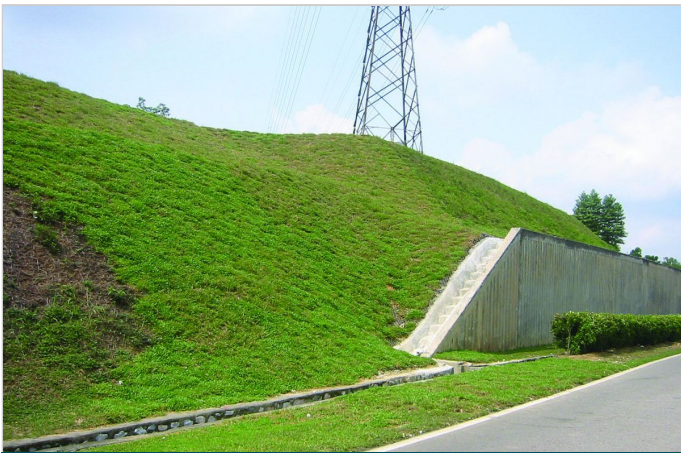
after construction
