## A90 TRUNK ROAD SCHEME PORTLETHEN, ABERDEEN, UNITED KINGDOM

### Slope Protection

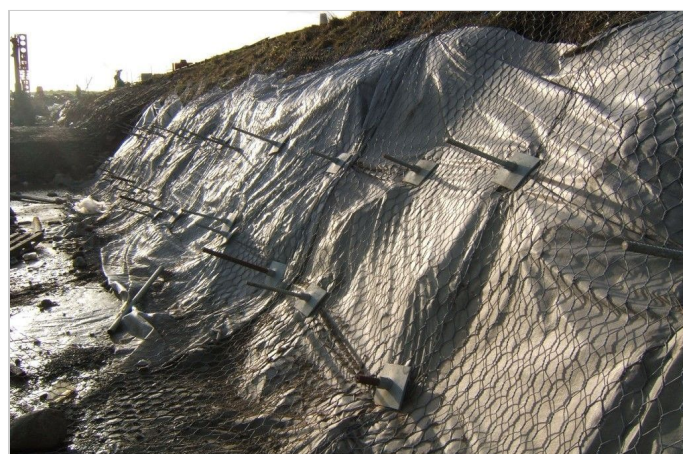
Empty Geomacs, placed on soil-nailed slope

This was excavated in 1.5m deep stages to allow the Geomac Mattresses to be fixed as work progressed. Dywidag soil nails, 8-10m in length were drilled and fixed to the Geomac Mattresses creating an efficient, stable structure.

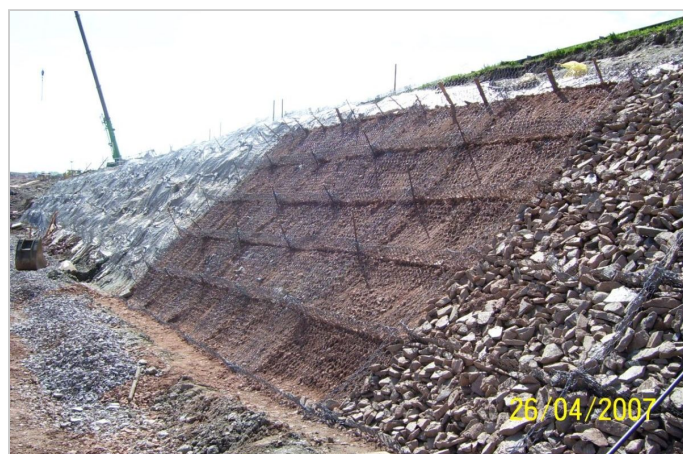
Geomac during installation showing partially filled units

Geomac Mattresses are large flat wire cages, similar to gabions, 6m x 2m x 0.23m, lined with filter fabric and filled with stone and soil. When installed and seeded, they create stable erosion protection panels of retained and encapsulated topsoil that promote rapid vegetative growth particularly on wet slopes and, in the case of the Portlethen Interchange, on steeply sloping dry embankments.

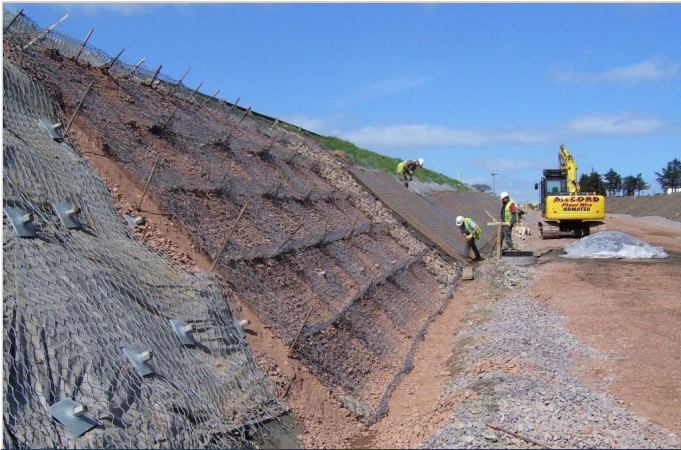
Geomac during installation

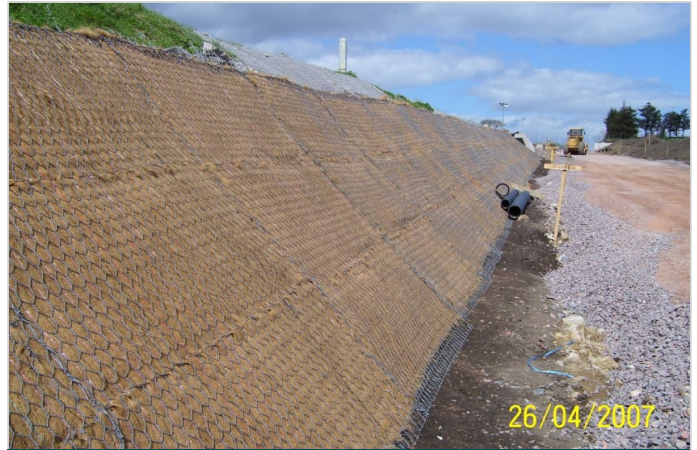
After installation, prior to vegetation establishment

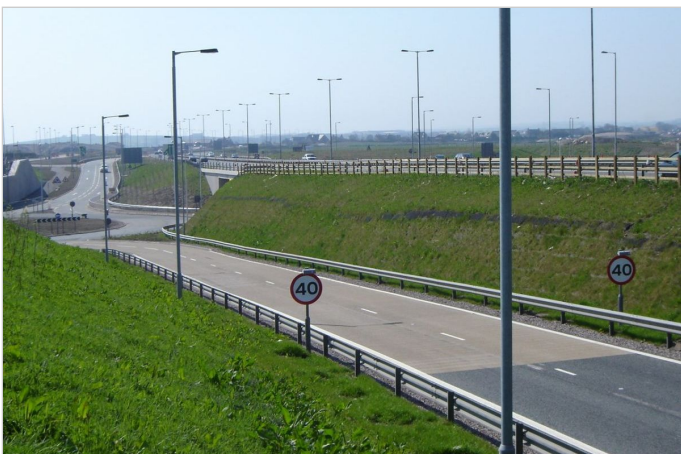
After construction, showing successful vegetation
