SSSI SITE — RIVER SEVERN ESTUARY RIVER SEVERN, GLOUCESTERSHIRE, UNITED KINGDOM

Revetment Protection

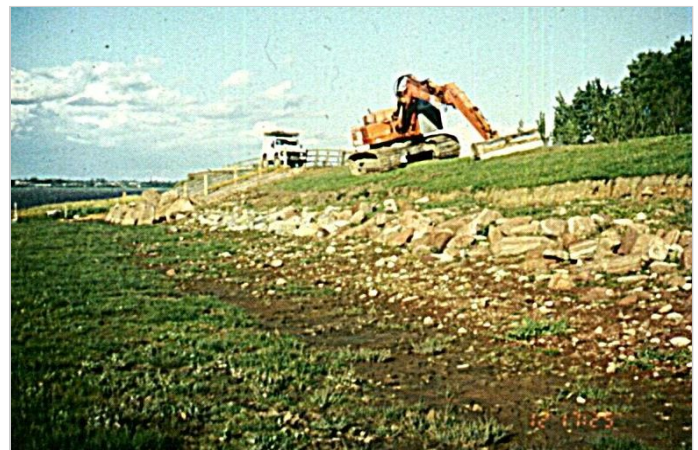
A 200m stretch of the river Severn in Gloucestershire had suffered acute erosion along the high tide line. This flood bank had already been protected with stone cladding, which unfortunately had not offered sufficient erosion protection. The mud flats in front of the flood bank are designated a SSSI which meant that engineered solutions required special consideration.

Existing scour line

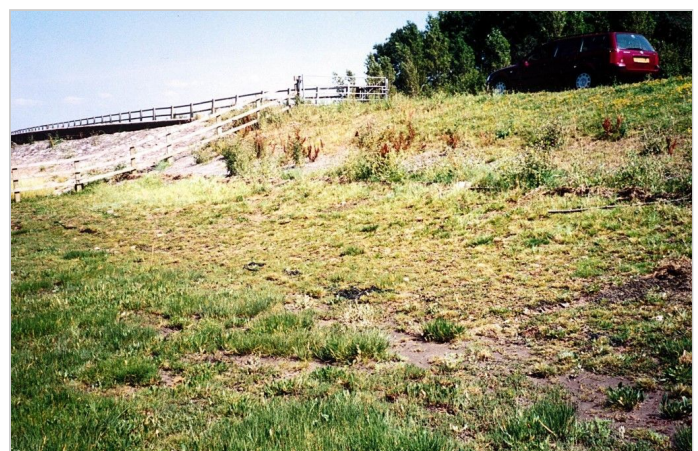
Newly installed Reno mattress / Geomac

As the erosion was acute, there would be no way that a soil-bioengineering solution alone (coir logs, root balls, riparian wattles etc) would offer sufficient erosion protection. Therefore, Maccaferri Ltd proposed an integrated design using stone filled Reno mattress base units made from double twisted hexagonal wire mesh. These units were laced together and filled with suitable stone. To accelerate the growth of vegetation, soil was then brushed in to fill the voids and to hide the stone surface this solution is also called Geomac.

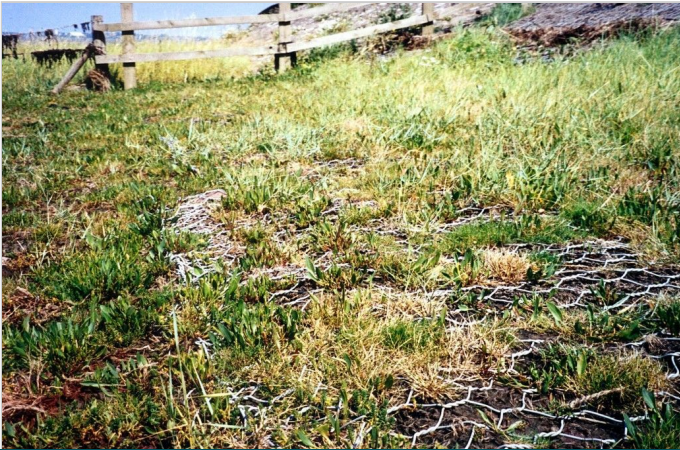
SSSI established in the Geomac
