## EROSION CONTROL AT LE MONT GABARD ST MARTIN ST MARTIN, JERSEY, UNITED KINGDOM

### Slope Protection

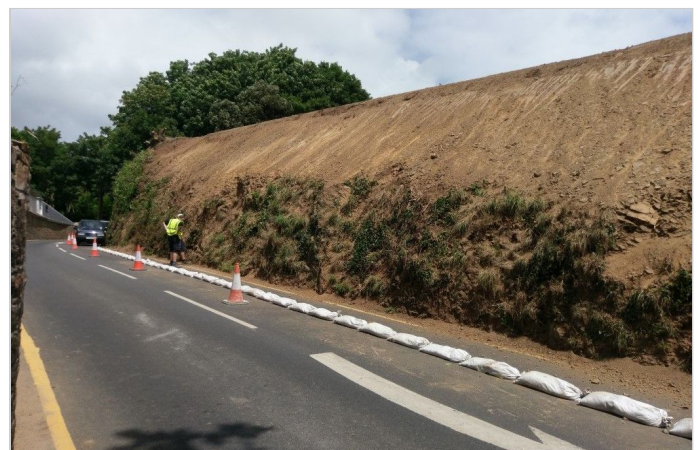
Pre-construction before the installation of MacMat® R

A large soil embankment on the side of a busy road started to deteriorate causing debris to fall thus causing potential danger for motorists and citizens using the route.

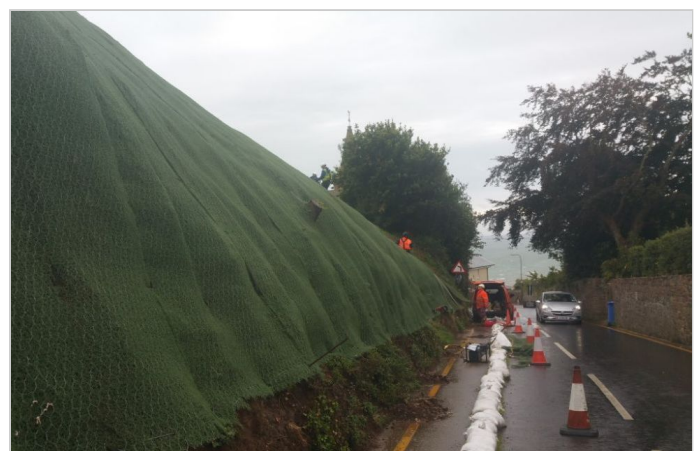
During construction in August 2016

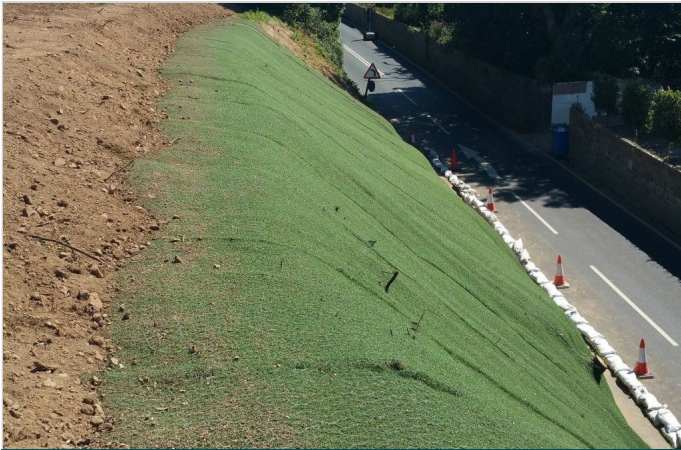
Completed construction and installation of MacMat® R

In the photos, you can see that the net nicely diffuses into the soil creating a smooth form.
