ÇÖPLER GOLD MINE ROCK FALL PROJECT

ERZİNCAN, DOĞU ANADOLU, TURKEY

Surface Strengthening and Support

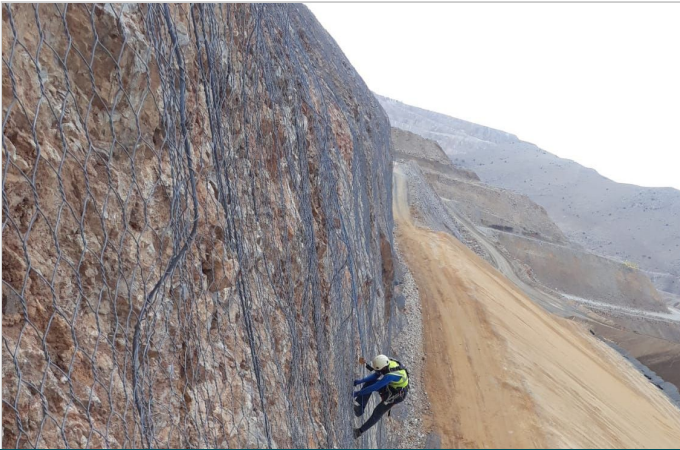
During construction

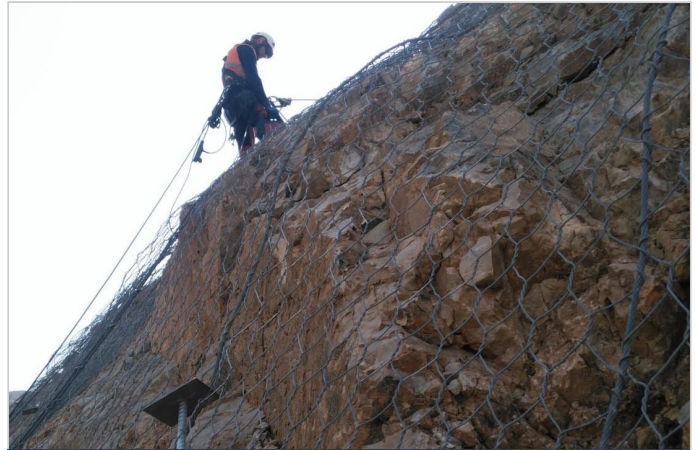
During construction

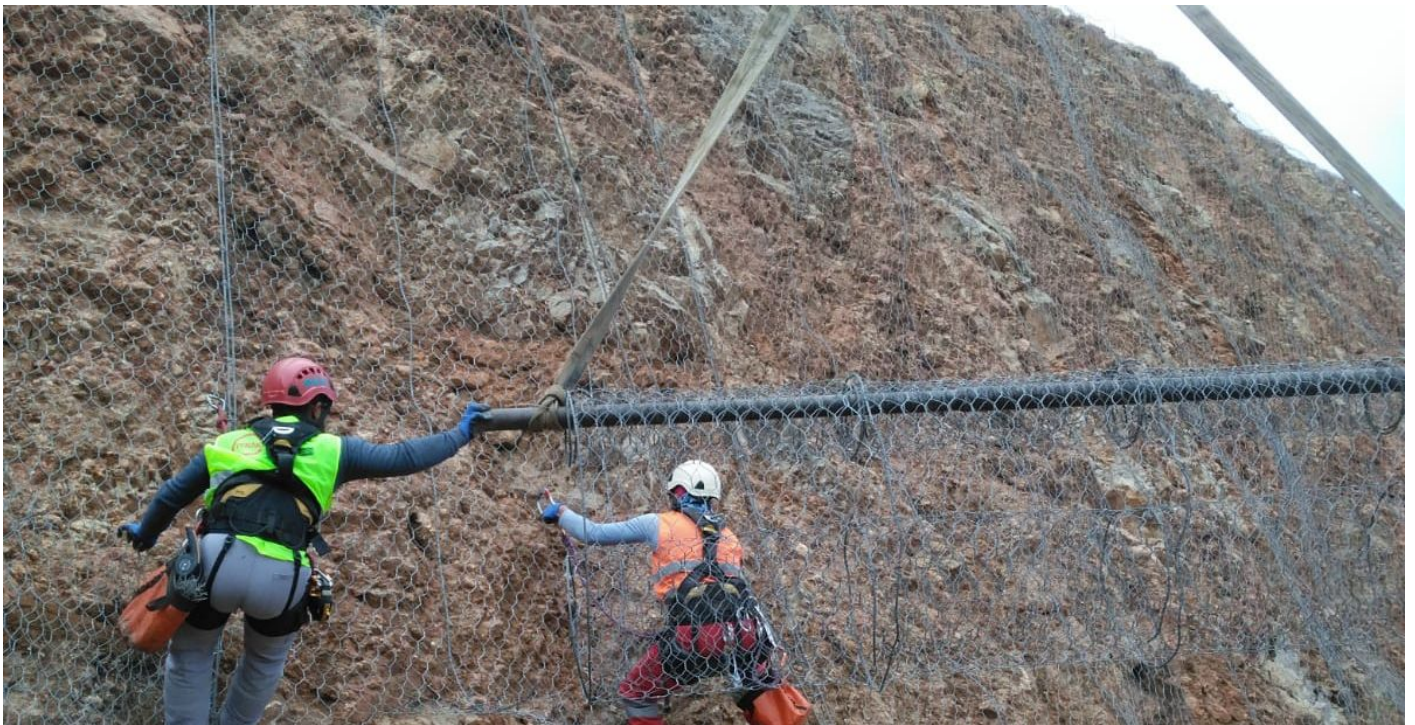
During the construction
