## ON THE RIGHT TRACK AT CUMBERWORTH

### CUMBERWORTH, NORTH YORKSHIRE, UNITED KINGDOM

#### Dynamic Barriers

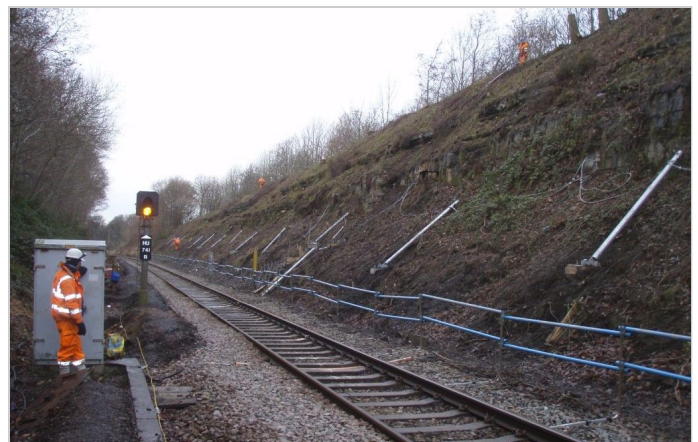
Catch fences being installed on the Cumberworth Tunnel line

The situation ultimately chosen was the installation of a network of high-strength dynamic rockfall catch fences

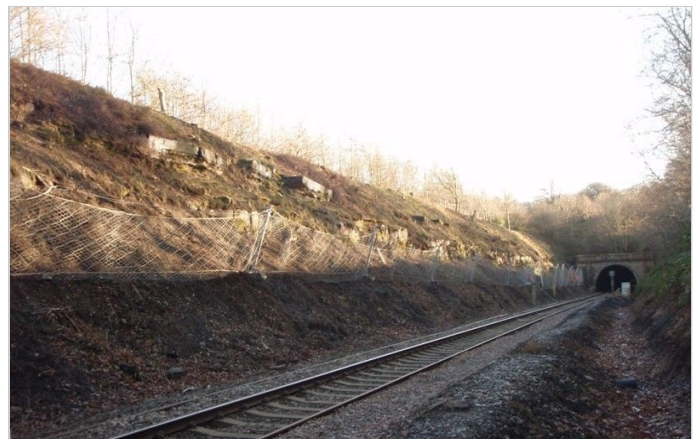
Catch fences installed on the Cumberworth Tunnel line

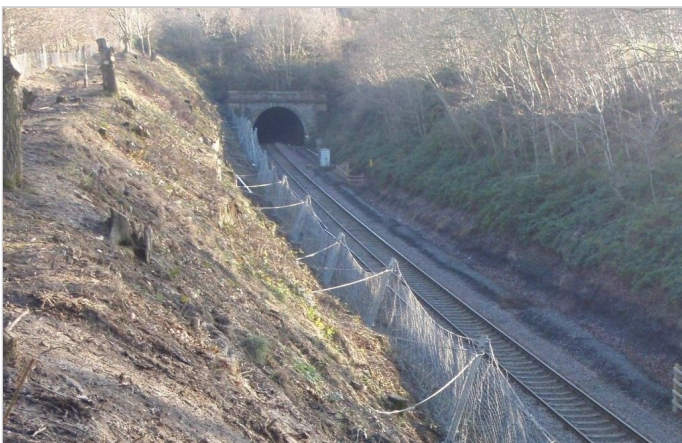
Catch fences installed on the Cumberworth Tunnel line

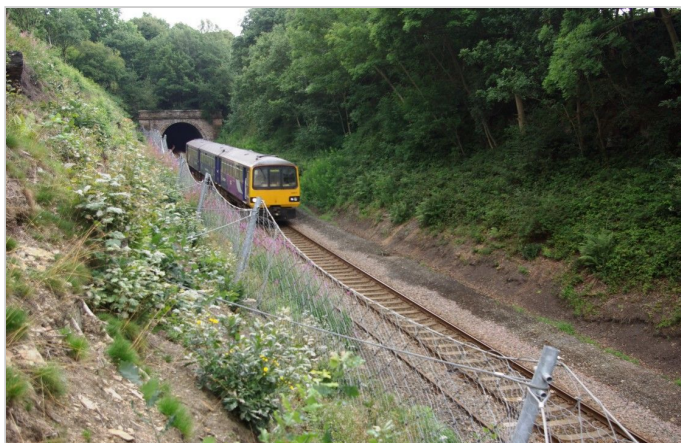
Post installation of the catch fences at Cumberworth

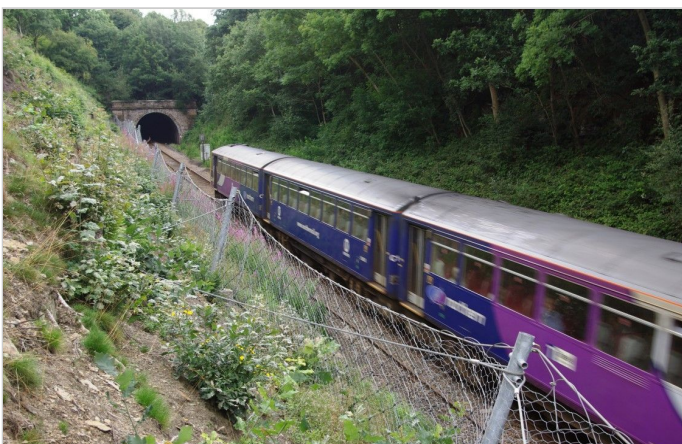
Post installation of the catch fences at Cumberworth

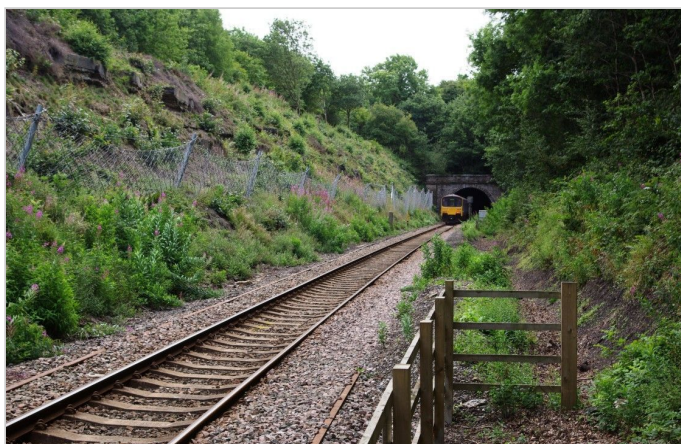
Post installation of the catch fences at Cumberworth
