**PAUL'S HILL WINDFRAM**  
**UPPER KNOCKANDO, SCOTLAND, UNITED KINGDOM****Suspended Drapery****Problem**

**Client:** Fred Olsen Renewables**Designer / Consultant:** Natural Power**Contractor:** CAN Scotland**Products used (Qty.)****Date of construction:** 03/2010 - 07/2010[Google Maps](#)[Google Earth](#)

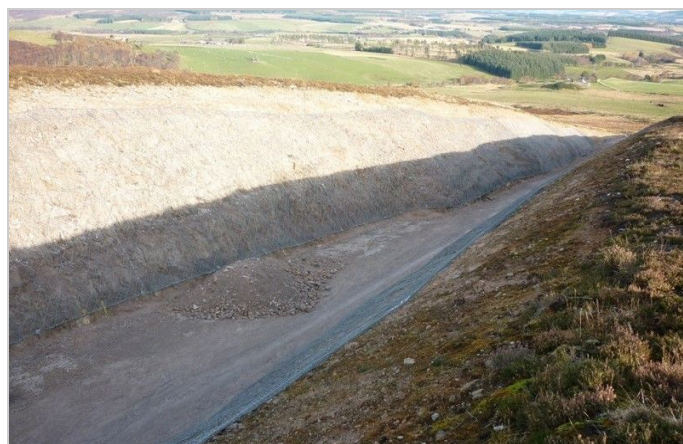
**Completed Installation - HEA and DT Mesh**

The scheme designer established general rock characteristics at the site and then demarked certain areas where the slope was deemed to be the greatest risk of failure. In these areas, the sliding and toppling modes of failure, combined with the relatively large block size, necessitated a very high-strength product with high dynamic durability. The remedial actions commenced with the protection of the entirety of the slope using Maccaferri PVC-coated rockfall netting. The highest risk areas were then protected using Maccaferri's high-strength HEA panels, installed over the rockfall netting. At certain areas along the slopes, the rocks gave way to boulder-laden Glacial Till and in these areas, the consultant was keen to ensure re-establishment of the natural vegetation. To this end, Maccaferri MacMat® R was used, in place of the rockfall netting, where the cut slopes were formed in Till.

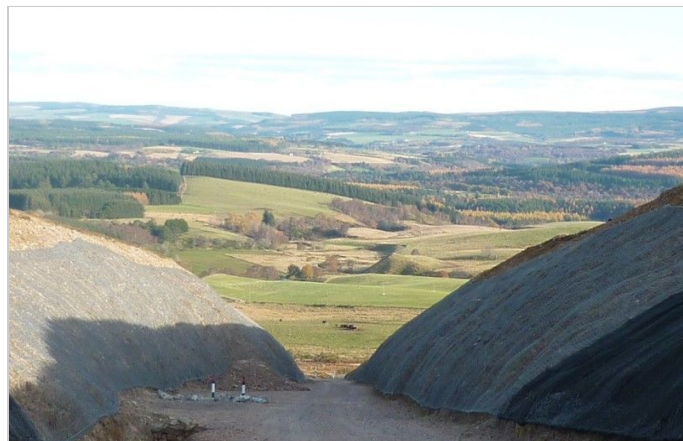
**Detail looking along cutting**

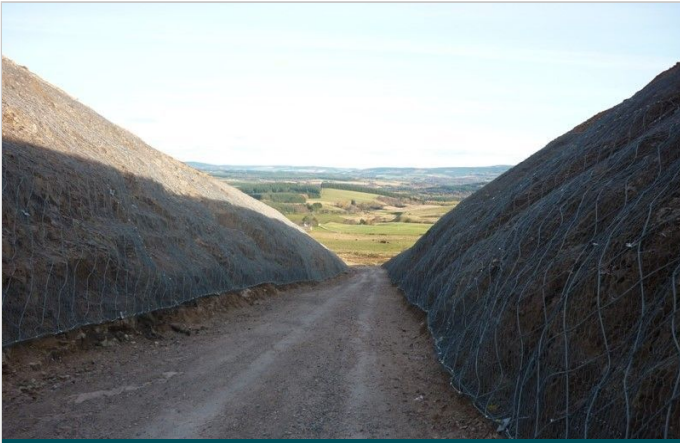
Narrow access way

The only main access route into the Paul's Hill Windfarm site passes through a narrow rock cutting, formed into the rolling Aberdeenshire landscape. The steep cutting sides posed a constant danger to vehicular traffic below and were selected for remedial action.
