**BROOKHOUSE FARM**  
**SOLIHULL, BIRMINGHAM, UNITED KINGDOM****Mass Gravity Retaining Walls****Problem**

**Solution**

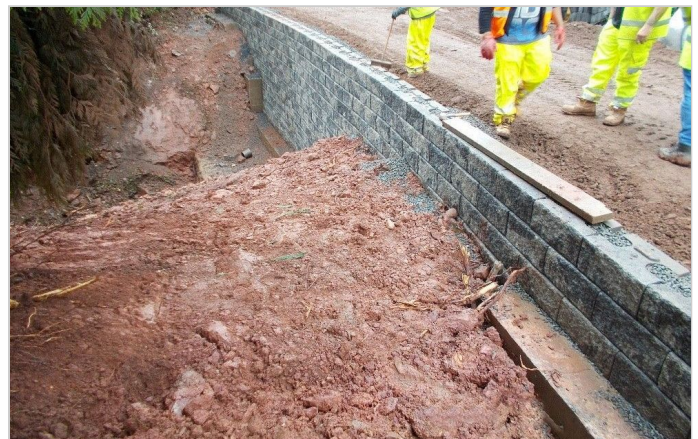
**MacWall® Vertica block facing MSE wall**

This proposal saw Paragrid Geogrid used as the reinforcement to the rear of the MacWall® Vertica block facing. Both the Paragrid and the Vertica block are BBA certified with a design life of 120 years.

The MacWall® Vertica blocks are a mortarless system that offers swiftness and ease of installation, relying on a friction connection with the Paragrid placed between the blocks at regular intervals to reinforce the granular backfill material which creates the reinforced soil wall.

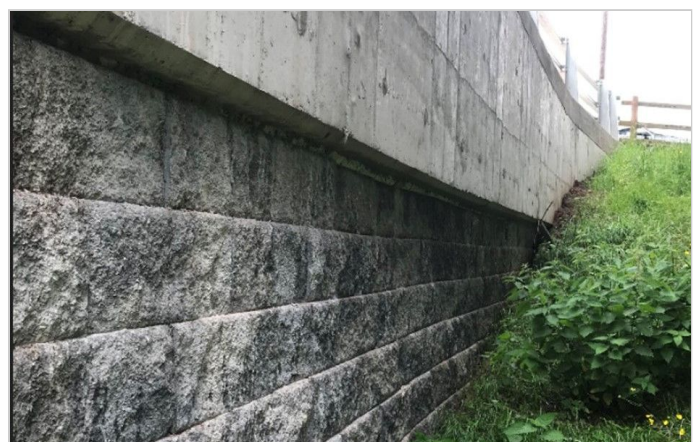
**Side view of the MacWall® Vertica blocks**

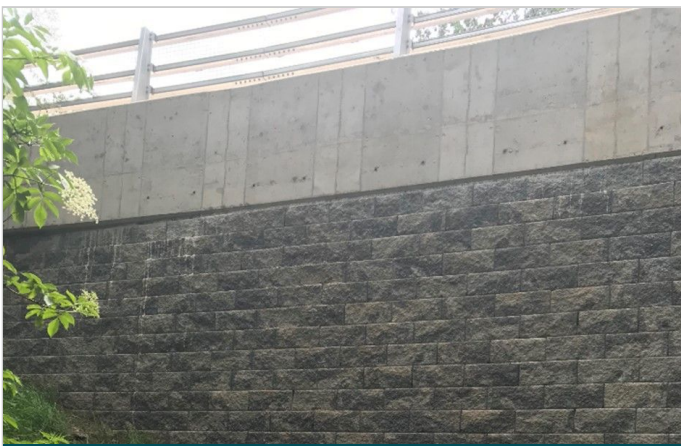
Culvert headwall below MacWall® Vertica structure

In addition to improved highway drainage, effective drainage of the structure was also introduced by utilising the Macdrain drainage geocomposite to the rear of the reinforced earth structure which connected to a heel drain outfalling into the culvert.

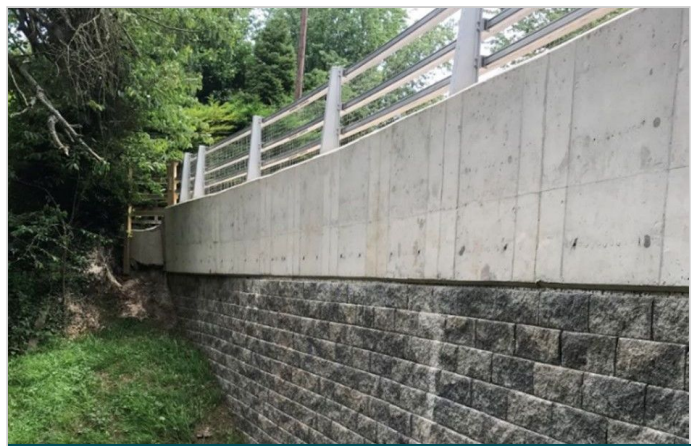
MacWall® Vertica MSE wall - side view
