**SLOPE STABILIZATION SOLUTION ALONG CORAMBA ROAD
BETWEEN DORRIGO AND COFFS HARBOUR, NEW SOUTH WALES, AUSTRALIA**

Slope Protection

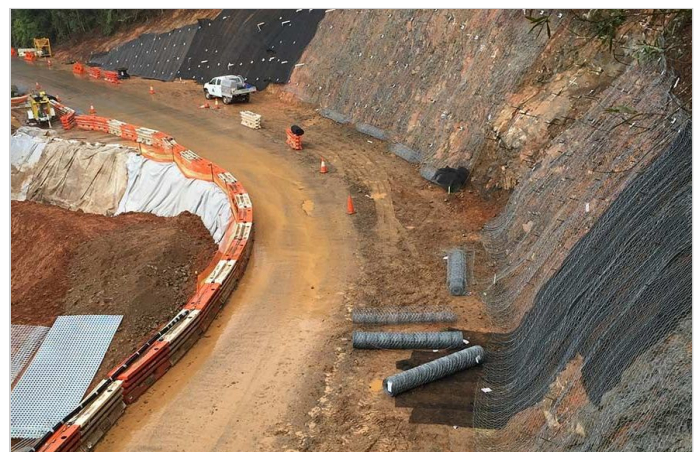
SG HR30 and erosion control mat installation in progress at upslope

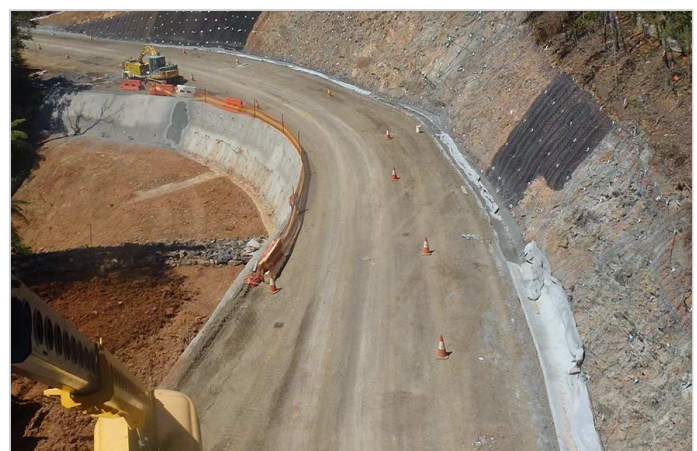
Complete installation of slope surface protection works

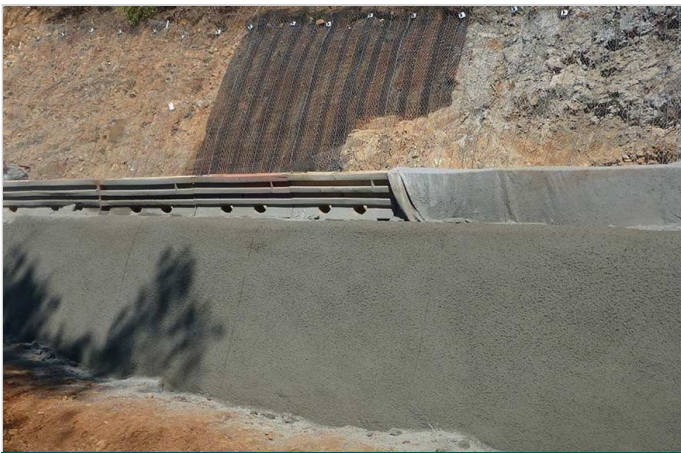
Front view of slope strengthening works upslope and downslope

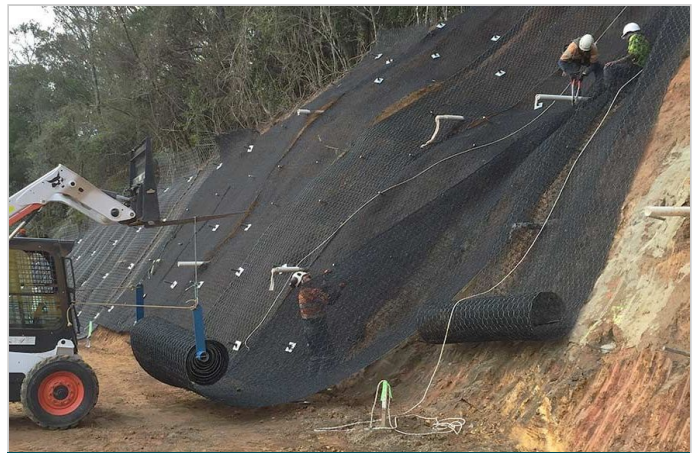
Erosion control mat installation in progress

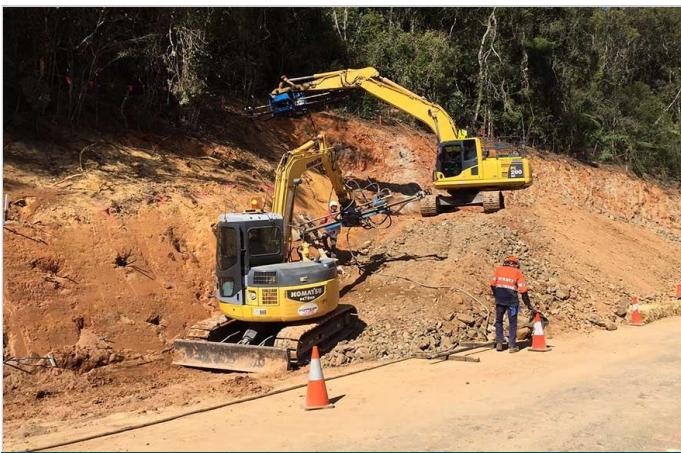
Upslope soil nail installation in progress

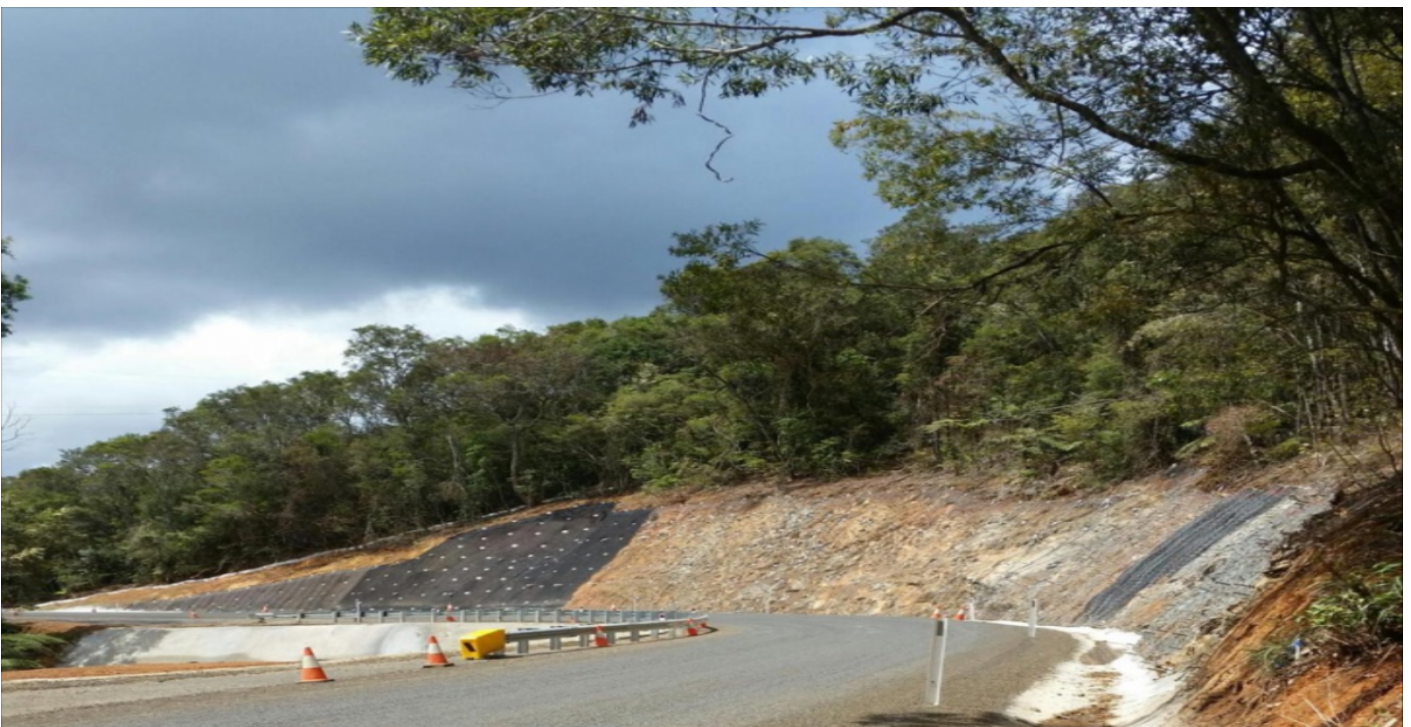
Completed rectification works
