## MACCAFERRI

Slope protection works

Fengshan County Liangli and Po  
Xiongbao Mine Rehabilitation Project

Hechi, Guangxi, China

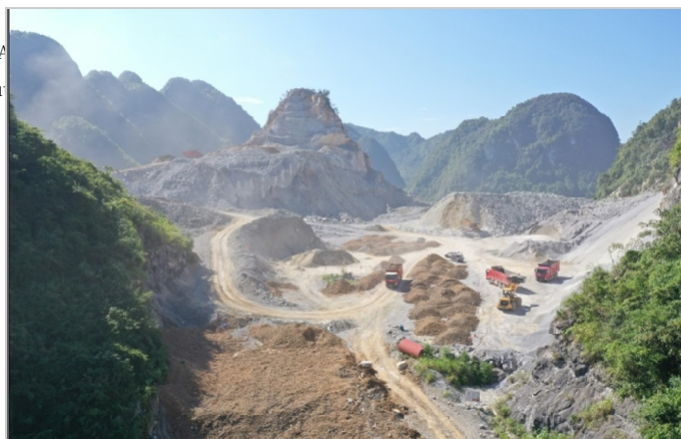
pre-construction

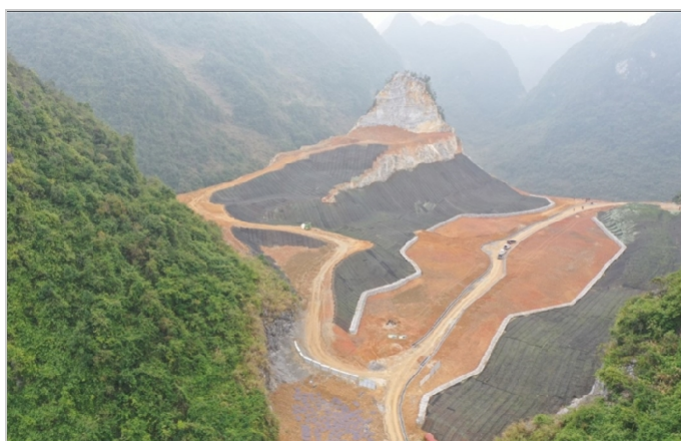
under construction

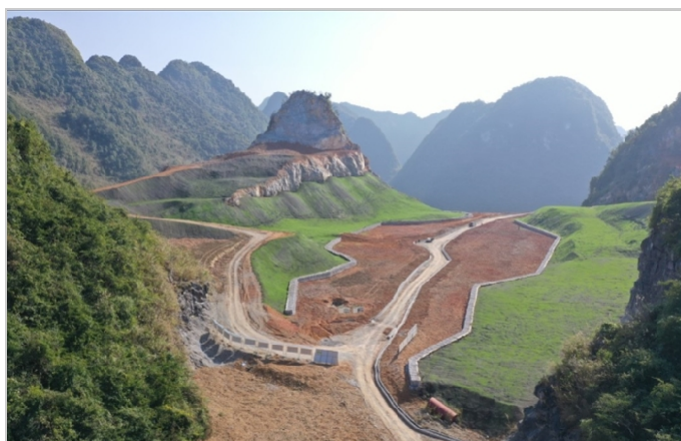
Construction completed

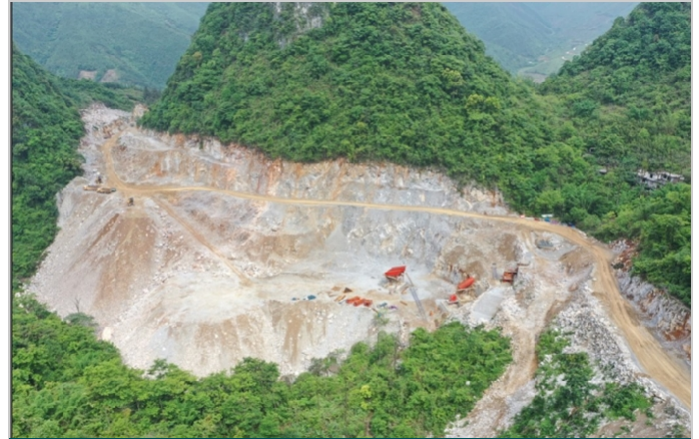
pre-construction

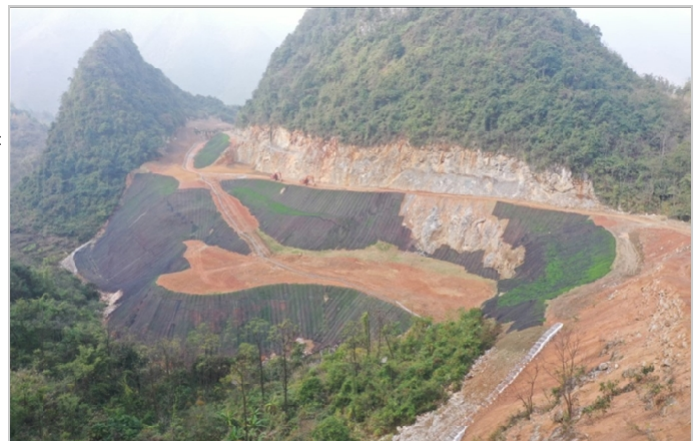
under construction

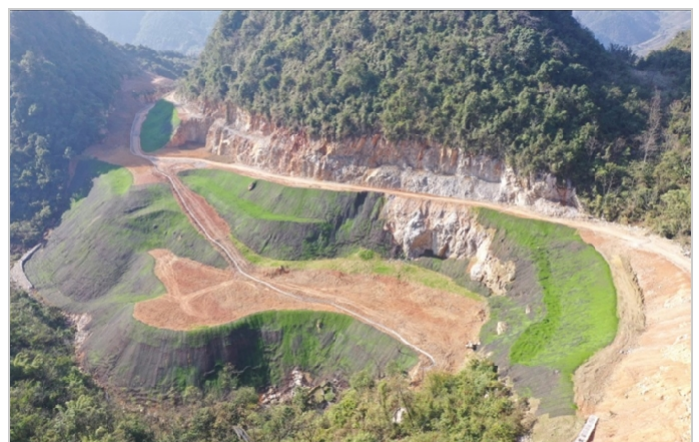
Construction completed
