## ARDAHAN DAM AND HYDROELECTRIC POWER PLANT

### ARDAHAN, DOĞU ANADOLU, TURKEY

#### Surface Strengthening and Support

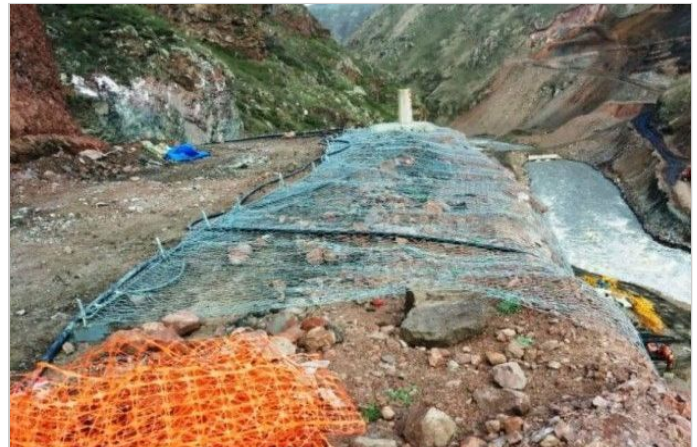
Rockfall Protection at Ardahan Dam

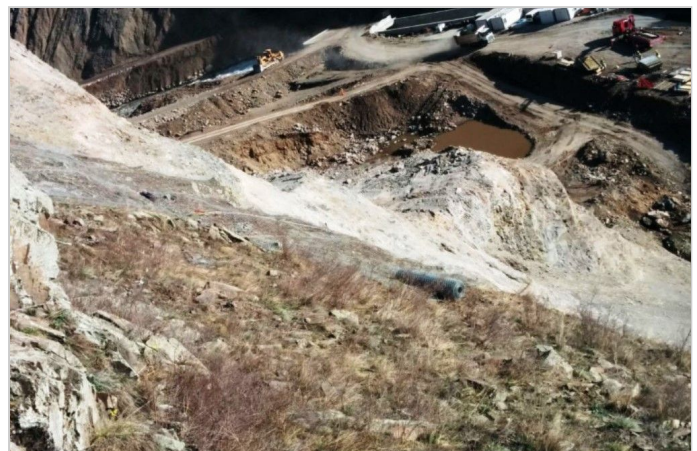
Rockfall Protection at Ardahan Dam

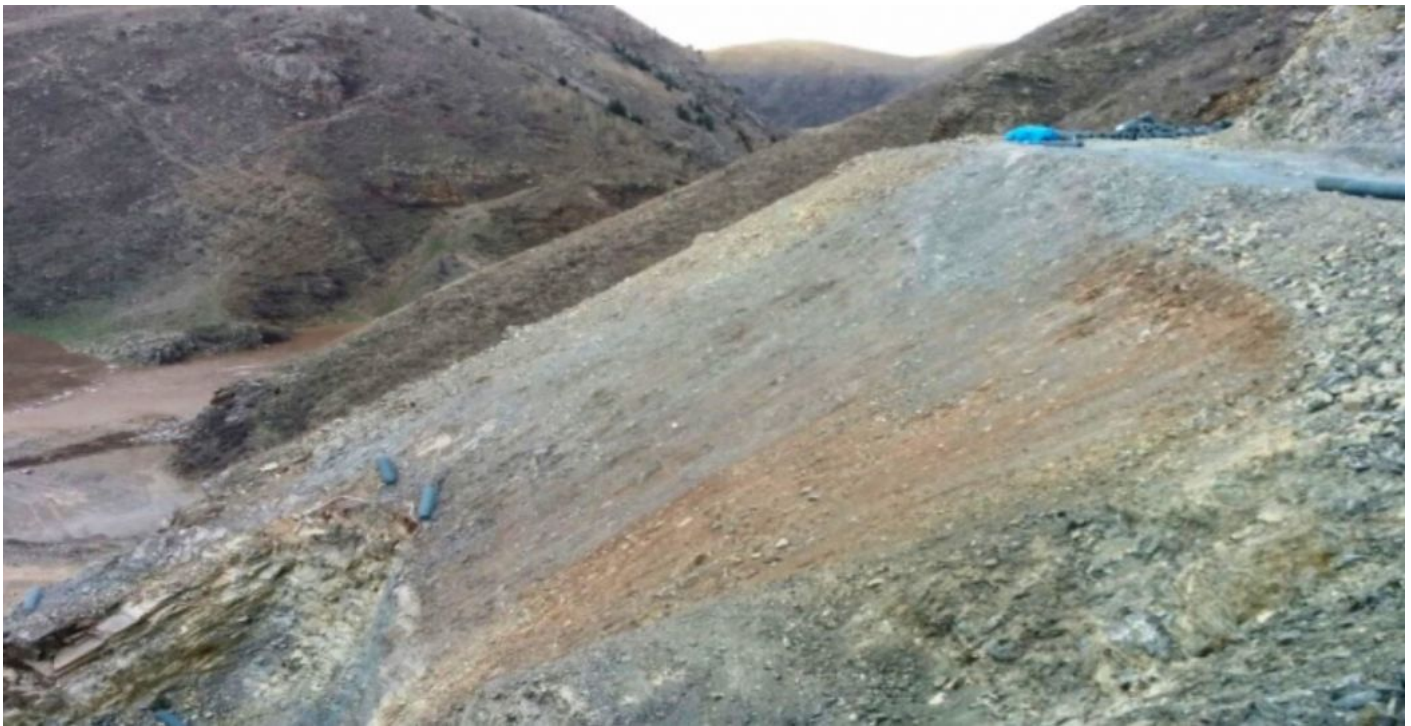
Rockfall Protection at Ardahan Dam
