**RETAINING WALL AT BATAM CHURCH REVITALIZATION
BATAM, KEPULAUAN RIAU, INDONESIA**

Sub-grade and Pavement Drainage

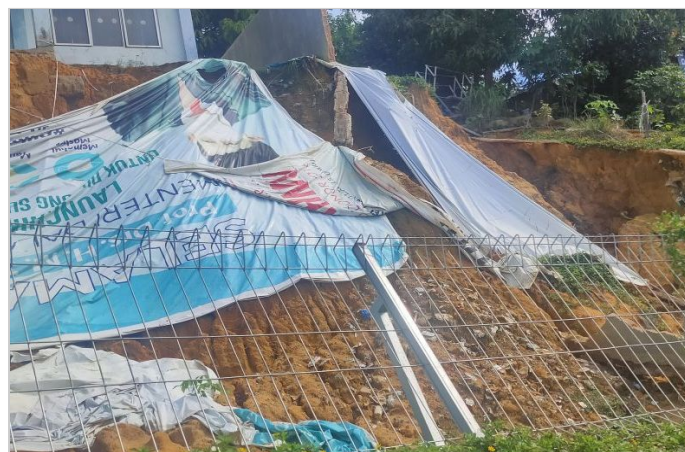
Before Construction

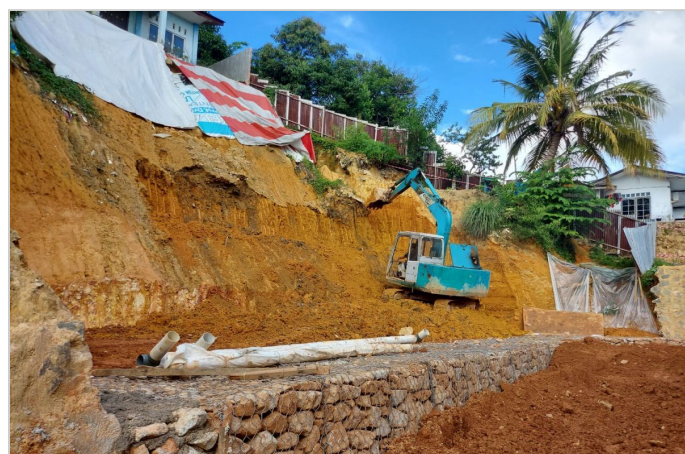
Construction Work

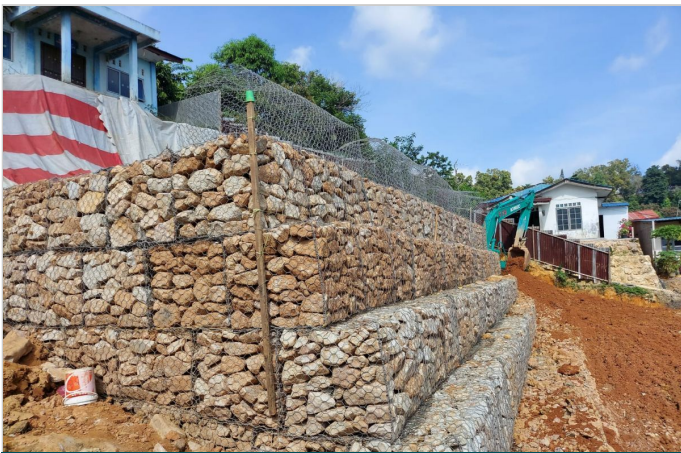
Construction Work

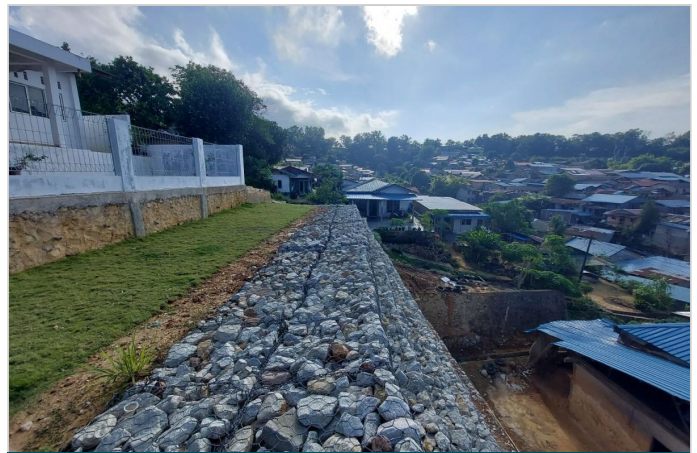
Finish Construction

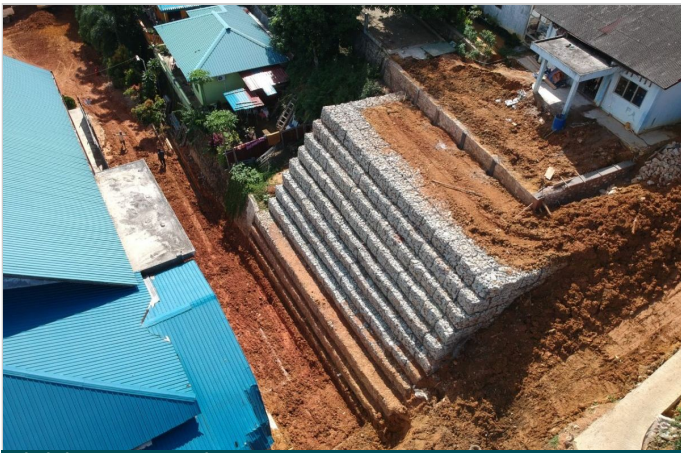
Finish Construction
