## **Embedded Plate Travel Path Damage**

Models Affected: All Operator Aboard Battery Extractors

Tech Tip TT-930

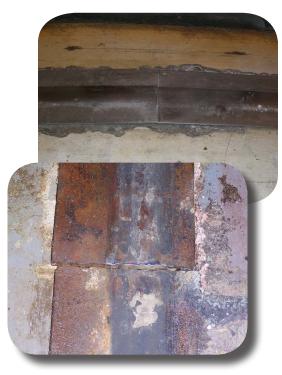
When steel plates are installed on top of, or embedded into concrete (where concrete is poured around and up to the plate), there is no way to completely seal the edges of the plate where it meets the floor. Even if epoxy floor coating is applied to the concrete up to the plate, a seam or crack will form over time between the coating and the plate. Any acidic water, whether it be from an acid spill or simply routine battery room wash down, can find its way between, around, and under the plates, causing erosion. As the concrete is compromised by the acid corrosion, soft spots or even voids will form under the steel plate. When the BE travels over the compromised areas, the plate will begin to flex. As the BE repeatedly travels back and forth over these areas, the repeated stress of the plate flexing in combination with the continuous deterioration of the concrete will cause the problem area to grow larger, thus worsening the travel path. Eventually the travel path becomes wavy and uneven, making the travel path of the steel plates worse than the original concrete floor. The plates and damaged concrete must be removed, and new concrete must be poured. The entire deterioration process will begin again if steel plates are reinstalled.

Floor damage from steel plates

BHS recommends a floor profile of the BE travel path to determine floor flatness and levelness. Corrective grinding must be performed if the floor is not within BHS recommended specifications. After a floor profile and corrective grinding (if required) are complete, a suitable self-leveling non-porous epoxy or similar floor coating may be applied for protection. Visit BHS1.com for additional information on Battery Room Floors.
