**Folder:** Parcel No. 77. 114-116 State Street.

**Series:** Area 1-A, Parcels 1-182, 1961-1962.

PROJECT AREA 1-A  
Parcel #77  
114 State Street

Parcel #77  
114-116 State Street

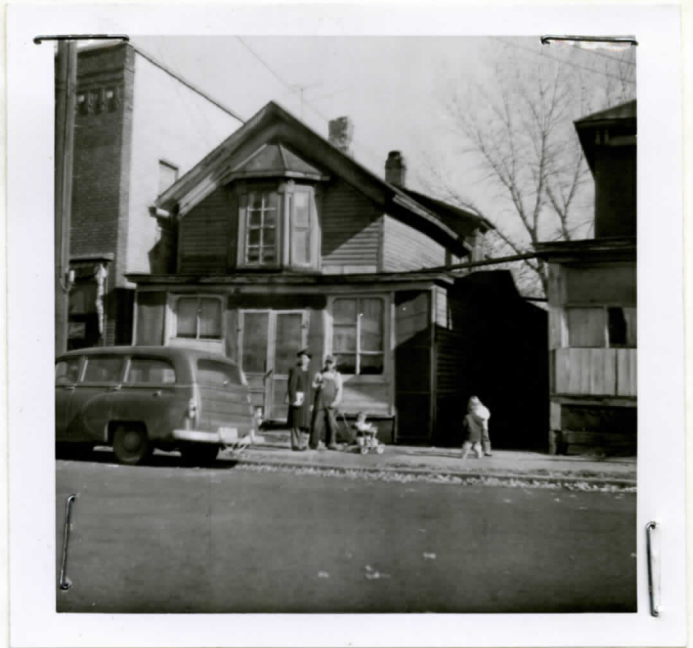
FRONT VIEW

This is a two story single family residence in poor condition. The first floor has 1 good sized front room with a small alcove adjoining, center room used as living room and kitchen with wood wainscot and round rim sink. The bath is off the kitchen, has round rim tub and low flush box. The second floor has 1 good sized, 1 fair and 1 small bedroom. The basement is full and has automatic hot water heater, dirt floor and stone foundation. There are hardwood floors on first and softwood on second, walls are plaster. This is heated with circulating space heater. The general condition of this house is poor. Rental, actual, \$30.00.

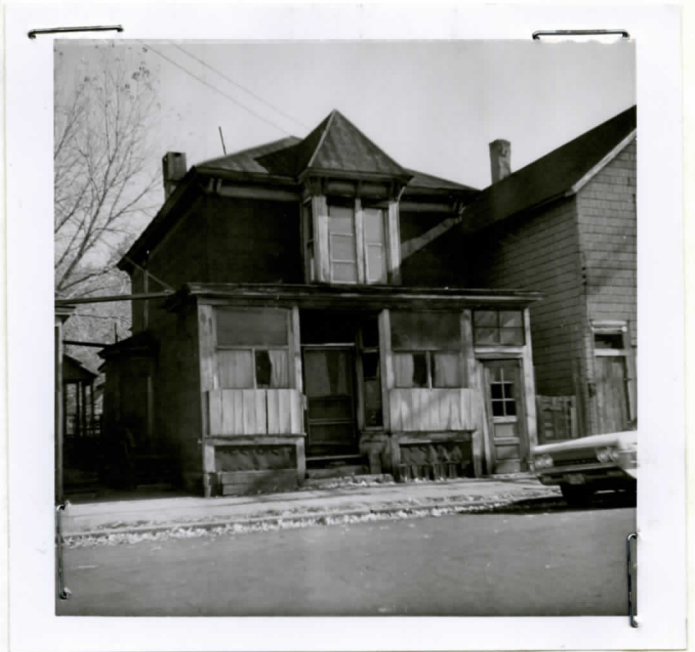
FRONT VIEW

This house with asphalt siding exterior is a full 2 story, and the first floor rear apartment has small living room with small bedroom adjoining, fair center room with another small bedroom adjoining, and a bath off the center room has round rim tub, and there is a good sized kitchen with old style sink and adjoining pantry. There are hardwood floors and considerable settlement is in evidence. There is an automatic hot water heater but it is not connected and they only have cold water service. This apartment is heated with stove.

Also on the first floor in the front is another large room rented by another party. There is merely a toilet in this. It is necessary to turn a faucet on to get water to the toilet.

The second floor which is vacant consists of 5 rooms and a toilet which is not connected to the plumbing, and the water pipe has also been disconnected on the second floor.
