Folder: Parcel No. 60 and 60A. 153 and 159 E.

Series: Area 1-B, Parcels 1-240A, 1961-1962.

Collection: Port Authority of the City of Saint Paul.

Project Areal-B Parcel No. 60 153 E. Fairfield Parcel No. 60A 159 E. Fairfield

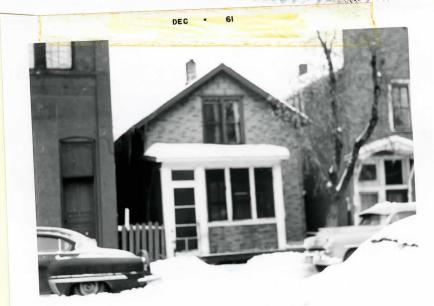
Front view 153 E. Fairfield

This is a $1\frac{1}{2}$ story frame dwelling with imitation brick exterior and asphalt roof, screened front porch, fair storms and screens. East Fairfield is paved, has sidewalk and curb, all improvements are in the street and connected to the property.

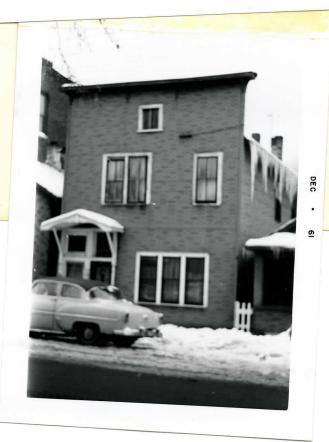
Rear view subject property

It was almost impossible (without great danger) to get to the rear of the lot to get access to the back entrance to the basement apartment and access to the cellar or basement. Melting snow off the roofs created a very dangerous situation in walking to the rear of the building. So in effect, the subject property can hardly be described as a 3-plex.
