Folder: Parcel No. 117. 233 East Chicago.

Project Area 1B
Parcel No. 117
233 East Chicago

Project Area 1-B
Parcel No. 117

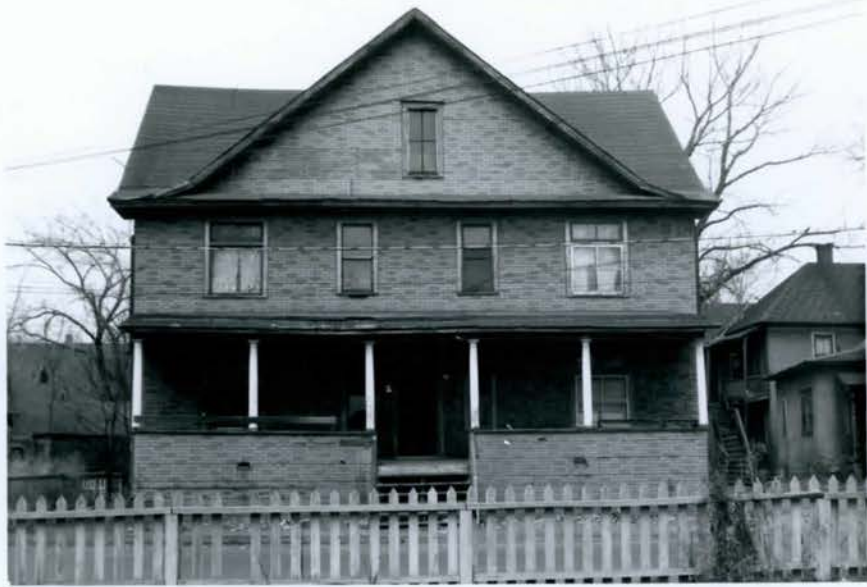
Front View

This property is located at the middle of the block on the North side of Chicago and is South facing. It is bordered on the East by State Street and on the West by Robertson and on the North by East Indiana. The building is set back approximately eight (8) feet from the street. The lot is level with street grade. This building has an open one-story porch across the front which is in poor condition. The wood is badly weather beaten and shows signs of rot and has a definite sag. There is an open stairway across the rear and it is in very poor condition. The main building is a rectangular two-story frame four-plex with imitation brick asphalt siding and composition roof. The siding is in very poor repair. Parts of the siding have been torn off and have not been replaced. On each end of the building in the rear there are two enclosed two-story storage areas. There are many broken windows which have not been repaired. The stone foundation is in need of pointing. There is a central entry way for the two first floor apartments and a central stairway for the two apartments on second floor. The lower East apartment consists of two bedrooms, living room, dining room, kitchen, and full bath. It has a gas fired automatic hot water heater which does not work, according to the tenant. This unit is heated by an oil space heater. The condition of this apartment is very poor. The plaster and the walls and ceilings are badly cracked and chipped and it is in need of decorating. The floors are also in very poor condition. This unit rents for \$35.00 per month and the tenants pay their own heat and utilities. The upper west apartment which is now vacant consists of two bedrooms, living room, dining room, kitchen, and full bath. There is a front and rear entrance. There is a hand fired hot water heater. There are hardwood floors in this unit. The plaster is badly cracked and the apartment needs decorating. The caretaker indicates that the rent for this apartment was \$35.00 a month and the tenant would pay his own heat and utilities. The upper East unit contains two bedrooms, living room, dining room, kitchen, and full bath. There are hardwood floors. The condition of the walls and ceilings in this apartment is very bad. There is a gas hand fired hot water heater for this unit. The floors for this unit are in very poor condition. This unit is heated by an oil space heater. The tenants in this apartment indicated that they pay \$35.00 a month rent and pay their own heat and utilities. There is a stairway to the attic from the second floor. This is a full attic for storage, with rough floors. The lower West unit consists of two bedrooms, living room, dining room, kitchen, and full bath. It has a gas hand fired

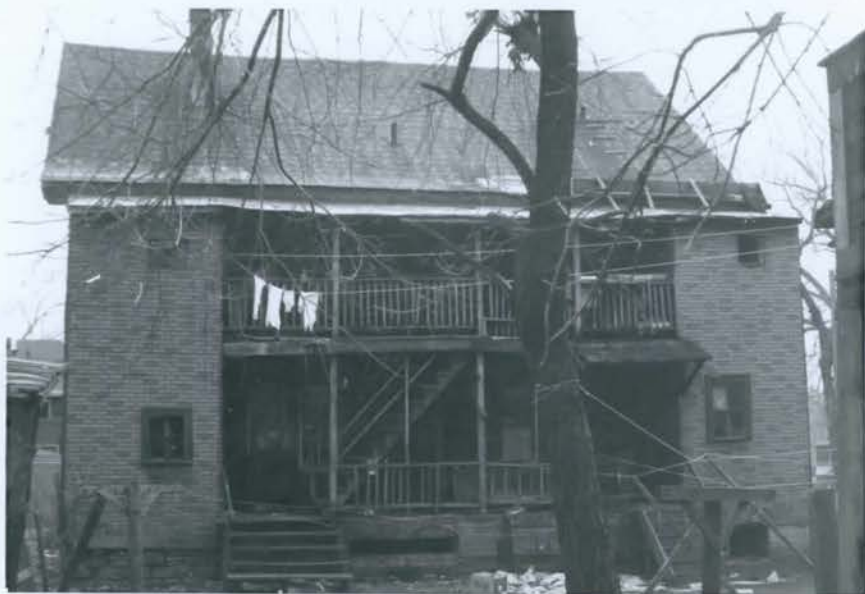
Rear View

automatic hot water heater. The plaster in this apartment is in very poor condition. It is badly cracked and is very much in need of decorating. In the dining room the plaster has fallen off the ceiling and partially off the wall. This unit is heated by an oil space heater. This unit rents for \$35.00 per month and the tenants pay their own heat and utilities. There is a full basement with a stone wall foundation and a dirt floor. The basement does not have much utility.
