**Folder:** Parcel No. 184. 209 and 211 Eva Street.

**Series:** Area 1-B, Parcels 1-240A, 1961-1962.

Project Area 1-B  
Parcel No. 184  
209 & 211 Eva Street

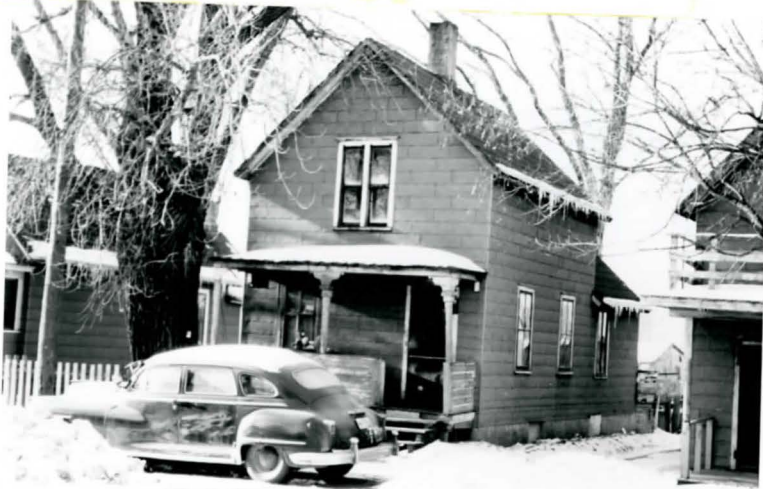
• JAN • 62

This dwelling at 209 Eva Street is actually a 2 family dwelling, frame with asphalt siding and asphalt roof. Storms and screens poor. Eva Street is dirt oiled, no sidewalk or curb. All improvements are in the street and connected to the property.

First Floor contains 4 rooms and old type bath off the kitchen, pantry, no cabinets, wall sink. Poor walls, poor floor, poor trim. This unit is in very bad condition. Rent \$37

Second floor has rear outside entrance. Contains 3 rooms and toilet only. In very bad condition - now vacant.

Full basement entrance from outside rear. Has limestone walls, dirt floor, new type hot air gas furnace, 30 gallon gas water heater, no laundry tubs or drain.

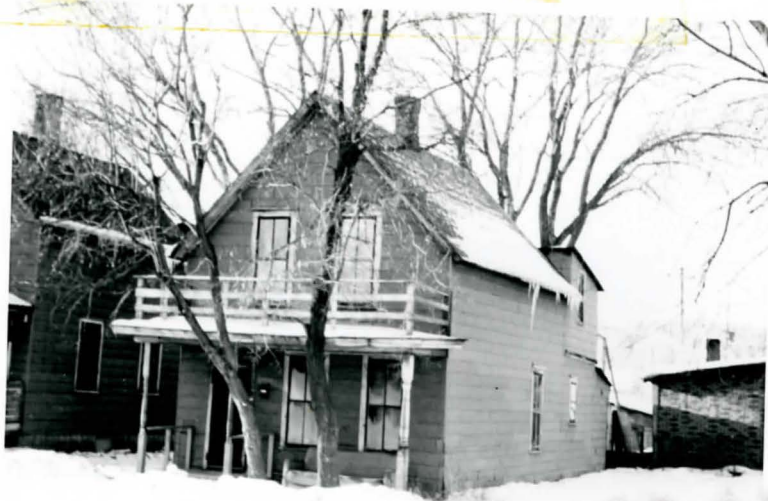
• JAN • 62

This is a  $1\frac{1}{2}$  story frame dwelling with asphalt exterior siding and asphalt roof. Poor exterior, poor storms and screens. All improvements are in the street and connected to the property.

The entire dwelling consists of 6 rooms, 3 rooms on each floor. This property is in deplorable condition - unfit for human living.

The floors, walls and trim are in terrible shape. The upstairs rooms are so bad they cannot be used. The toilet is upstairs.
