LET'S TALK ABOUT

WATERPROOFING

ISSUE 11 NOVEMBER 2019

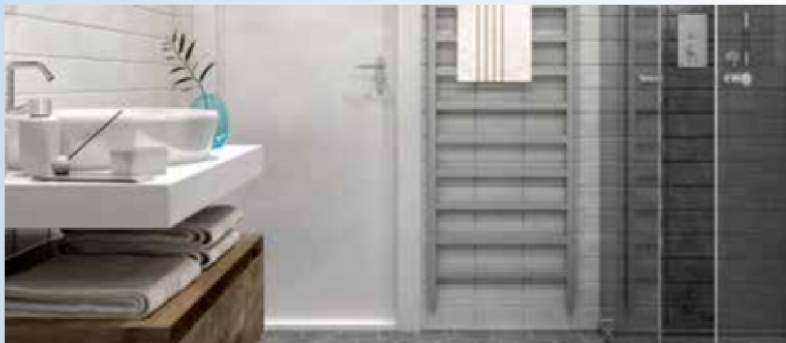
The NCC Volume 1 and 2 including the Australian Standard, together, gives us the performance requirements for building elements in the wet area that must be waterproofed.

The BCA Volume 2 is silent on the need to provide floor waste in a Class 1 building such as a single dwelling house except for rooms containing wall hung urinals in which a floor waste gully is mandatory to achieve the performance requirements of the PCA.

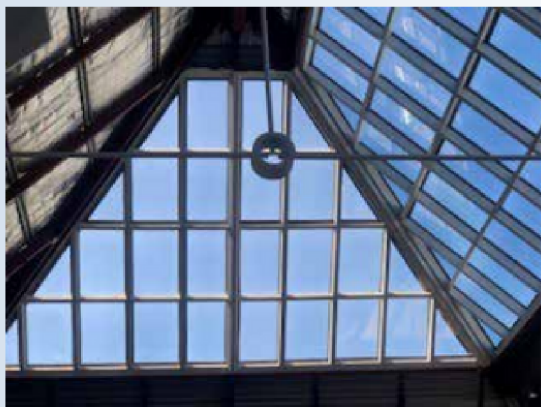
Simpleseal Preformed Silicone Bandage

Leaking skylights have long since been a source of angst for asset owners. It seems, at some stage in the life cycle of a skylight, it will eventually leak.

The repair of these skylights has been problematic and financially prohibitive, where in some cases a complete replacement has been necessary.

Similarly, Simpleseal can be used over the top of existing failed expansion joints on curtain walling. Using Simple seal negates the need to remove the old sealant. Simpleseal offers a 10-year warranty, with an expected service life well beyond that.
