# DAM SAFETY INSPECTION REPORT

Upper Shaker Lake Dam

File Number: 1314-002

Inspection Date: September 30, 2014

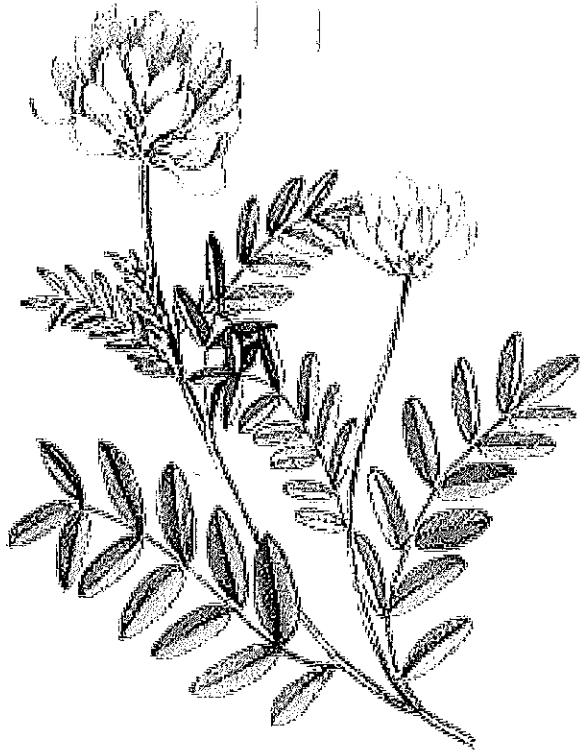
**Figure 1: Crown Vetch**  
(Source: <http://www.vg.com>)

Crown vetch, a perennial plant with small pink flowers, has been used on some dams in Ohio but is not recommended (see Figure 1). It hides the embankment surface, preventing early detection of cracks and erosion. It is not effective in preventing erosion.
