Oilheating

July 2002

The inner chamber...

The refractory material that makes up a combustion chamber has to withstand temperatures as high as 4700° F. Inspection and preventative maintenance are essential for proper operation and safety.

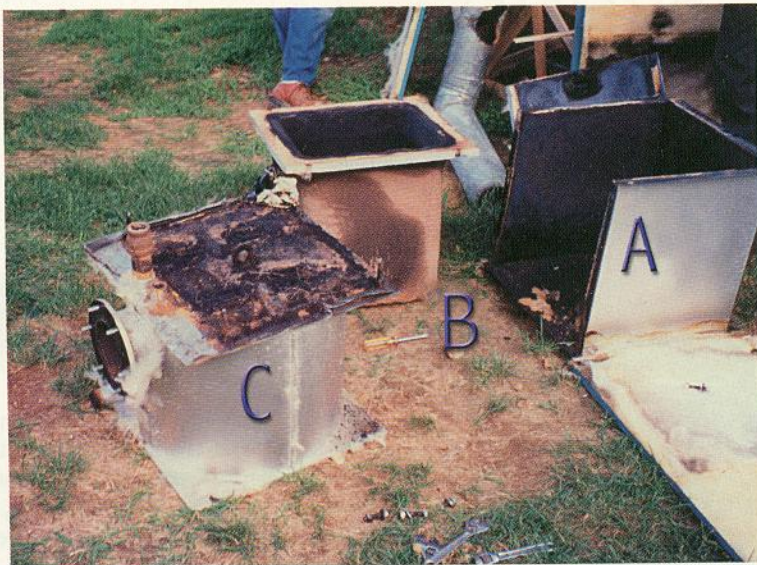
(Above) Dismantled dry base boiler. "B" is the "tub-like" refractory in this type of boiler.

(Below) Combustion chamber from an oil-fired furnace.

Gasket leakage in dry base boilers at chamber/heat exchanger interface: Dry base boilers depend on the condition of the combustion chamber refractory since its integrity is the only component containing combustion gases. An early indication of dry base boiler chamber failure is leakage of combustion gases at the Gap/Seal between the combustion chamber and the boiler's heat exchanger.

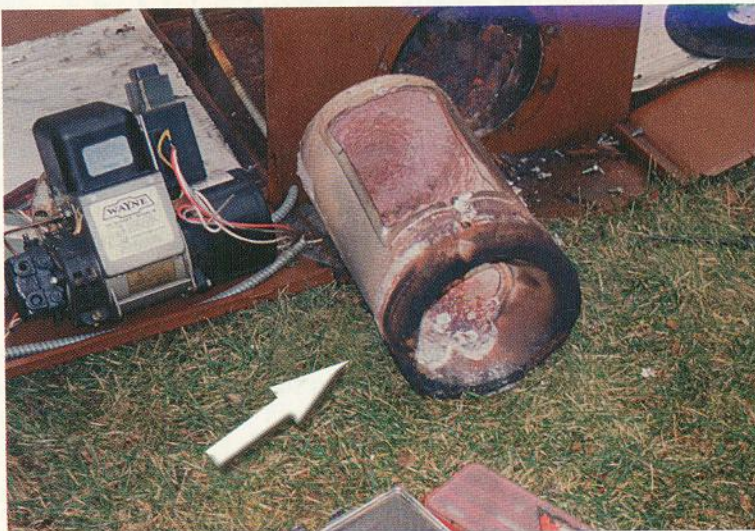
Chamber damaged by cleaning tools

Damage to refractory can also result from cleaning instruments striking the chamber. Care also must be taken to insure that the liner is not damaged during service intervals.

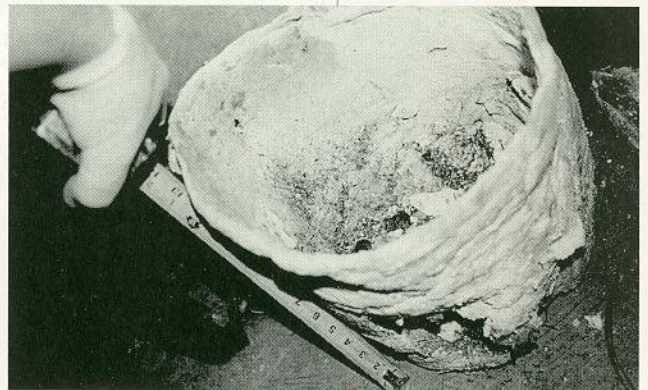
This target wall's refractory was paper thin; it's no wonder the furnace had a hole in the heat exchanger here.

Thinning: Thinning of refractory is an indication of a limitation of the remainder of its useful life. In the event that the thickness of the refractory is reduced significantly, the refractory should be replaced. Particular attention should be paid to the rear wall (target wall) area of the chamber. If crater-like depressions (spalls) of any depth are seen in the refractory, this is an indication that impingement of the flame to the liner is occurring and that the refractory should be replaced.

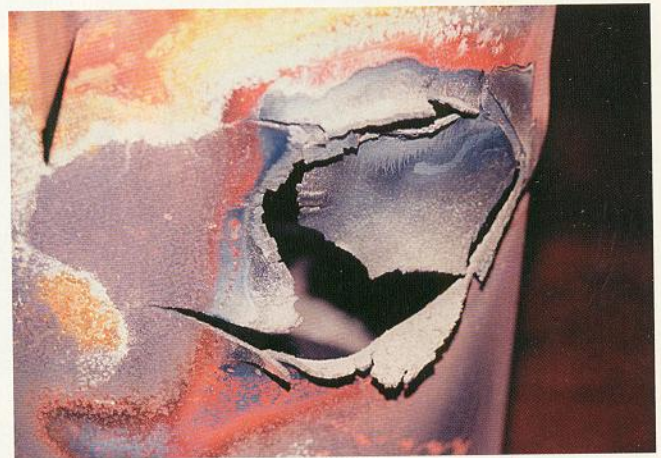
(Right) The flame impingement hole is visible in the furnace's heat exchanger.

Flame impingement induced overheating: Failed refractory will allow the burner flame to contact the steel components of a forced hot air heat exchanger or a boiler's combustion chamber components.

When this happens, the burner flame temperature exceeds the temperature of the melting point of the steel. This in turn causes the heat exchanger to fail in what is called a *Flame Impingement Failure*.
