Large Wood Debris Management Plan Recommendations for Fairfax Creek at the Sunnyside Flood Diversion and Storage (FDS) Facility

Fairfax, California

December 2019

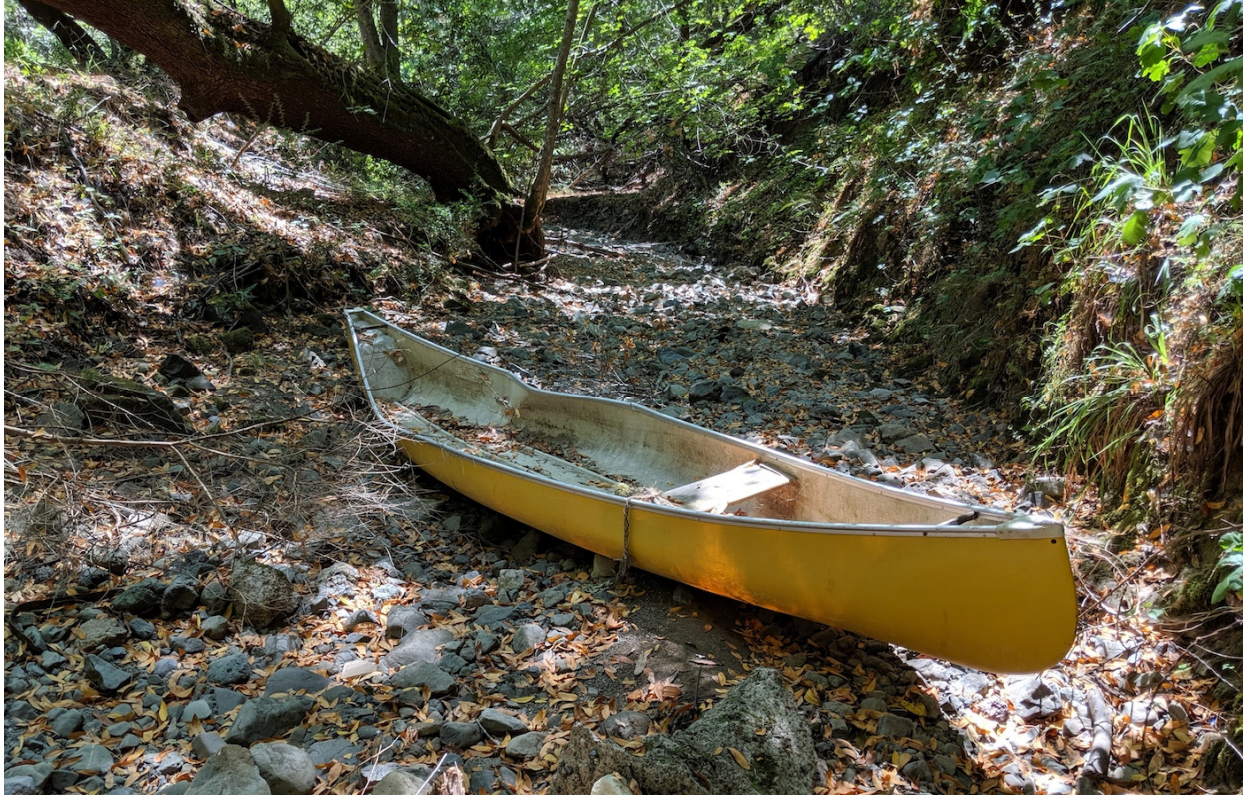
Floated Debris from Girl Scout Camp on Upper Fairfax Creek (July 25, 2019)

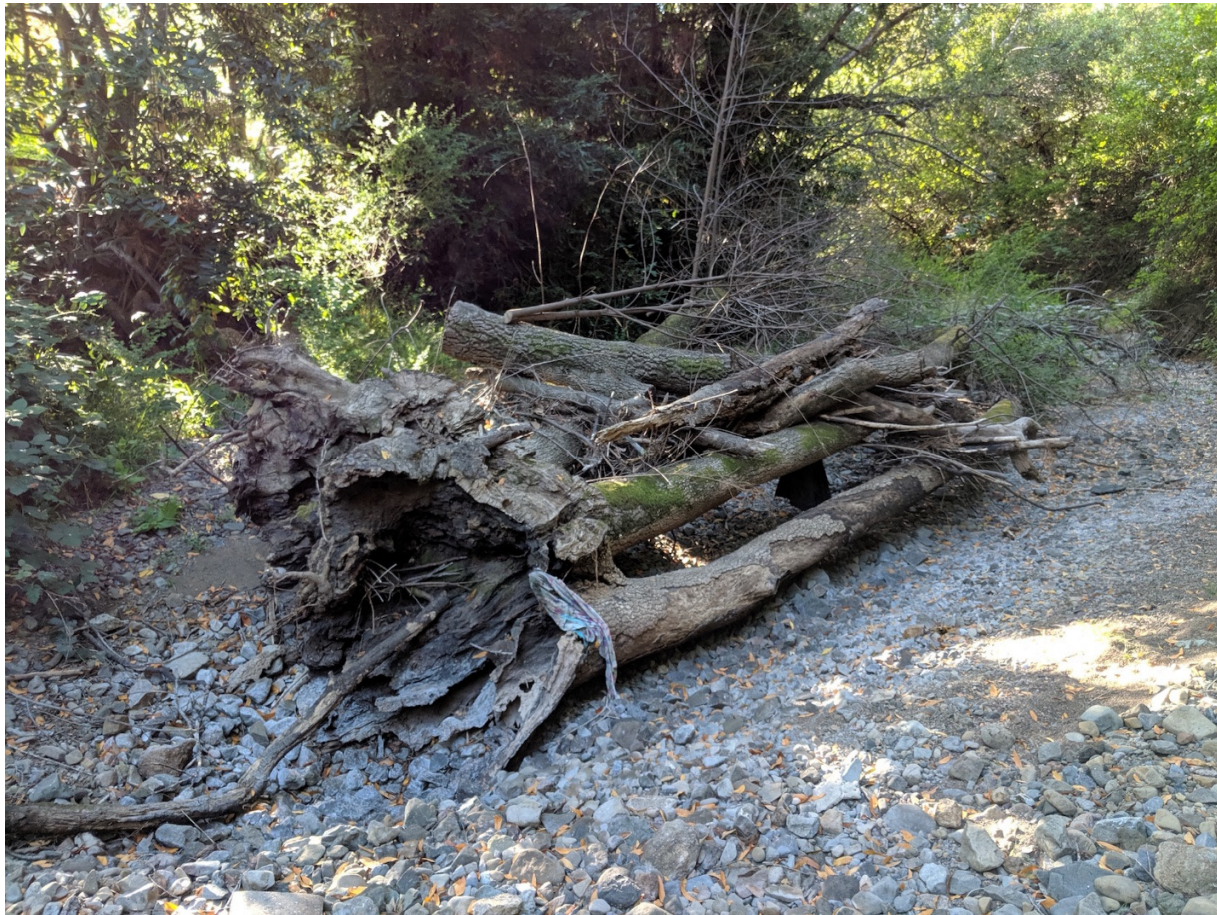
Large dead wood lengths, diameters, and volumes within the bankfull channel from the FDS basin upstream to first culvert on Baywood Canyon Creek (Figure 2). Note that some bay laurel pieces at the same distance (e.g. three x 0.3 diameter pieces at 250 m) are actually one piece joined at the rootwad, but the stem volumes were calculated as individual pieces, see photo below.

Dead bay laurel 250 m (273 yd) upstream from FDS basin.

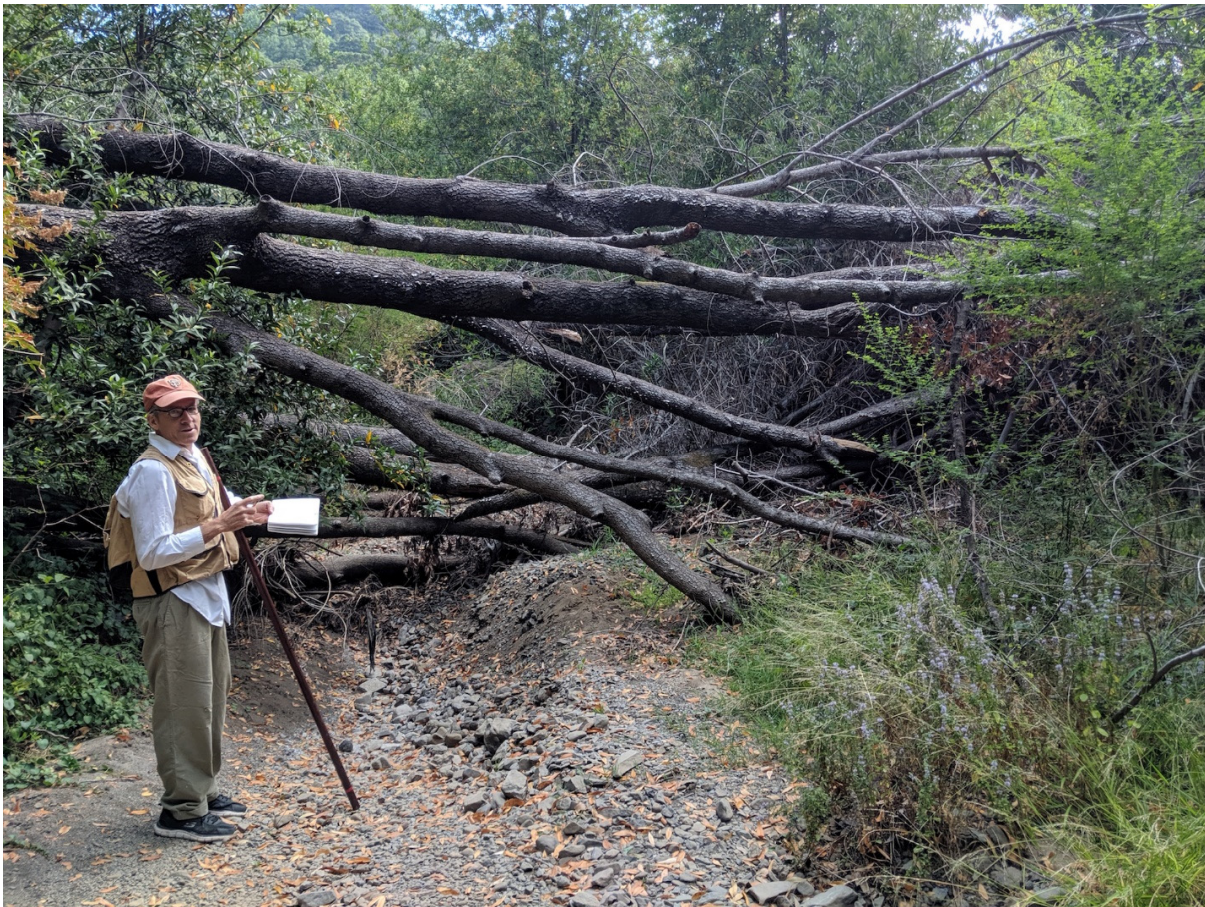
Note that some bay laurel pieces at the same distance are actually one piece joined at the rootwad, but the stem volumes were calculated as individual pieces, see example from reach #2 on Baywood Canyon Creek below.

Multiple-stem down-dead trees in Baywood Canyon Creek segment of management reach.
