PHASE I ENVIRONMENTAL SITE ASSESSMENT

2592 Lakeville Highway
Petaluma, Sonoma County, California 94954

AEI Project No. 396580
Client Reference Name: Baywood

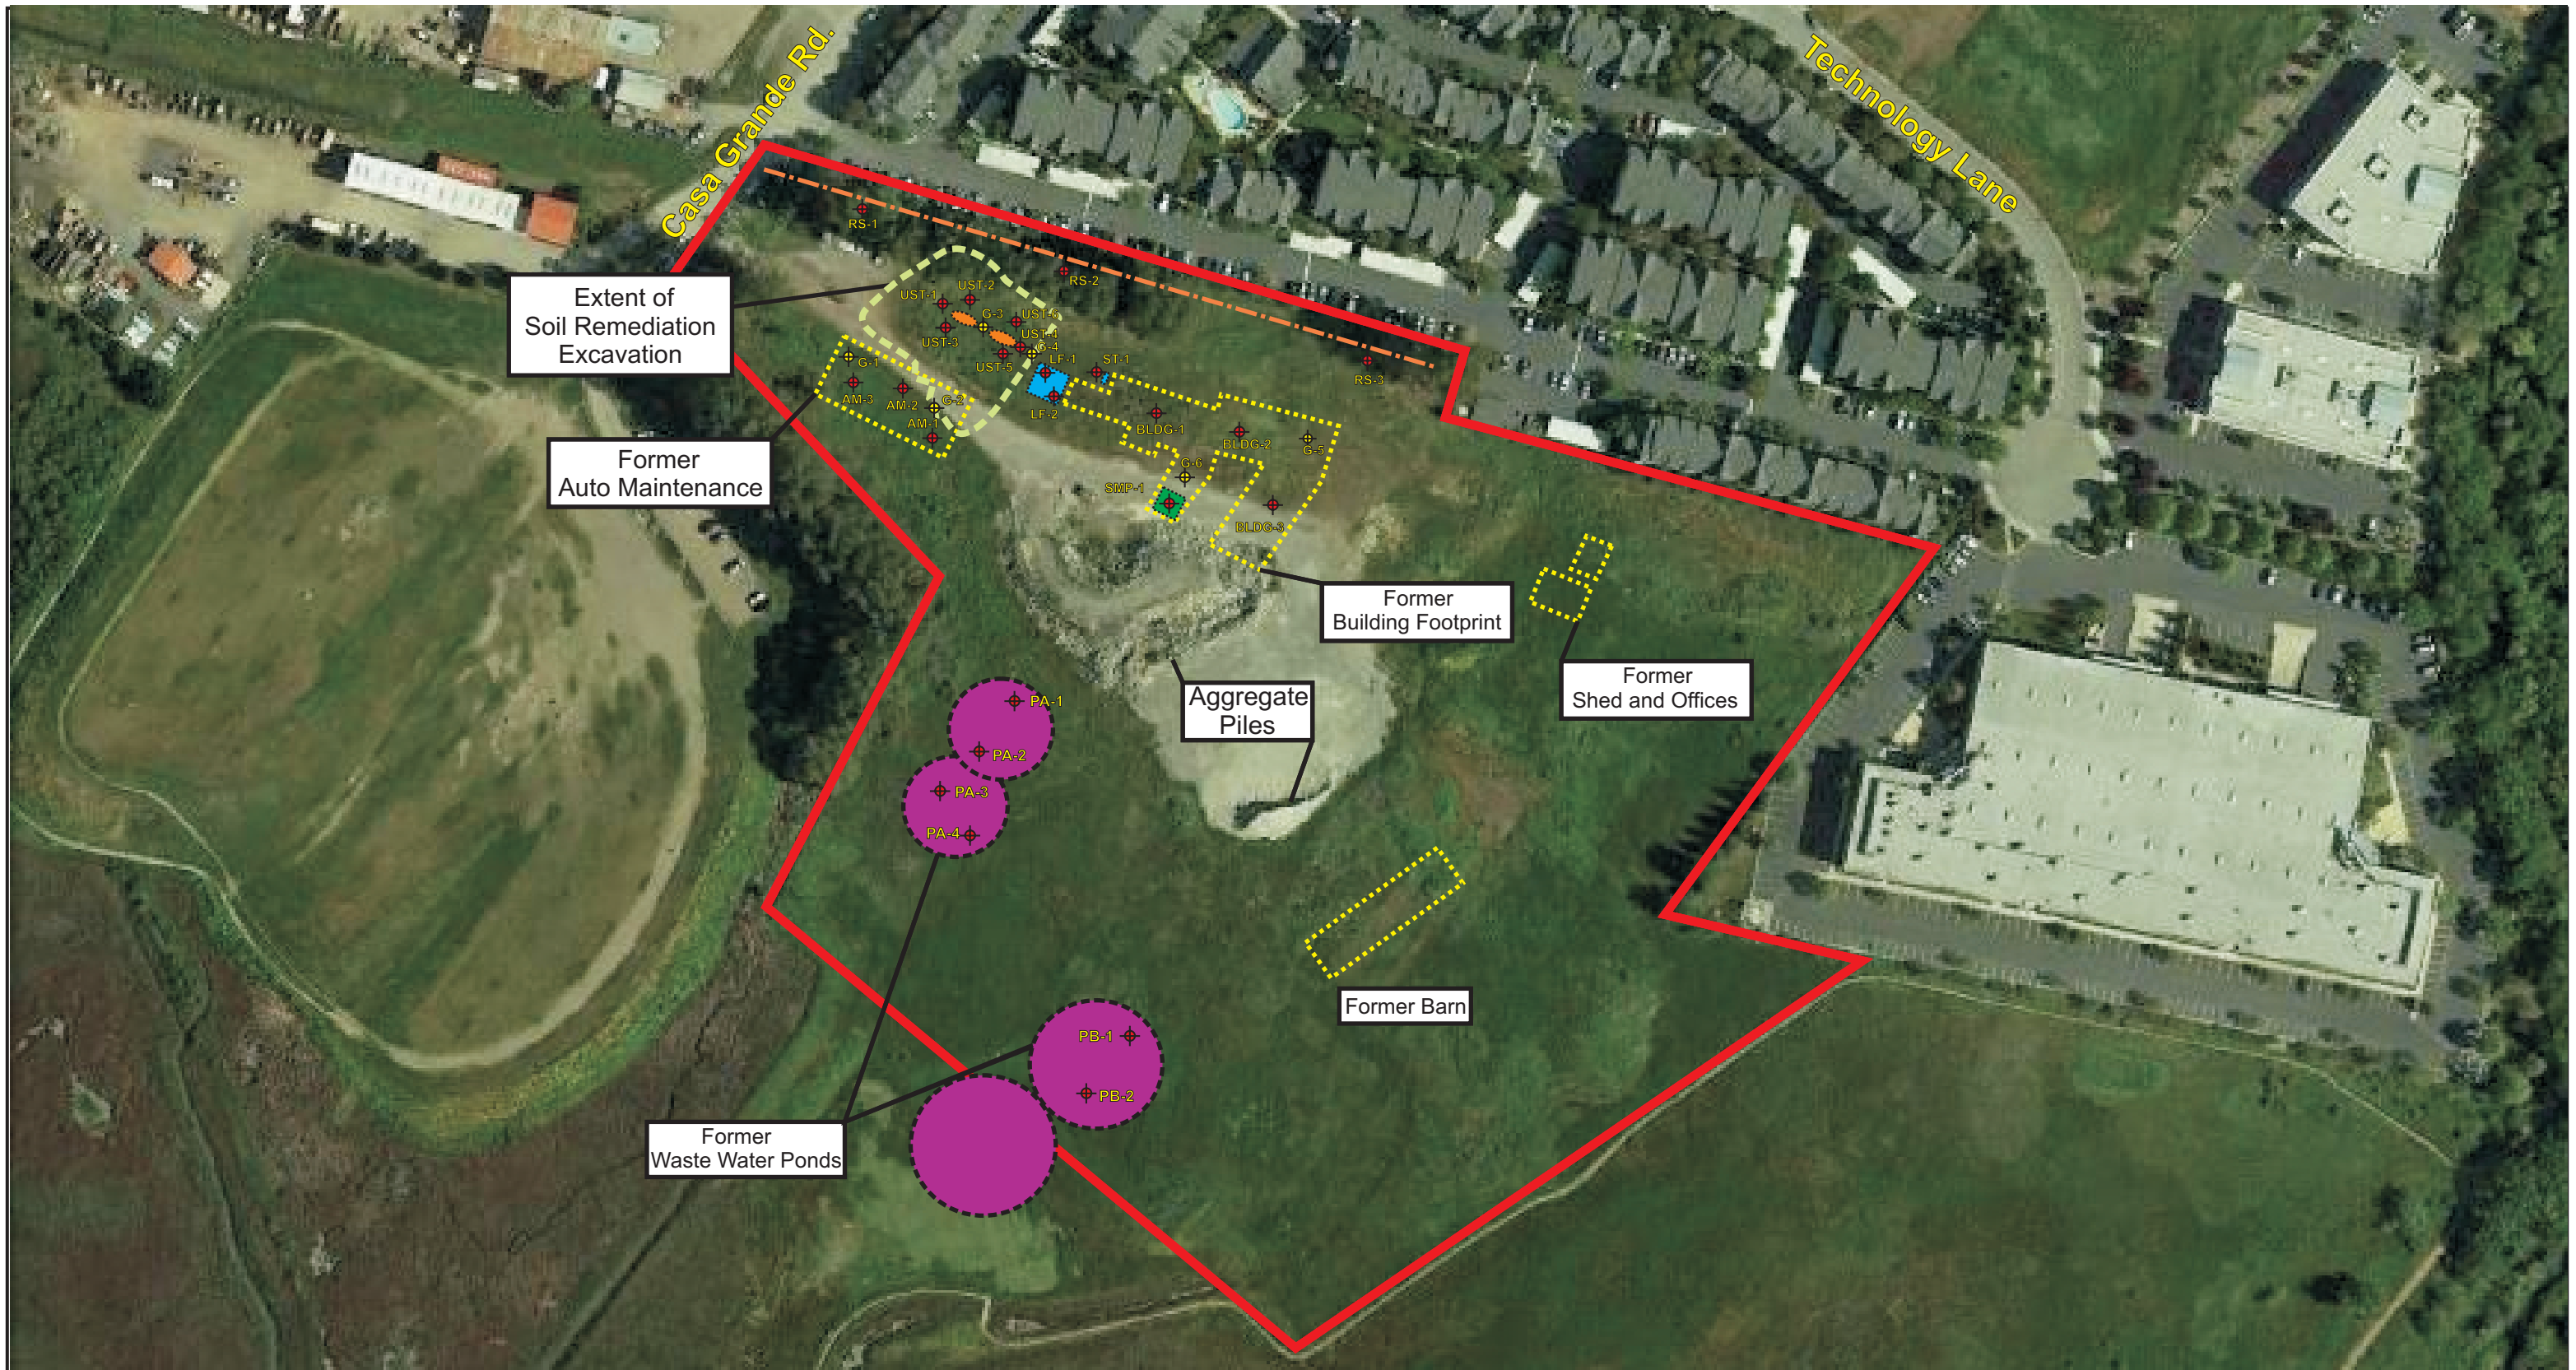
AEI CONSULTANTS 2500 CAMINO DIABLO, WALNUT CREEK, CALIFORNIA	
2014 BORING LOCATIONS	
2592 Lakeville Highway Petaluma, California	FIGURE 2 Project No. 327703

LEGEND			
	Approximate Property Boundary		AEI Soil Boring Locations
	Former Railroad Spur		AEI Soil Gas Well Locations
	Former Structures		Approximate Extent of 2012 Remedial Excavation Source: Site Plan-Darling International, Inc. (Figure 2) MFG, Inc. Project No. 030070, 11/08/2006
	Former Sump		Former Septic System Leach Field
	Former USTs		Former Septic Tanks Area
	Former Wastewater Ponds

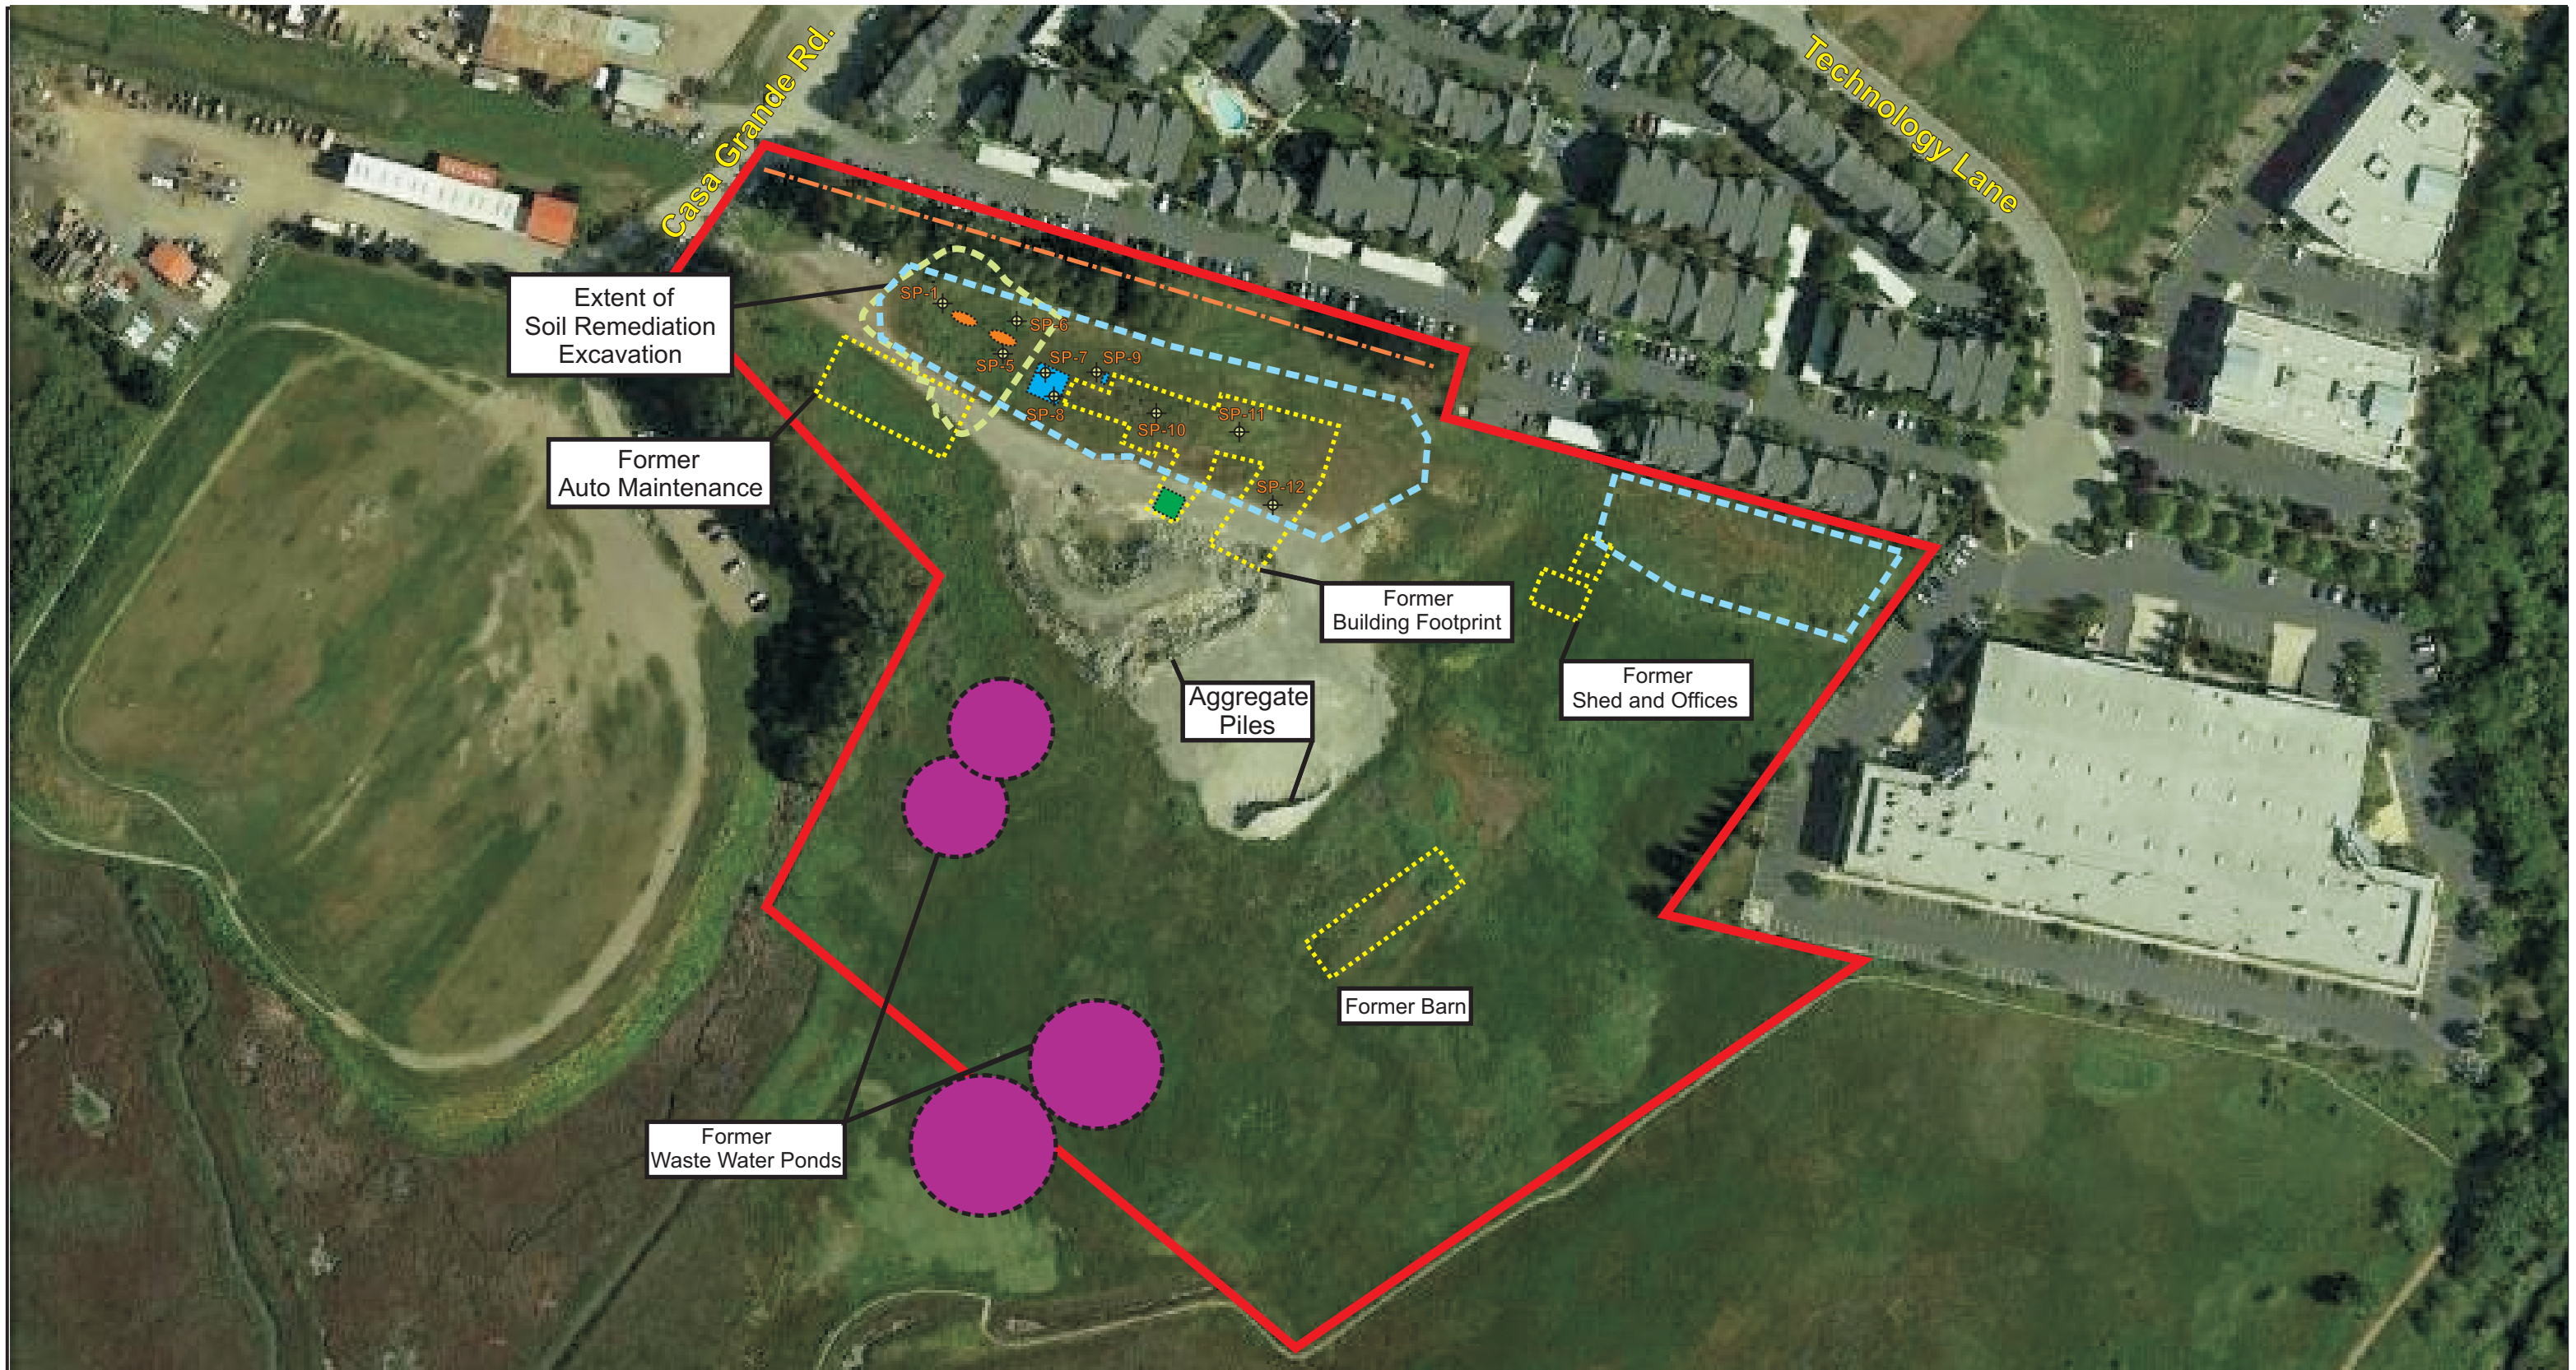
AEI CONSULTANTS 2500 CAMINO DIABLO, WALNUT CREEK, CALIFORNIA	
2014 STOCKPILE LOCATIONS	
2592 Lakeville Highway Petaluma, California	FIGURE 3 Project No. 327703

LEGEND			
	Approximate Property Boundary		Former USTs
	Former Railroad Spur		Former Septic System Leach Field
	Former Structures		Former Septic Tanks Area
	Approximate Boundaries of Stockpiles		Former Wastewater Ponds
	Former Sump		AEI Stockpile Soil Sampling Locations
			Approximate Extent of 2002 Remedial Excavation Source: Site Plan-Darling International, Inc. (Figure 2) MFG, Inc. Project No. 030070, 11/08/2006

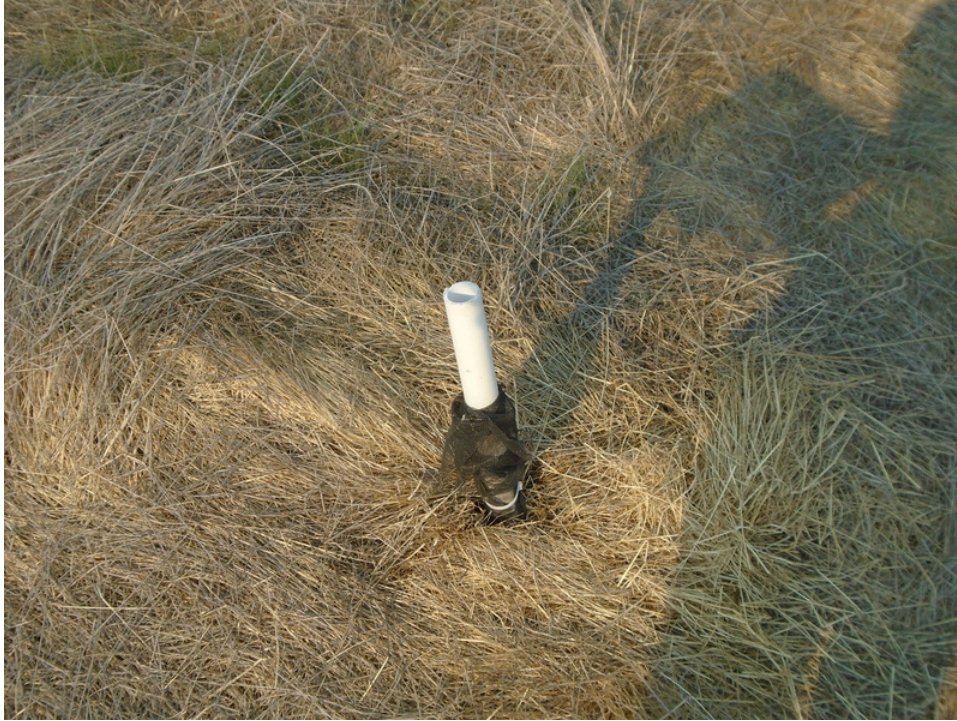
7. View of a possible monitoring well observed on the northeast portion of the property

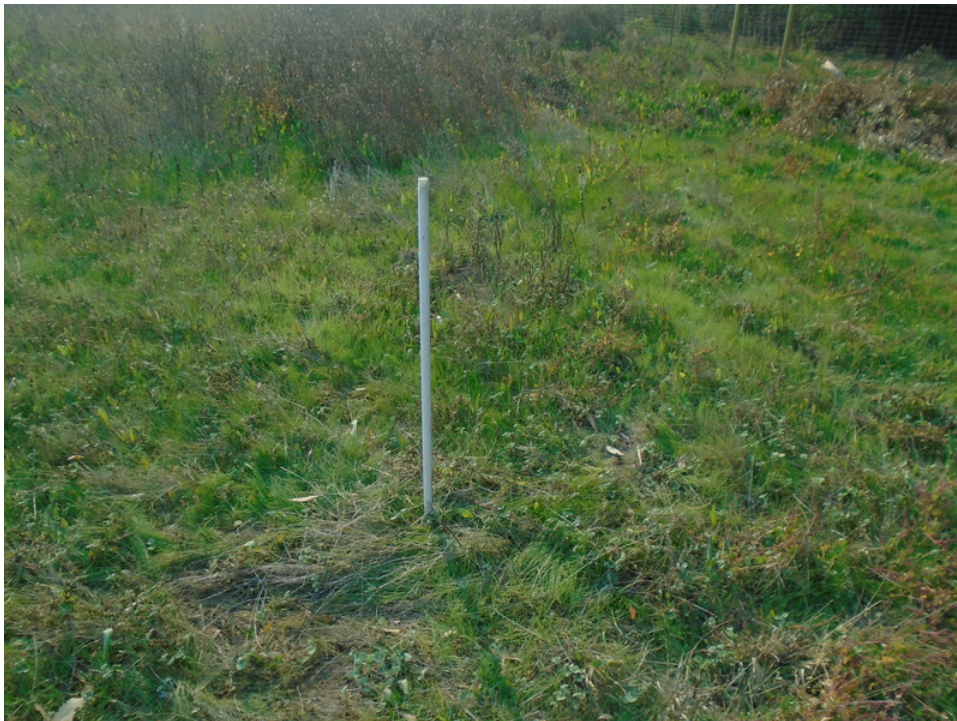
8. Additional view of a possible monitoring well observed on the western portion of the property

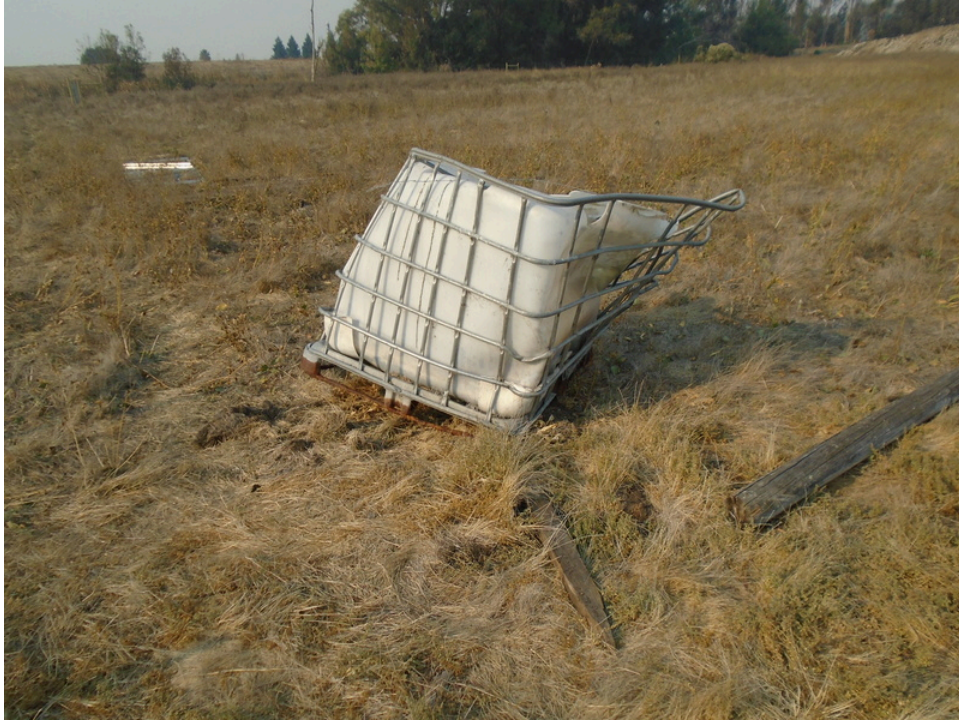
9. View of the unidentified substance container located on the southern portion of the subject property
