Proposed Downtown Housing & Economic Opportunity Overlay Parcel Inventory Report, November 2023

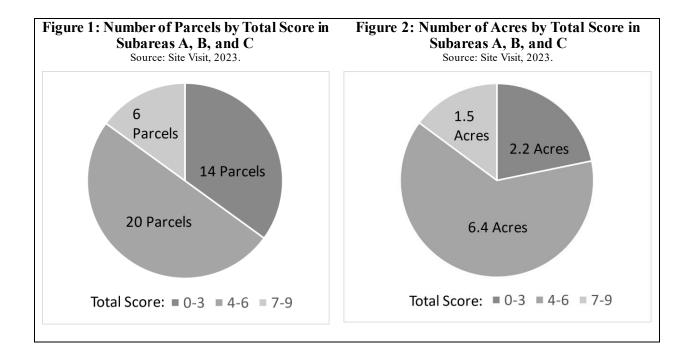
Overall, the majority of the total combined acreage of the subareas, $8.6 \text{ of} \pm 10.1$ acres, or 86%, is underdeveloped and underutilized, as shown in Figure 2 below. Approximately 85% of all parcels

(\pm 29 parcels) exhibited a combined score of 6 or less out of 9, with nine parcels developed to the maximum extent of the allowable height and lot coverage, as well as supported residential-commercial mixed use. None of the parcels in any of the subareas scored an 8 or higher, meaning none of the parcels made use of all the height, land use, or lot coverage allowances outlined in the IZO.

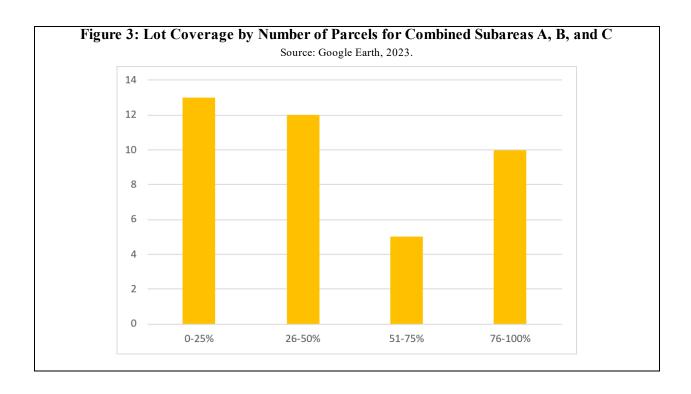
Of the parcels in all the subareas, 32.5% or 13 parcels have lot coverage of 25% or less, and 62% or 25 parcels have less than half of their land area covered by a structure, as shown in Figure 3 below. Only 25% of all parcels, or 10 parcels, have lot coverage of more than 75%. This finding shows that the majority of the parcels in the total study area could be considered underutilized and underdeveloped when considering the maximum allowable lot coverage allowances in the IZO.

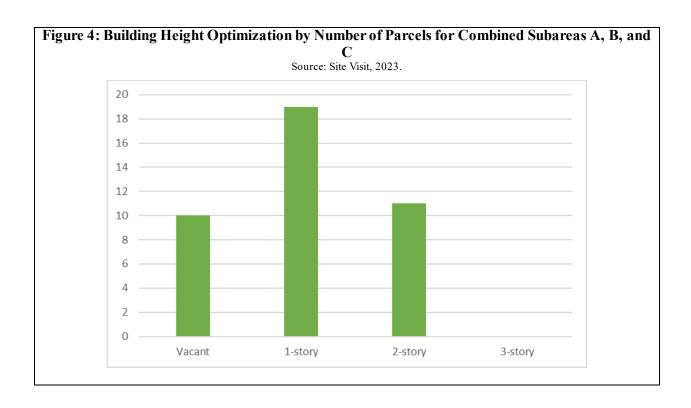
Most parcels within the study area are developed with single-story structures, with 19 parcels of 47% of all parcels, as shown in Figure 4 below. By comparison, 25% of parcels, or 10 parcels are completely vacant of structures, and 11 parcels, or 27% of the study area, contain 2-story structures. None of the parcels in the study area are developed with 3-story structures, the maximum allowed according to the IZO.

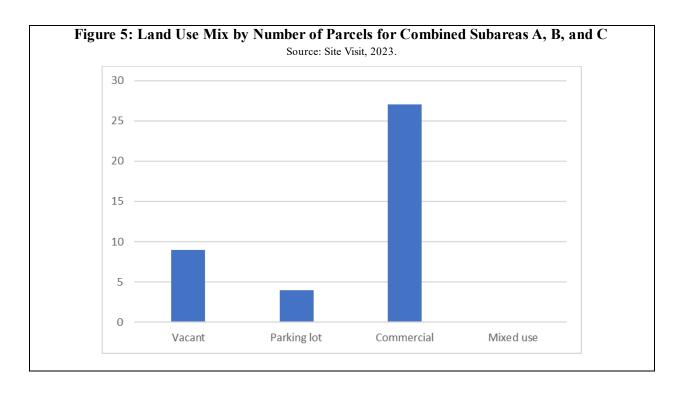
Throughout all of the subareas, parcels support only single uses, with none of the parcels utilizing the mixed-use residential and commercial allowances found in the IZO. The majority of the parcels, 27 parcels or 67% of the total study area, include only commercial uses, as shown in Figure 5 below. Nine parcels, or 22% of the total area, do not support any uses, and four parcels, or 10% of the parcels are used exclusively as surface parking lots.

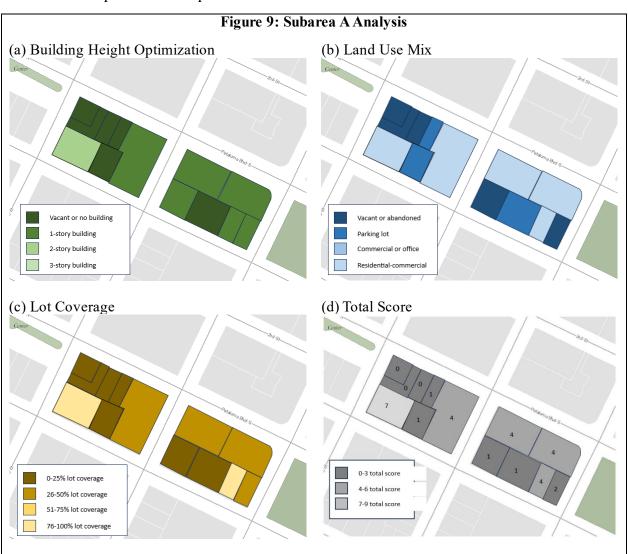
Figure 9a identifies the heights of structures on the parcels and how most of the parcels in the subarea contain no built-up structures, with the highest structure being the 2-story Rex Ace Hardware store. Figure 9b highlights the mix of land uses, with all of the land uses in the subarea being used for either commercial or office space, parking, or are vacant. The coverage of each of the individual parcels by built-up structures is showcased in Figure 9c, with most of the parcels having structures that cover no more than 25% of the lot area. Combining the scores of all of the three scoring criteria provides the total development scores highlighted in Figure 9d, which depict how all but one of the parcels scored less than 6, meaning that most of the parcels in the subarea are underdeveloped when compared to the standards allowed.

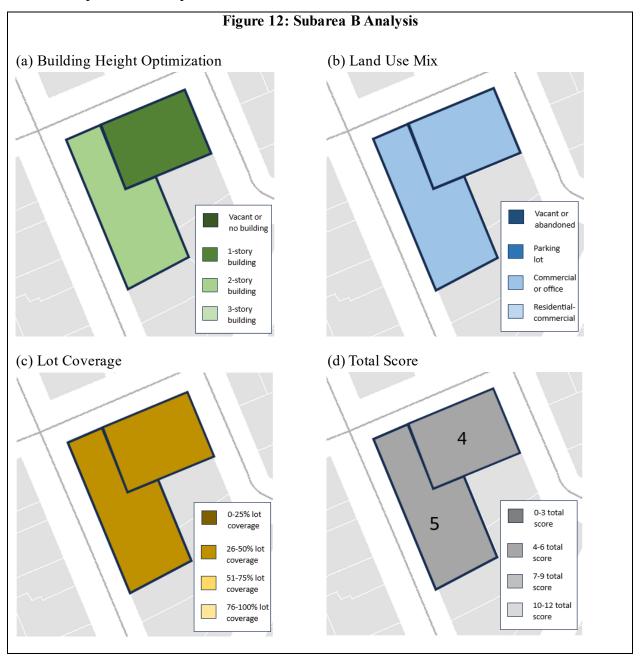
Figure 12a identifies the heights of structures on the parcels and how both parcels in the subarea are built up, with the highest structure being the 2-story Wells Fargo bank building. Figure 12b highlights the mix of land uses and how both parcels are used for commercial uses. The coverage of each of the individual parcels by built-up structures is showcased in Figure 12c, with both parcels having structures that cover no more than 50% of the lot area. Combining the scores of all of the three scoring criteria provides the total development scores highlighted in Figure 12d, which depict how both parcels scored less than 6, meaning that all of the parcels in the subarea are underdeveloped when compared to the standards allowed.

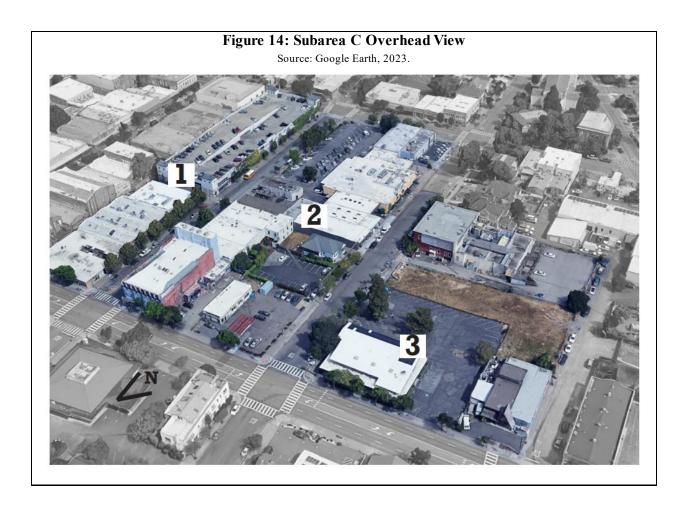
Figure 15: Subarea C – Block 1 Parcel Information

160 Keller Street

Parcel ID: 006-363-001

Current Use: 1-story office

Parcel Size: 8,500 sqft.

Scoring:

Use Optimization: 1 (1-story)

Land Use Mix: 2 (commercial)

Lot Coverage: 3 (95%)

Total: 6

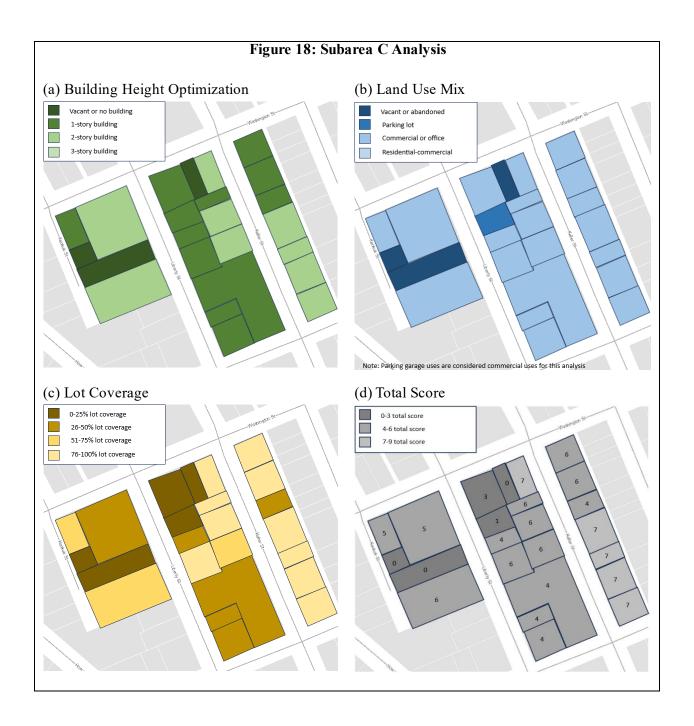
Figure 18a identifies the heights of structures on the parcels and how the majority of the parcels in the subarea contain 1-story structures, with nine structures being 2 stories tall. No structures utilize the maximum 3-story height, however, the Keller Street Parking Garage contains a section that utilizes the roof as space for parking, meaning that there are three levels for parking in the structure. Figure 18b highlights the mix of land uses, with all but five of the parcel land uses in the subarea being used for either commercial or office space. The coverage of each of the individual parcels by built-up structures is showcased in Figure 18c, with 10 of the parcels having structures that cover more than 75% of the lot area, and 12 parcels where the structures cover less than 50% of the lot area. Combining the scores of all of the three scoring criteria provides the total development scores highlighted in Figure 18d, which depict how all but five of the parcels scored less than 6, meaning that the majority of the parcels in the subarea are underdeveloped when compared to the standards allowed.
