Geotechnical Engineering Report  
Overlook Apartments  
xxx – Orlando Street  
Port Orchard, Washington  
PN: 302402-3-063-2008, 4598-005-028007,  
-022-0003, -017-0109, 4598-006-001-  
0303, -004-0003, -007-0000, -010-0104  
Doc ID: OVAHII.LLC.OrlandoSt.PhaseII.RG.REV02

## INTRODUCTION

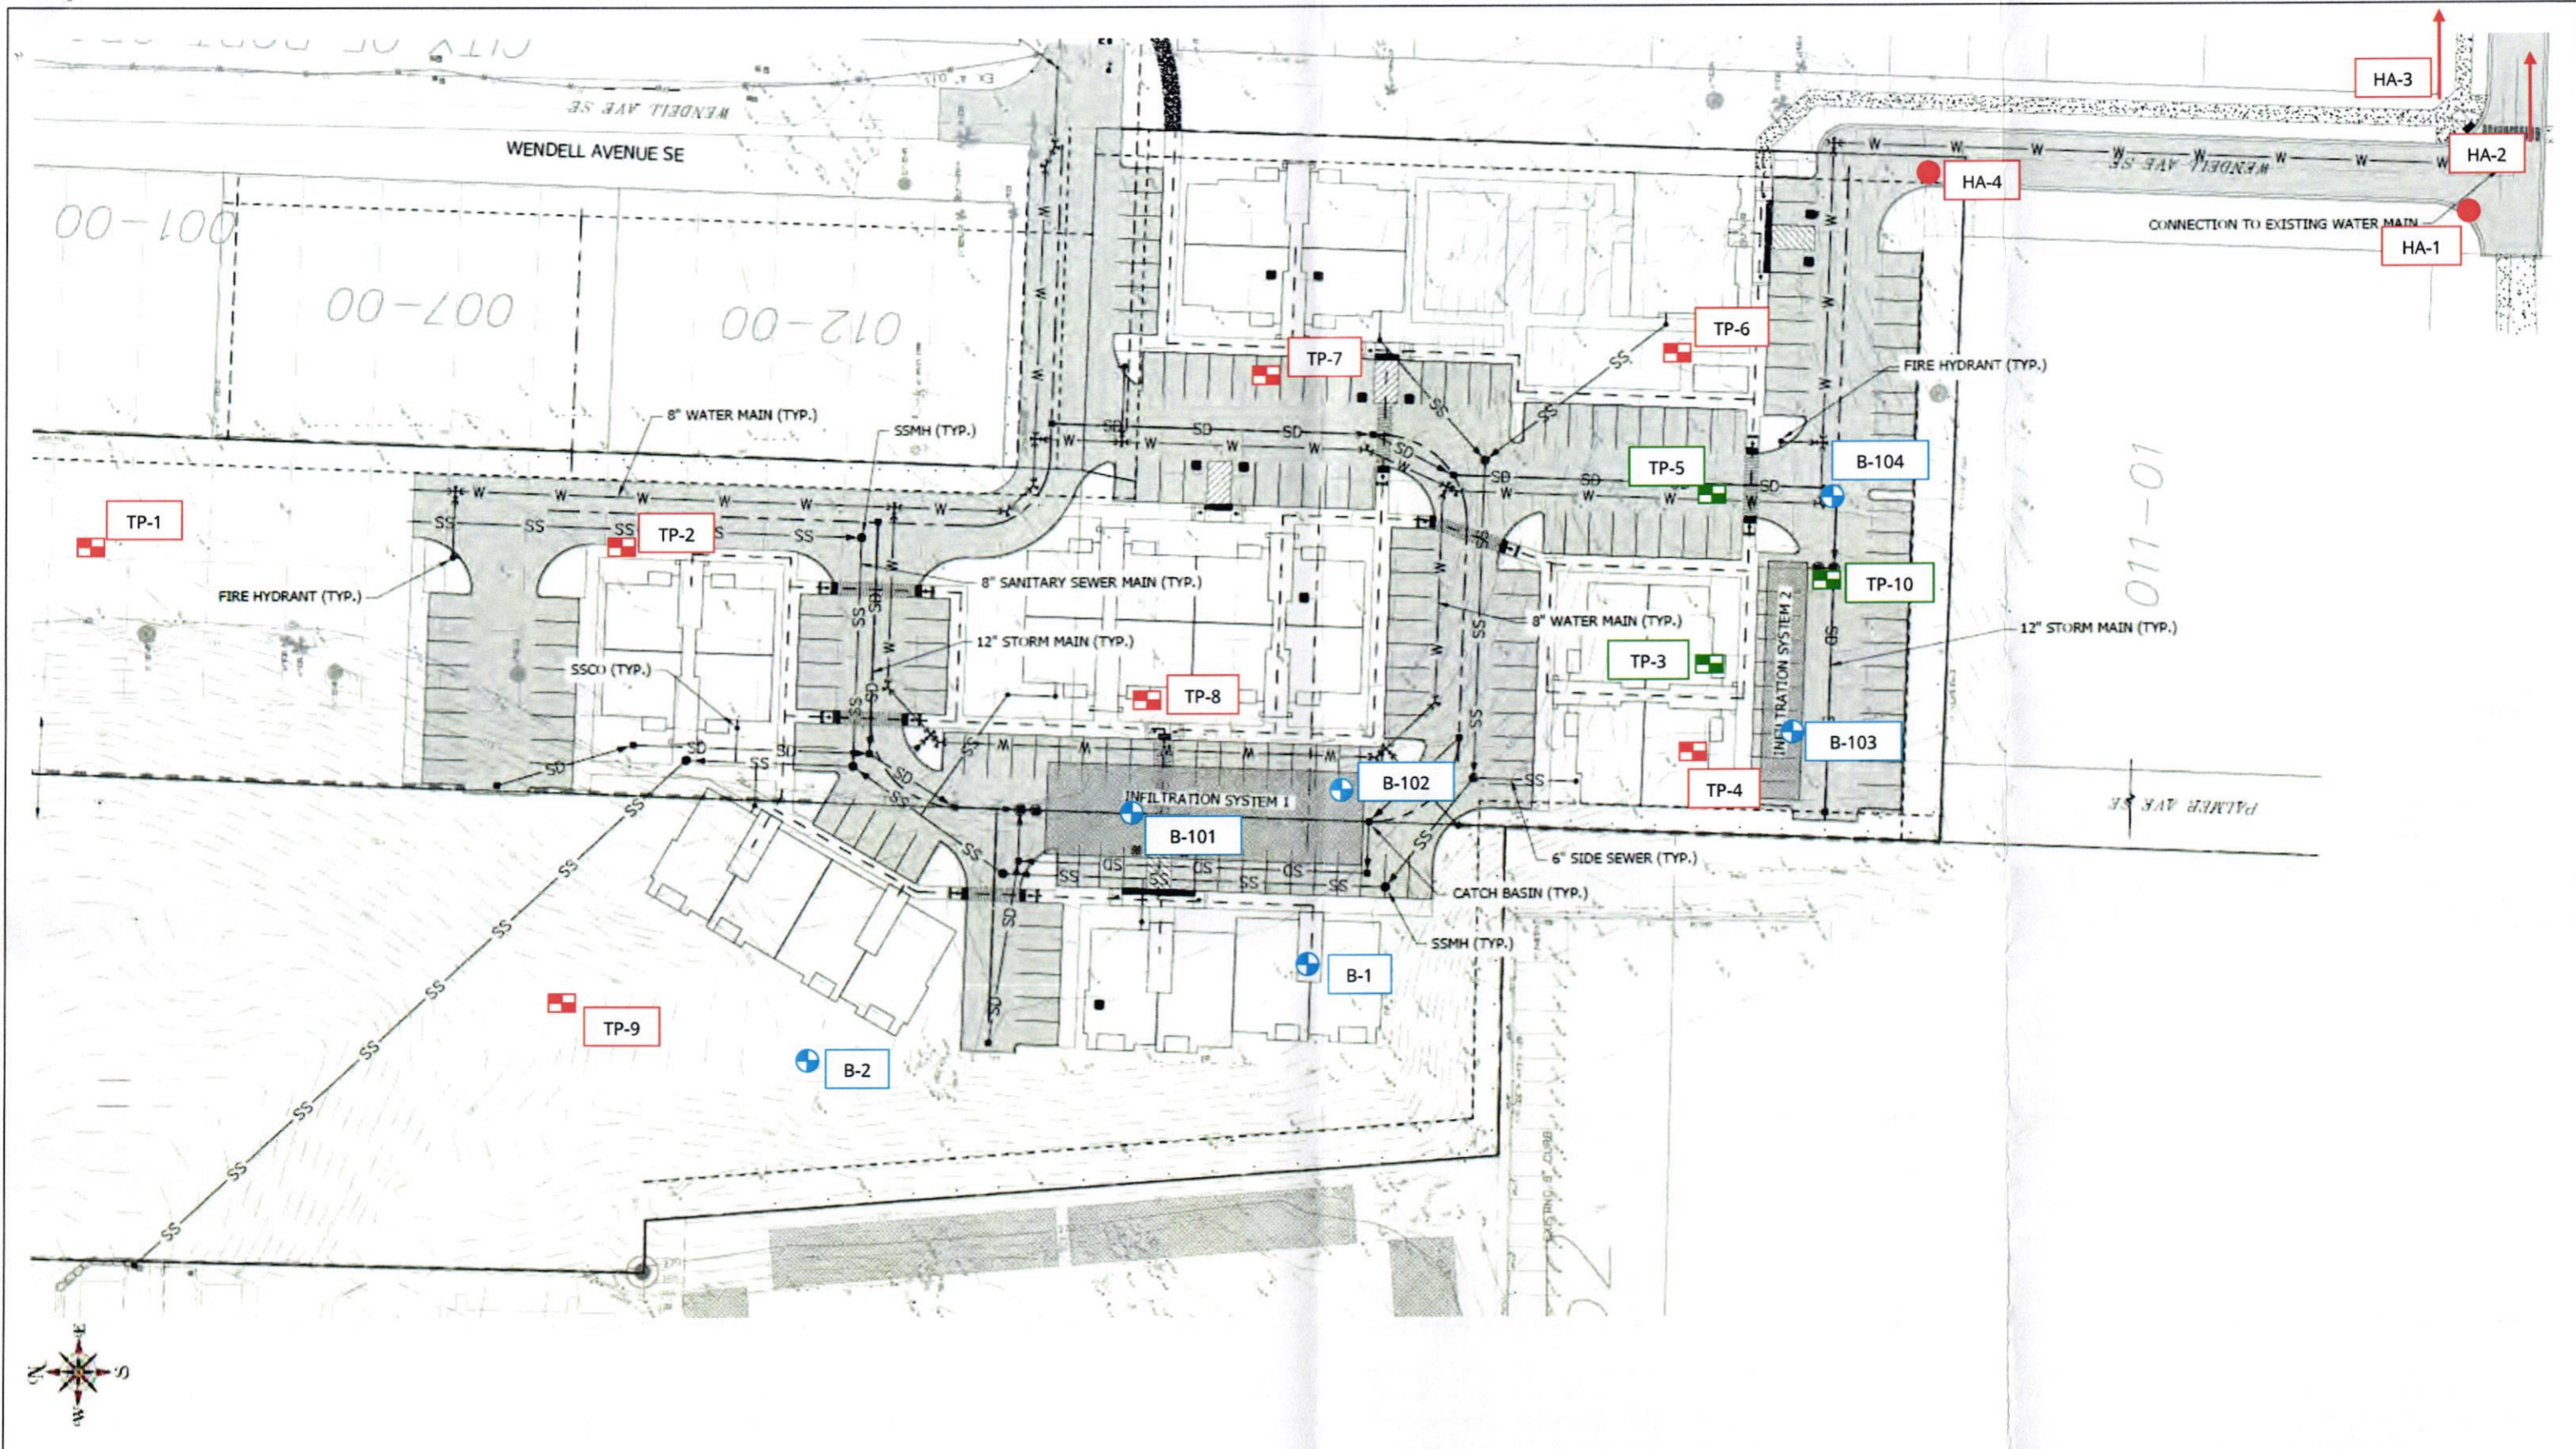
**Site & Exploration Plan**  
 Proposed Residential Development  
 xxx - SE Orlando Street  
 Port Orchard, Washington

- TP-1 Test pit number and approximate location
- B-1 Boring location and approximate location
- HA-1 Hand auger number and approximate locations

The subsurface explorations excavated as part of this evaluation indicate the subsurface conditions at specific locations only, as actual subsurface conditions can vary across the site. Furthermore, the nature and extent of such variation would not become evident until additional explorations are performed or until construction activities have begun. Based on our experience in the area and a review of published geologic literature, it is our opinion that the soils encountered in the explorations are generally representative of the soils at the site. The soils encountered were visually classified in accordance with the Unified Soil Classification System (USCS) and ASTM D: 2488. The USCS is included in Appendix A as Figure A-1. The approximate locations of our explorations are indicated on the attached Site and Exploration Map, Figure 3, while the descriptive logs of our borings and test pits are included in Appendix A, Figures A-2 through A-7.

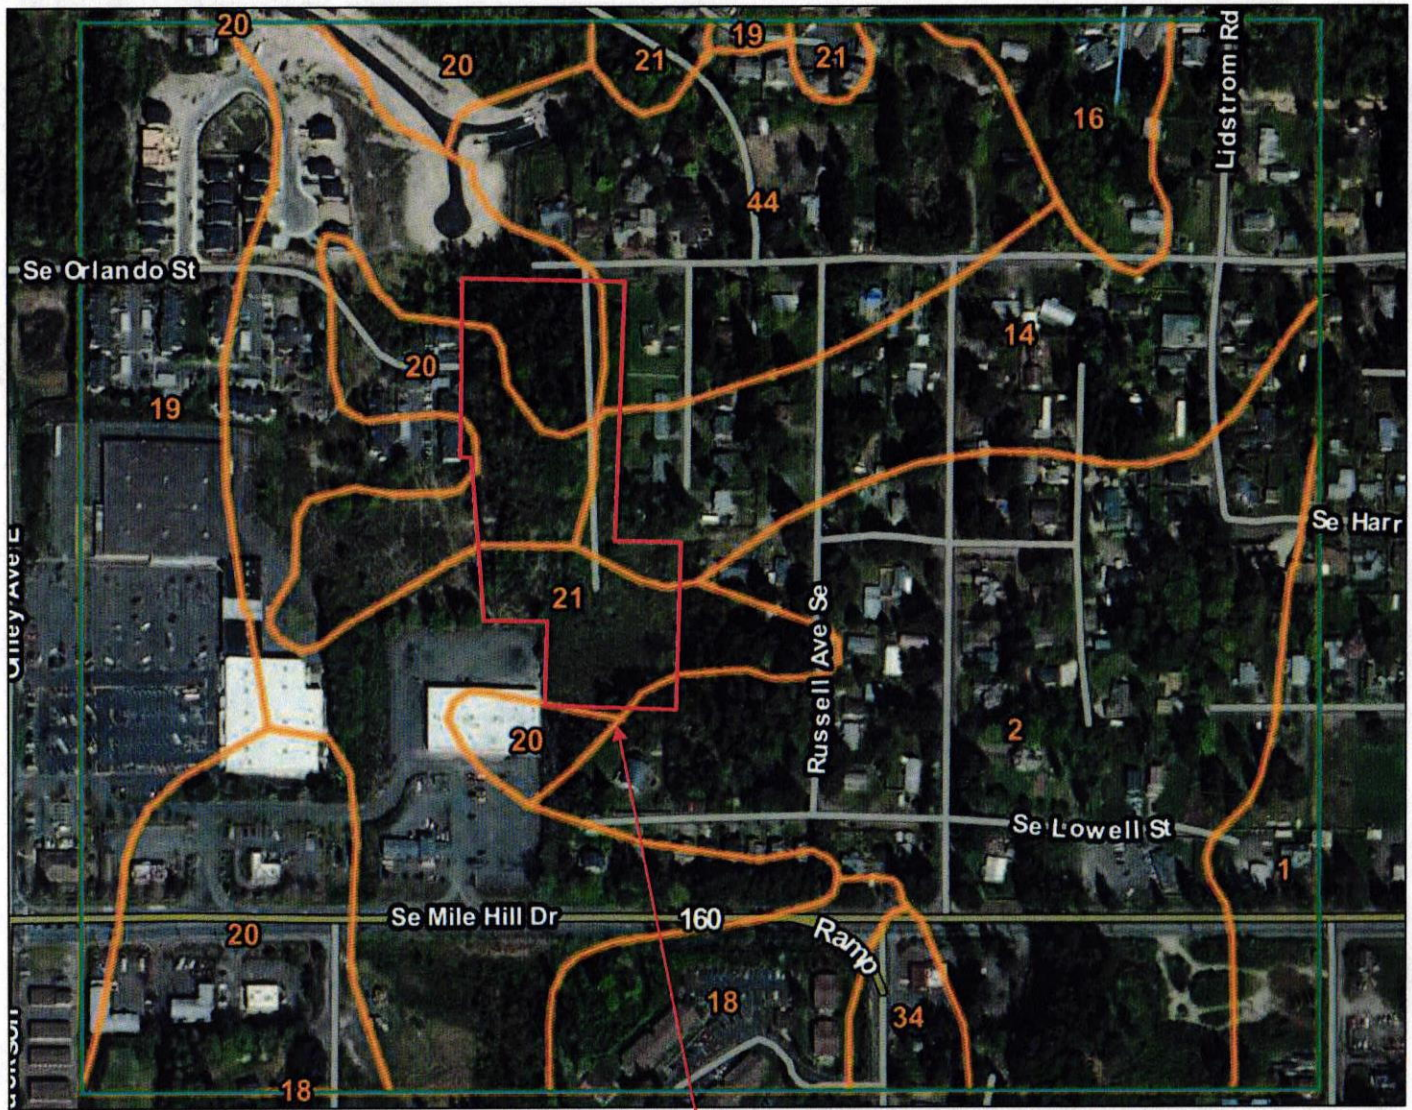
**NRCS Soils Map**

**Approximate Site Location**

The USDA Natural Resources Conservation Service (NRCS) Web Soil Survey maps the site as being underlain by Alderwood gravelly sandy loam (2 and 14), Indianola loamy sand (20), Indianola-Kitsap complex (21), and Ragnar fine sandy loam (44) soils. The Alderwood soils are derived from glacial till and form on slopes of 8 to 15 percent and 15 to 30 percent, respectively. These soils have a "slight" to "moderate" erosion hazard when exposed and are included in hydrologic soils group B. The Indianola soils are derived from sandy glacial outwash and form on slopes 15 to 30 percent. These soils have a "moderate" erosion hazard and are included in hydrologic soils group A. The Indianola-Kitsap soils are derived from glacial outwash, form on slopes of 45 to 70 percent, have a "severe" erosion hazard, and are also included in hydrologic soils group A. The Ragnar soils are derived from glacial outwash with ash and form on slopes of 0 to 6 percent. These soils have a "moderate" erosion hazard and are included in hydrologic soils group A. A copy of the referenced NRCS Soils Map is included as Figure 4.

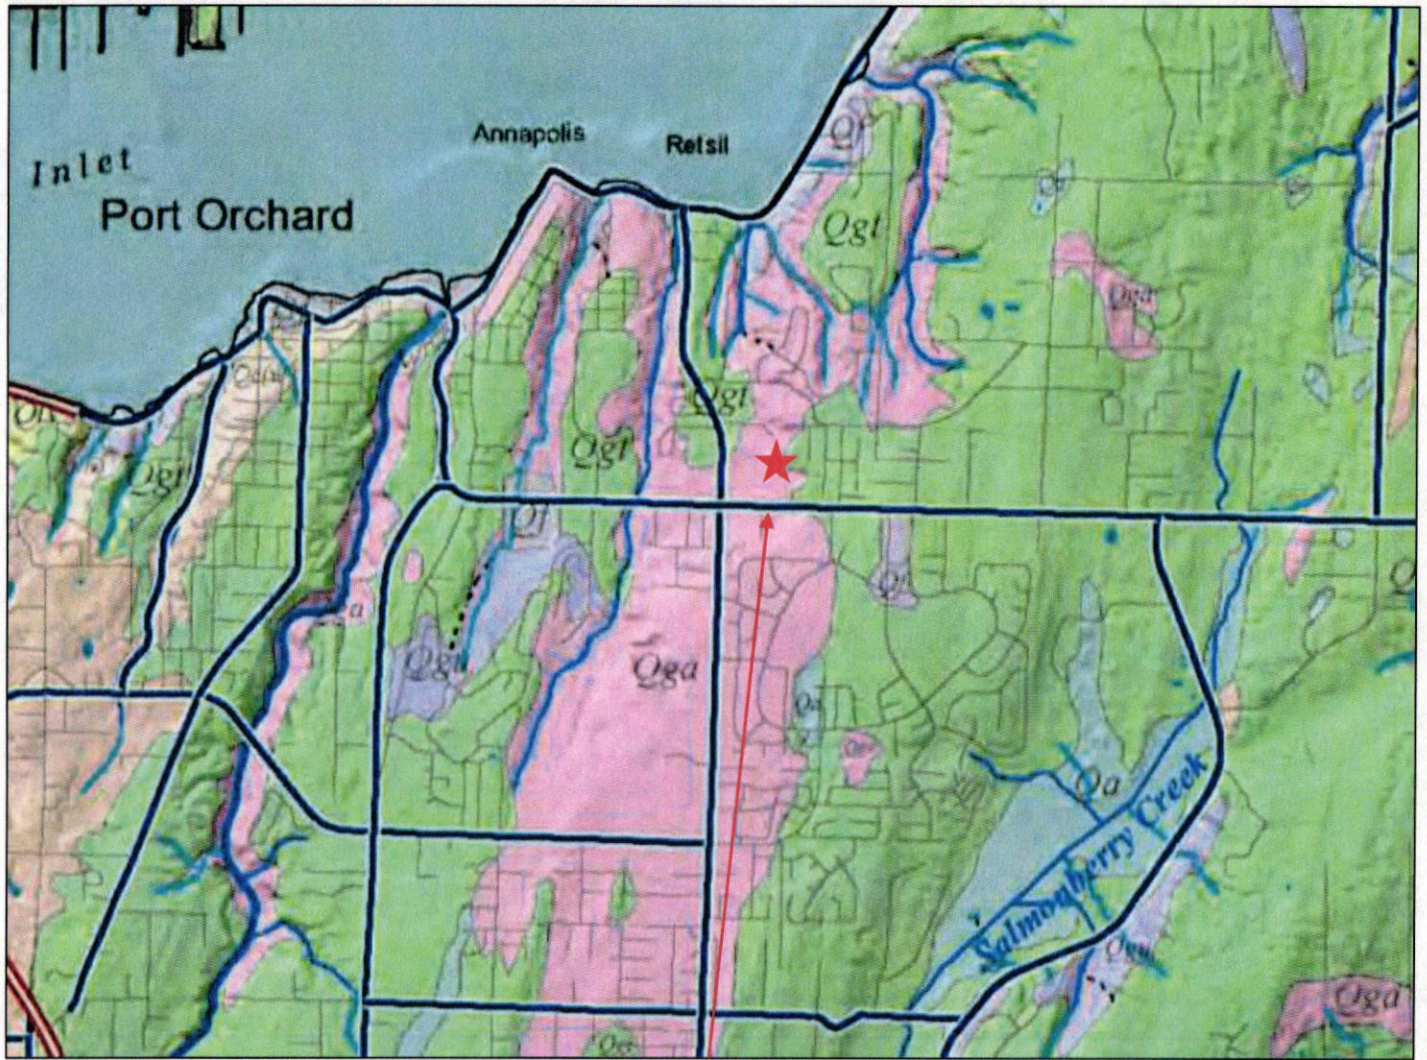
**USGS Geologic Map**

Washington State Department of Natural Resources Division of Geology and Earth Resources Open File Report 2005-3, 1:100,000-scale (December 2005)

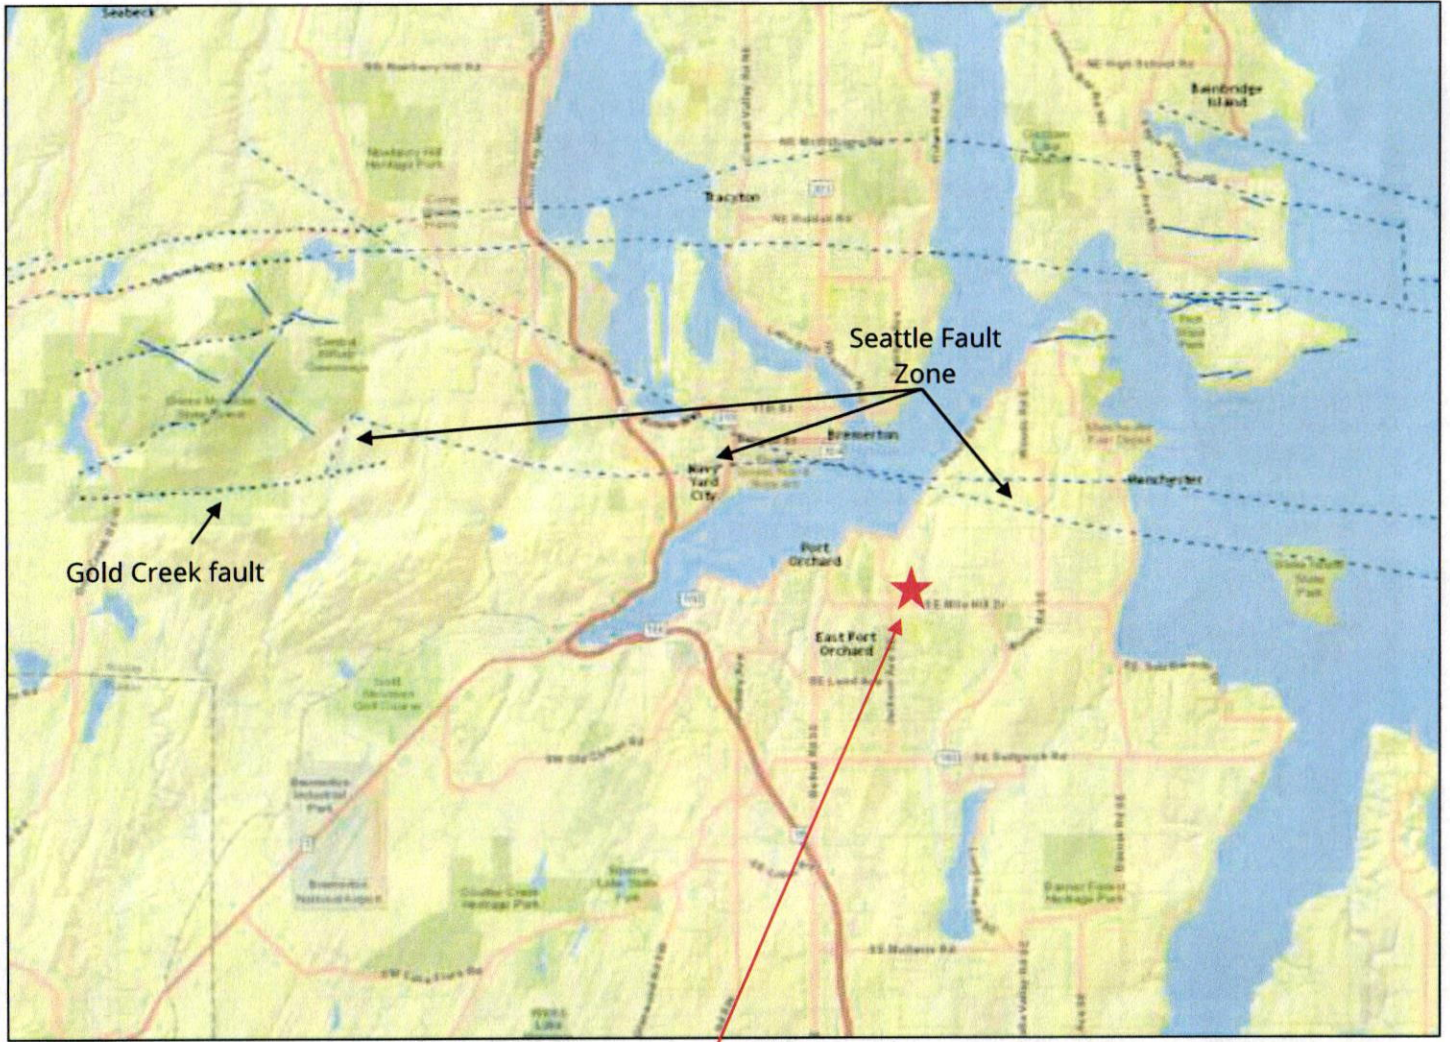
**Washington DNR Natural Hazards Map**

(Map created from Washington DNR Geologic Information Portal  
<http://fortress.wa.gov/dnr/protectiongis/geology/?Theme=wigm>)

We also reviewed the Department of Natural Resources Natural Hazards Map (Geologic Information Portal). The Map indicates that the site is situated about 1.3 miles south of the Seattle Fault zone. No evidence of surficial fault rupture was observed at the site at the time of our site visit. A copy of the referenced DNR Natural Hazards Map is included as Figure 6.

Earthquake-induced geologic hazards may include liquefaction, lateral spreading, slope instability, and ground surface fault rupture. In our opinion, the potential for liquefaction and lateral spreading is not significant because of the depth to groundwater. The ground surface at the project site slopes gently to moderately towards the west; therefore, the potential for earthquake-induced slope instability is also low. According to the Department of Natural Resources Geologic Hazards Map (Geologic Information Portal), the site is located south of the Seattle Fault Zone and southeast of the Gold Creek fault, as shown on Figure 6. In our opinion, the potential for ground surface fault rupture is also low.

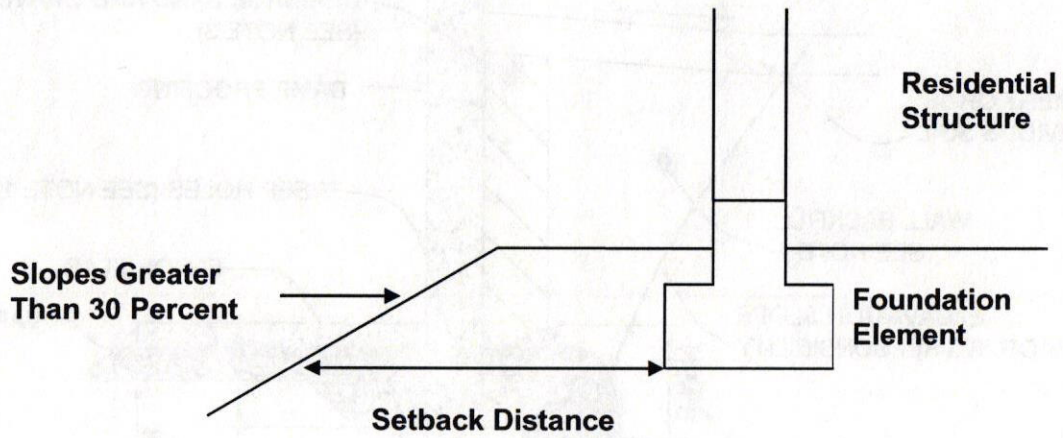
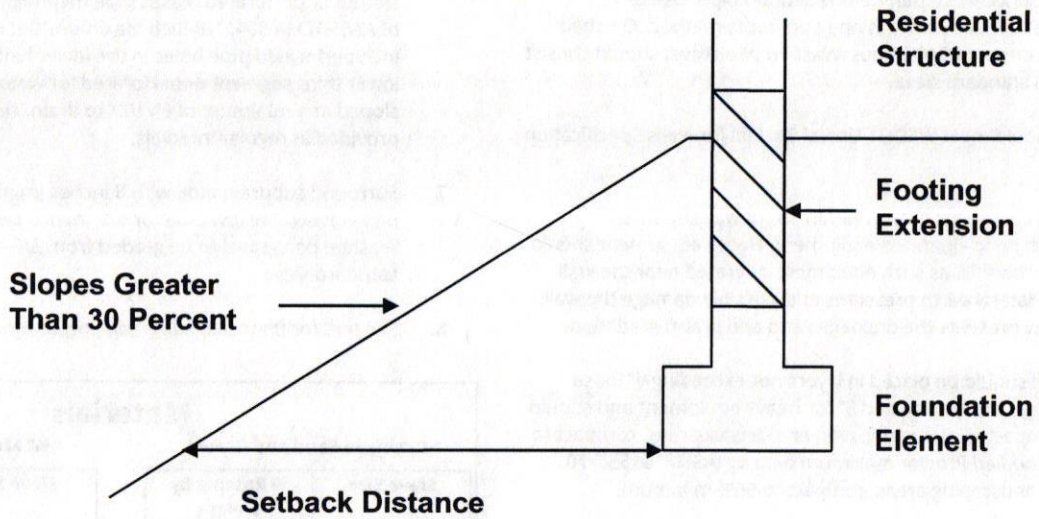
## Typical Structural Setback

### Conventional Footing

### Footing Extension

As stated above, the steep slope at the site has a vertical height of about 24 to 40 feet. Per the 2015 IBC, in its current configuration, the slope area should have a minimum setback of 8 to 14 feet from the top of the slope. If the setback from the top of the slope cannot be achieved, the IBC allows for the use of a "structural setback", as shown on Figure 7. The structural setback includes deepening foundations and measuring from the bottom of the foundation to the face of the slope, at the corresponding elevation. A daylight basement configuration could be used to meet this setback and should provide additional housing units and higher density.

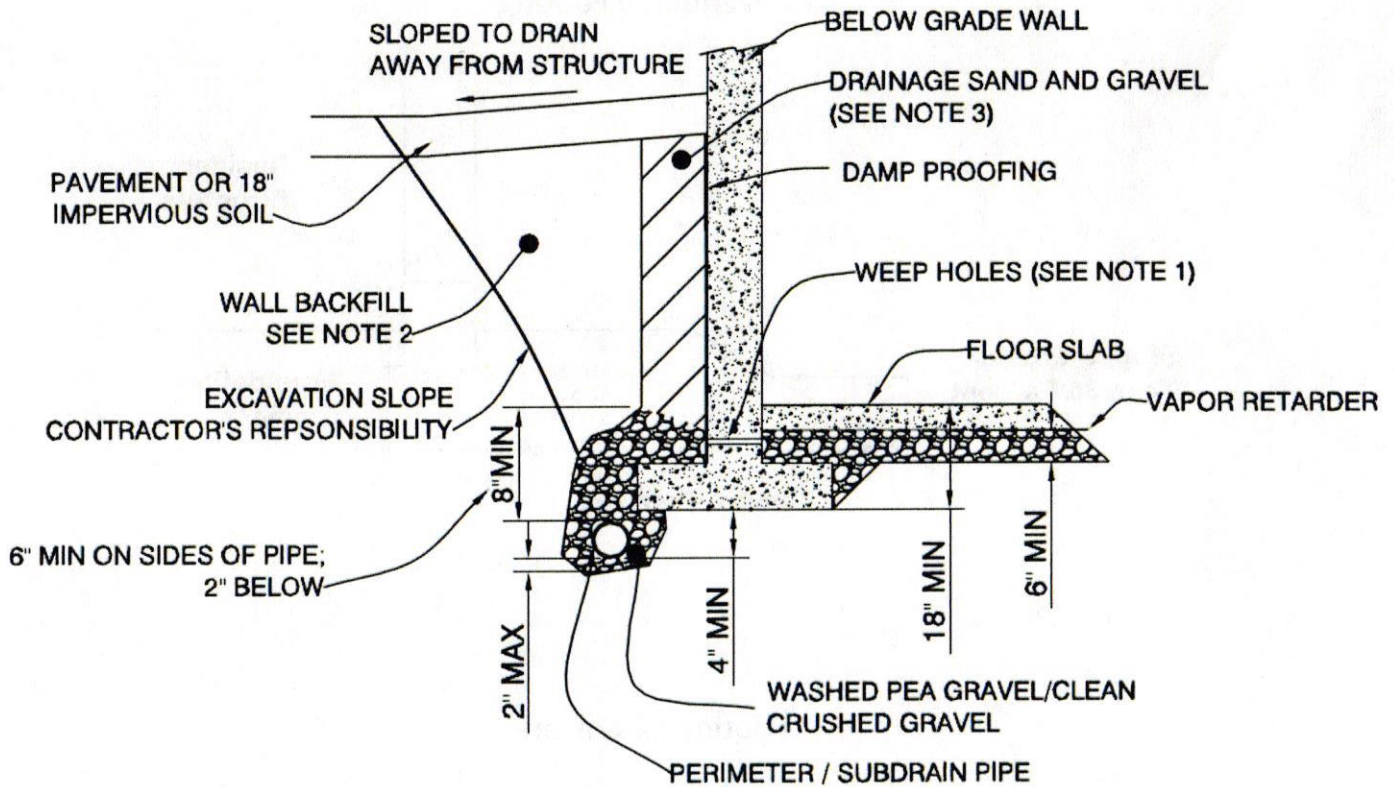
## Typical Wall Drainage and Backfill

1. Washed pea gravel/crushed rock beneath floor slab could be hydraulically connected to perimeter/subdrain pipe. Use of 1" diameter weep holes as shown is one applicable method. Crushed gravel should consist of 3/4" minus. Washed pea gravel should consist of 3/8" to No. 8 standard sieve.

Drainage Sand and Gravel		¾" Minus Crushed Gravel	
Sieve Size	% Passing by Weight	Sieve Size	% Passing by Weight
¾"	100	¾"	100
No 4	28 - 56	½"	75 - 100
No 8	20 - 50	¼"	0 - 25
No 50	3 - 12	No 100	0 - 2
No 100	0 - 2	(by wet sieving)	(non-plastic)

Adequate drainage behind retaining structures is imperative. Positive drainage which controls the development of hydrostatic pressure can be accomplished by placing a zone of drainage behind the walls. Granular drainage material should contain less than 2 percent fines and at least 30% greater than the US No. 4 sieve. Assuming properly compacted structural fill is used to backfill the foundation walls, an allowable active fluid pressure of 35 pcf should be appropriate for design. Typical wall drainage and backfilling details are shown in Figure 8.

A minimum 4-inch diameter perforated or slotted PVC pipe should be placed in the drainage zone along the base and behind the wall to provide an outlet for accumulated water and direct accumulated water to an appropriate discharge location. We recommend that a nonwoven geotextile filter fabric be placed between the soil drainage material and the remaining wall backfill to reduce silt migration into the drainage zone. The infiltration of silt into the drainage zone can, with time, reduce the permeability of the granular material. The filter fabric should be placed such that it fully separates the drainage material and the backfill, and should be extended over the top of the drainage zone.
