SOA Dust Control Measures
Oceano Dunes SVRA 2019

Oceano Dunes SVRA 2019

2019/20 SOA Dust Control Vegetation Projects

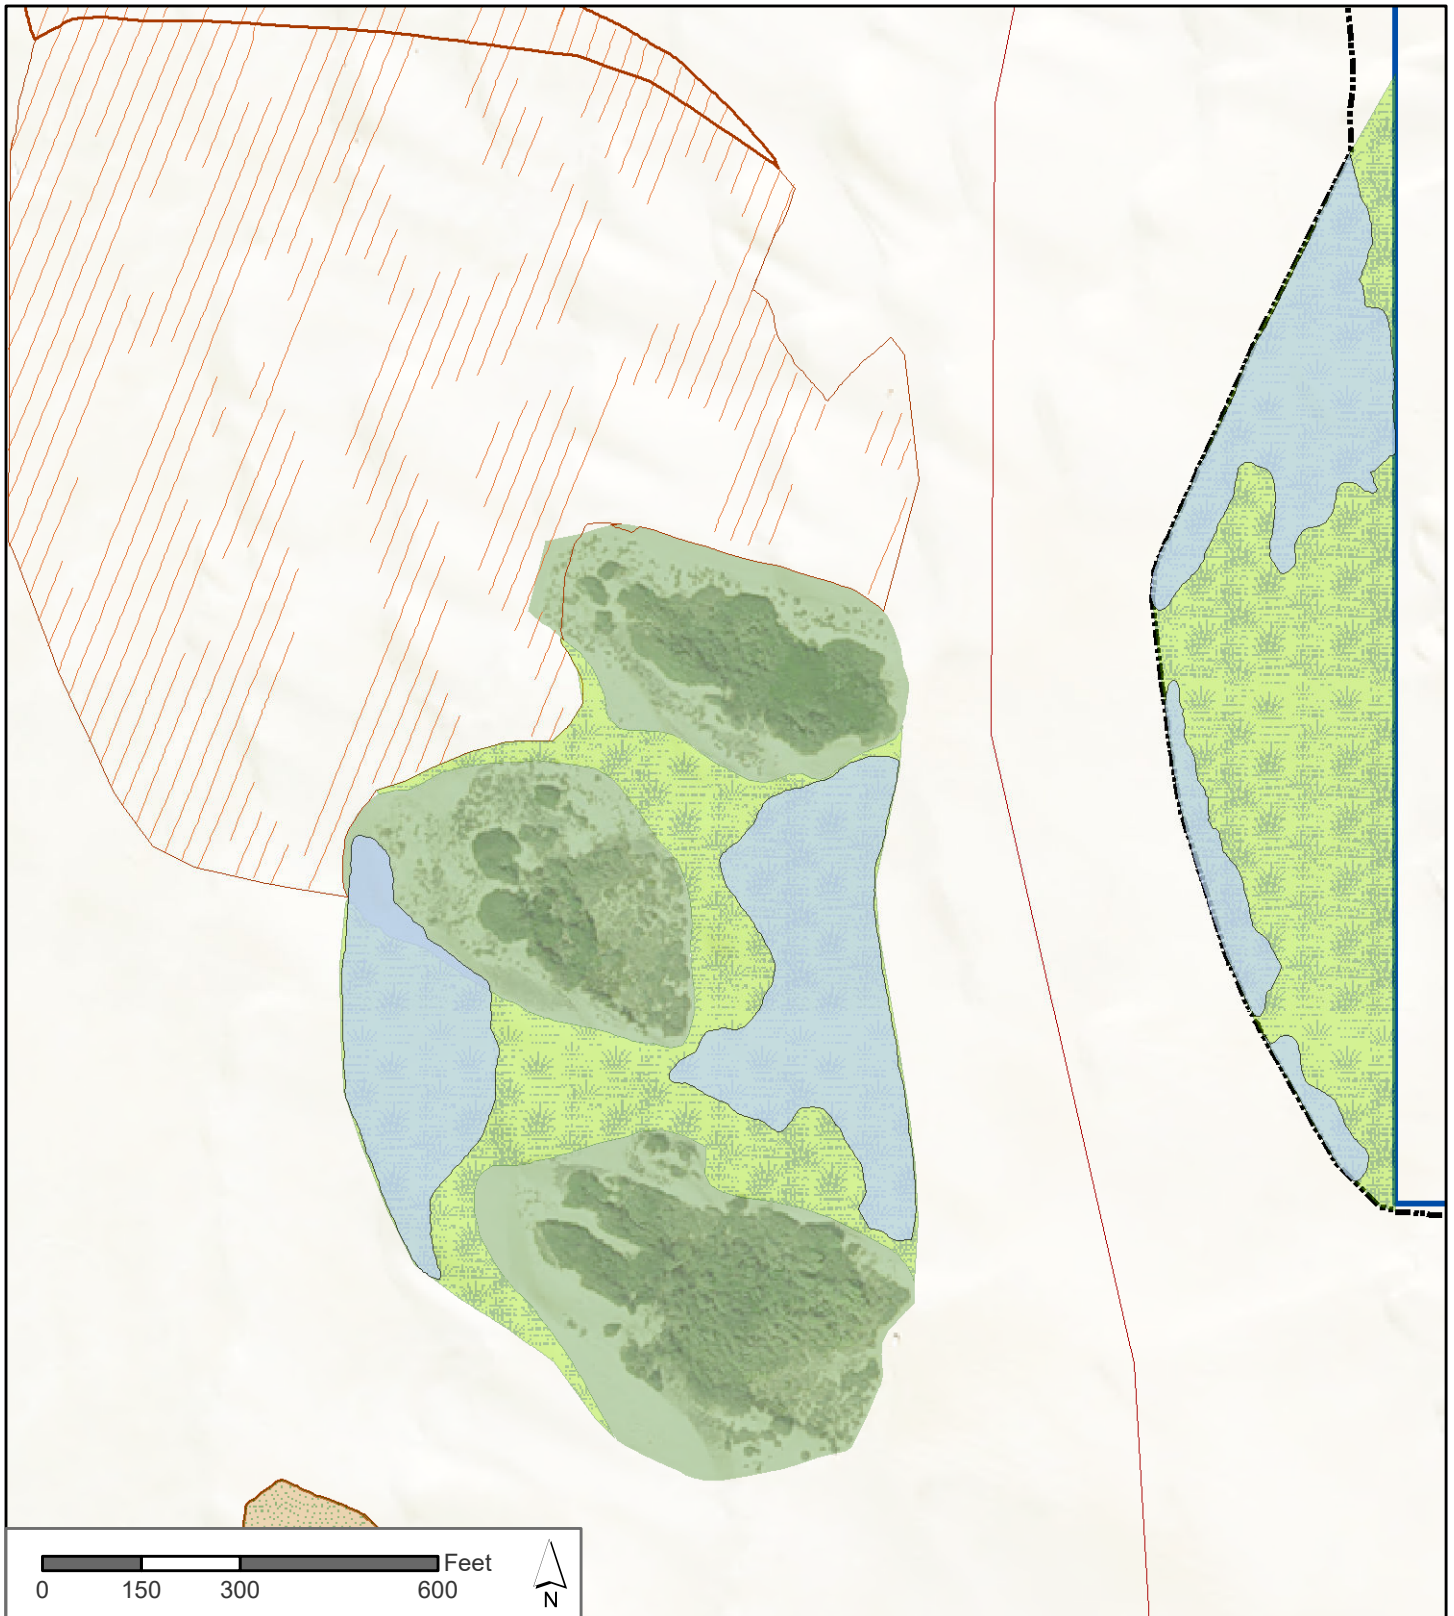
Exhibit 2

2018/19 Supplemental Dust Control Restoration Project

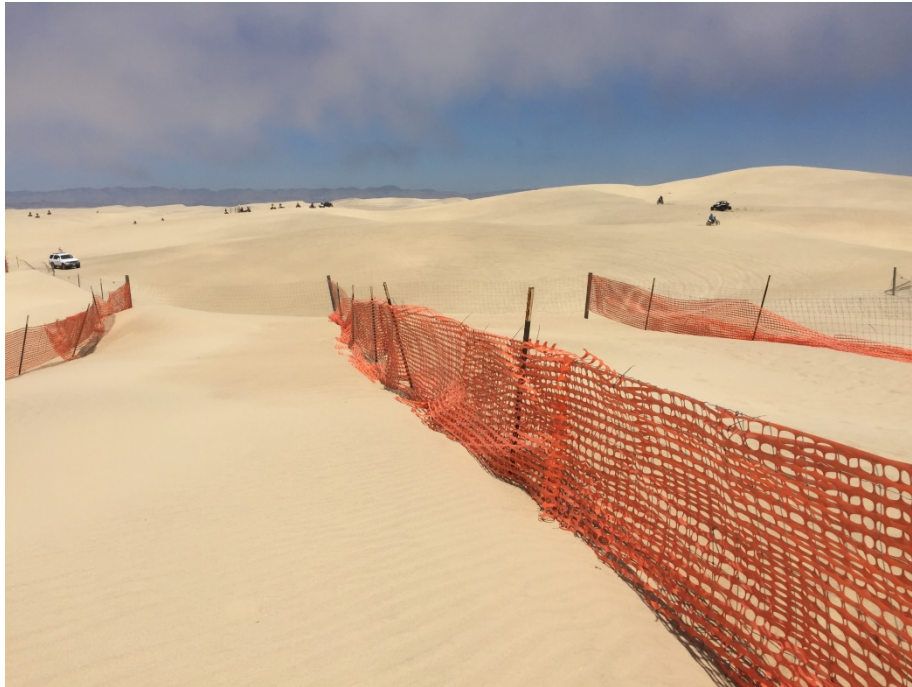
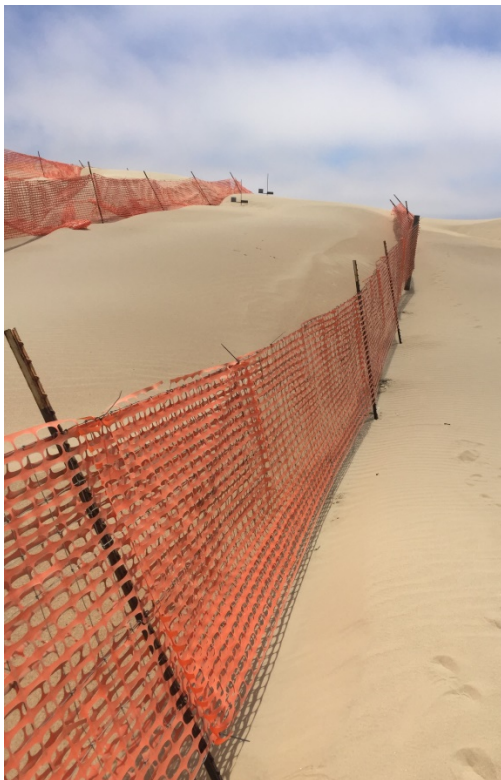
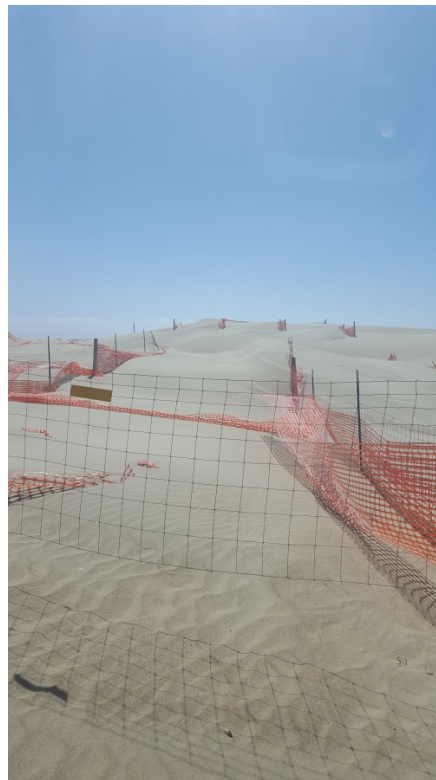
Exhibit 3: Example 2018 Wind Fence Photographs

Exhibit 3. 2018 wind fencing projects installed at Oceano Dunes SVRA. Partially buried fencing requiring maintenance is visible in the top and lower right photographs.

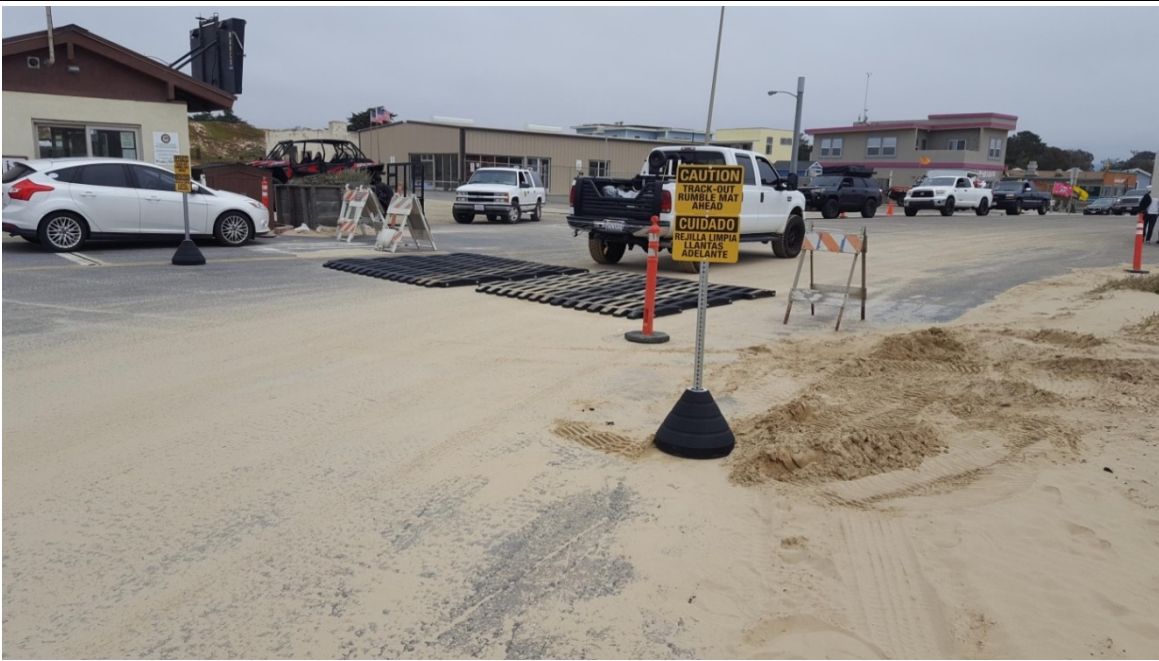
Exhibit 4: Pier Avenue Trackout Mat

Exhibit 4. Pier Avenue Trackout Mats.

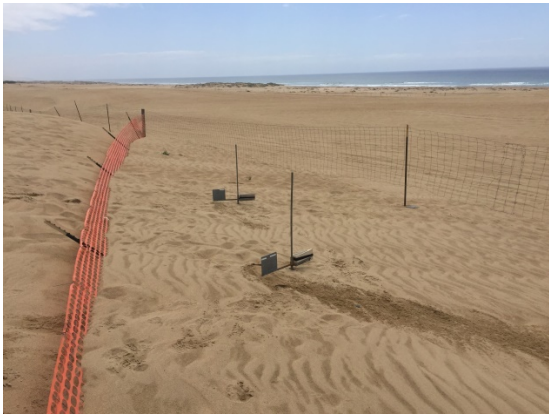
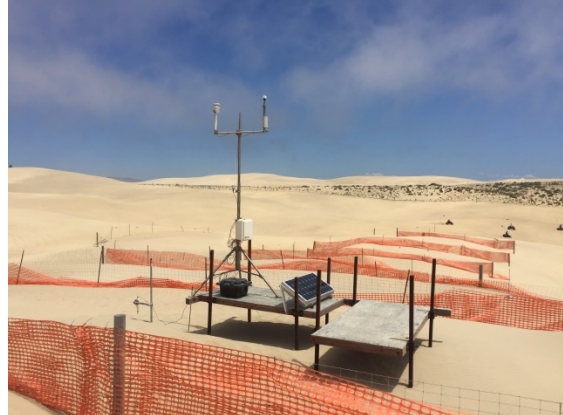
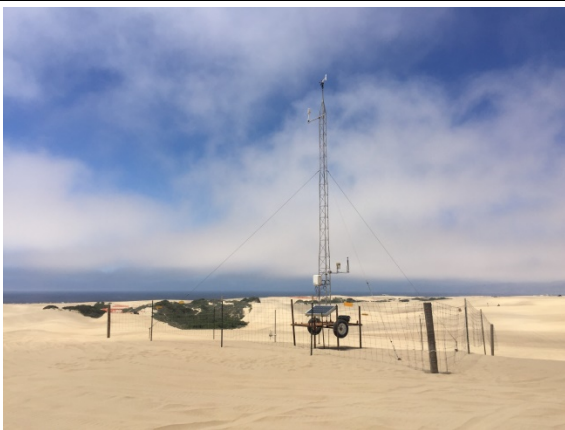
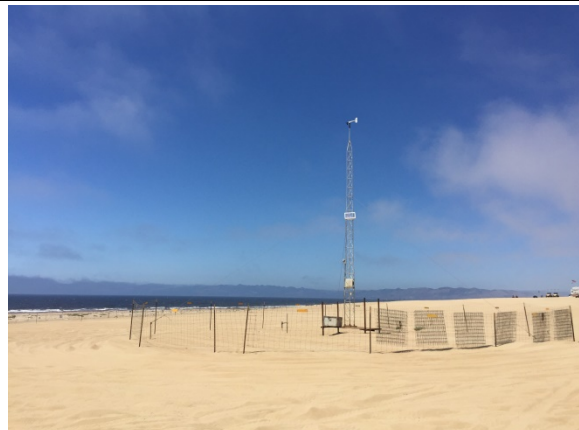
Exhibit 5: Example Monitoring Equipment

Exhibit 5. Example monitoring equipment, including BSNEs (top left), PM₁₀ and wind speed/direction instruments (top right), and meteorological monitoring stations (bottom).
