WHY FRIDGES FAIL PART 2: RTM Data for Maintenance

January 2016

Prepared by Mozambique Ministry of Health, Nexleaf Analytics and VillageReach

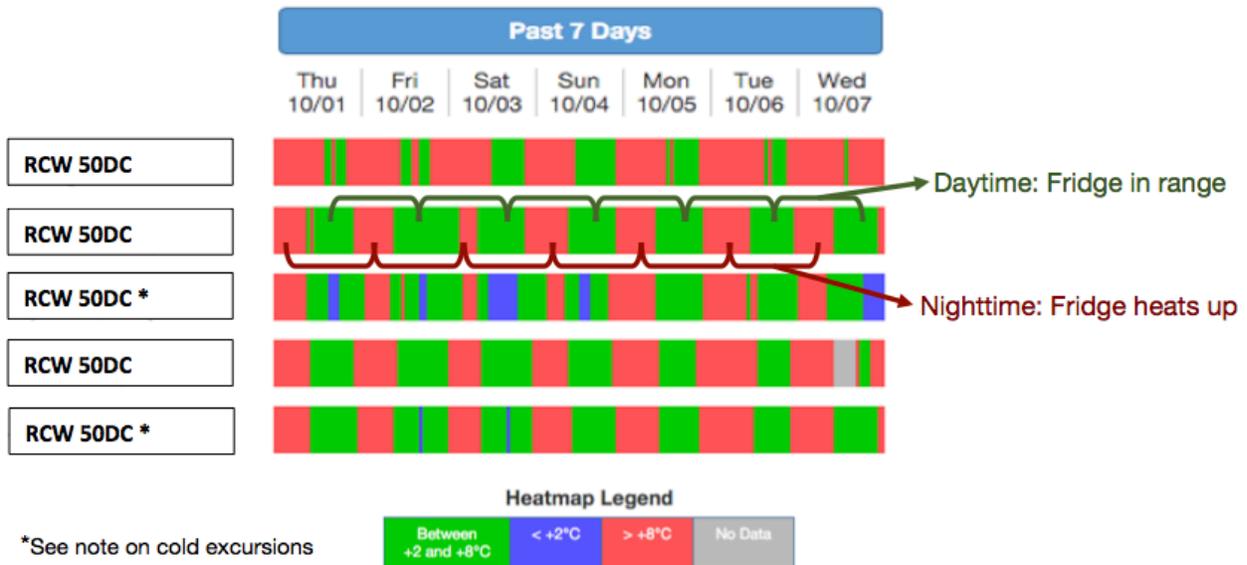
When diagnosing a RCW 50DC model solar fridge with a flat battery, a **distinctive periodic pattern of temperature excursions appeared on the weekly temperature summary** (Figure D). During the day, the compressor ran using solar power, and the fridge reached the appropriate temperature range. However, overnight the vaccines were exposed to heat excursions because the flat battery failed to store any power to keep the fridge running while the sun was down.

Figure D: Screenshot of the weekly summary visualization on the ColdTrace dashboard showing temperature excursions for several fridges with flat solar batteries. **A distinct periodic pattern of temperature excursions can be observed.**

***Note on cold excursions:** It was previously thought that a flat battery would only cause heat excursions. However, in the case of these fridges, the combination of a flat battery and an improperly adjusted thermostat caused cold excursions, which would occur when the sun was up during the day.

The technicians identified 11 facilities with Dometic RCW 50DC model solar fridges that had **flat batteries in need of replacement**. These fridges experienced unacceptable frequency and duration of temperature excursions. Unfortunately, due to lack of replacement batteries, the expert and technician could not fix this problem during the assessment. There is an **immediate need** for replacing these batteries and for monitoring fridge performance after replacement.
