BUILDING PERFORMANCE: HURRICANE ANDREW IN FLORIDA

OBSERVATIONS, RECOMMENDATIONS,
AND TECHNICAL GUIDANCE

FEDERAL EMERGENCY MANAGEMENT AGENCY
FEDERAL INSURANCE ADMINISTRATION

DECEMBER 21, 1992

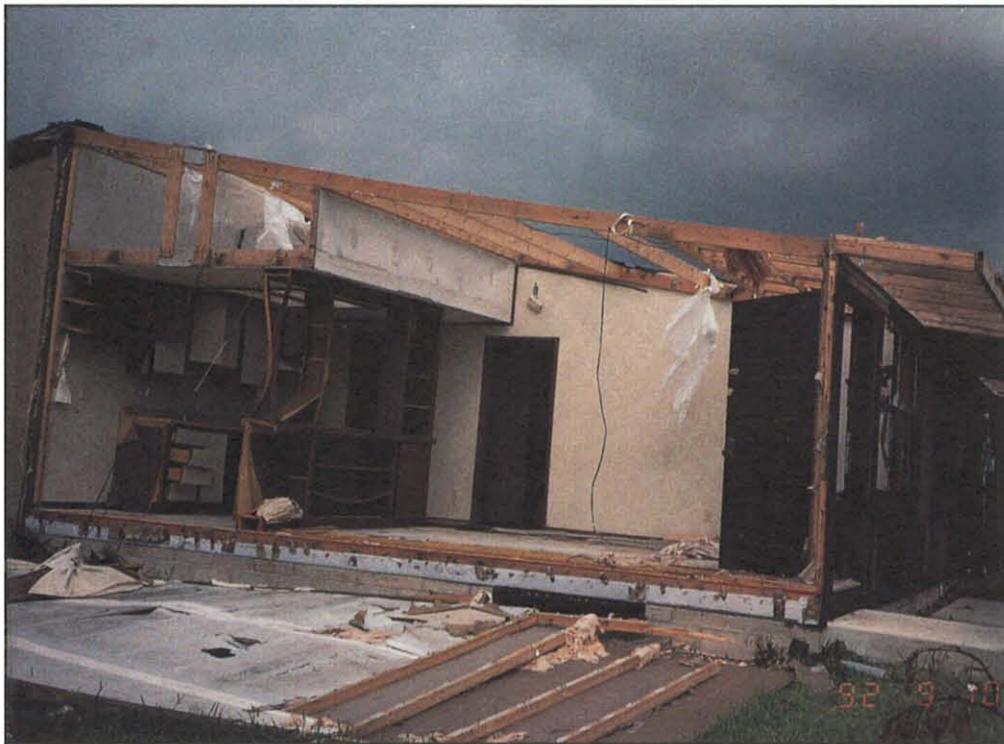
FIGURE 19. *Modular home. End wall of end unit separated from unit; withdrawal of nails along eave line and roof sheathing failure were also observed.*

Two end-wall (end wall of end modules) failures were observed in a modular home subdivision. Poor connection of the tops of the walls to the roof diaphragms was evident in these instances. Some roof sheathing was observed missing from rafters, judged to be due either to building envelope breach (window and/or door failure) or to external wind and debris. Generally, the rafters themselves were left entirely intact, because of the inherent rigidity developed by the relatively short spans and secure connections. (SEE FIGURES 19 AND 20.)

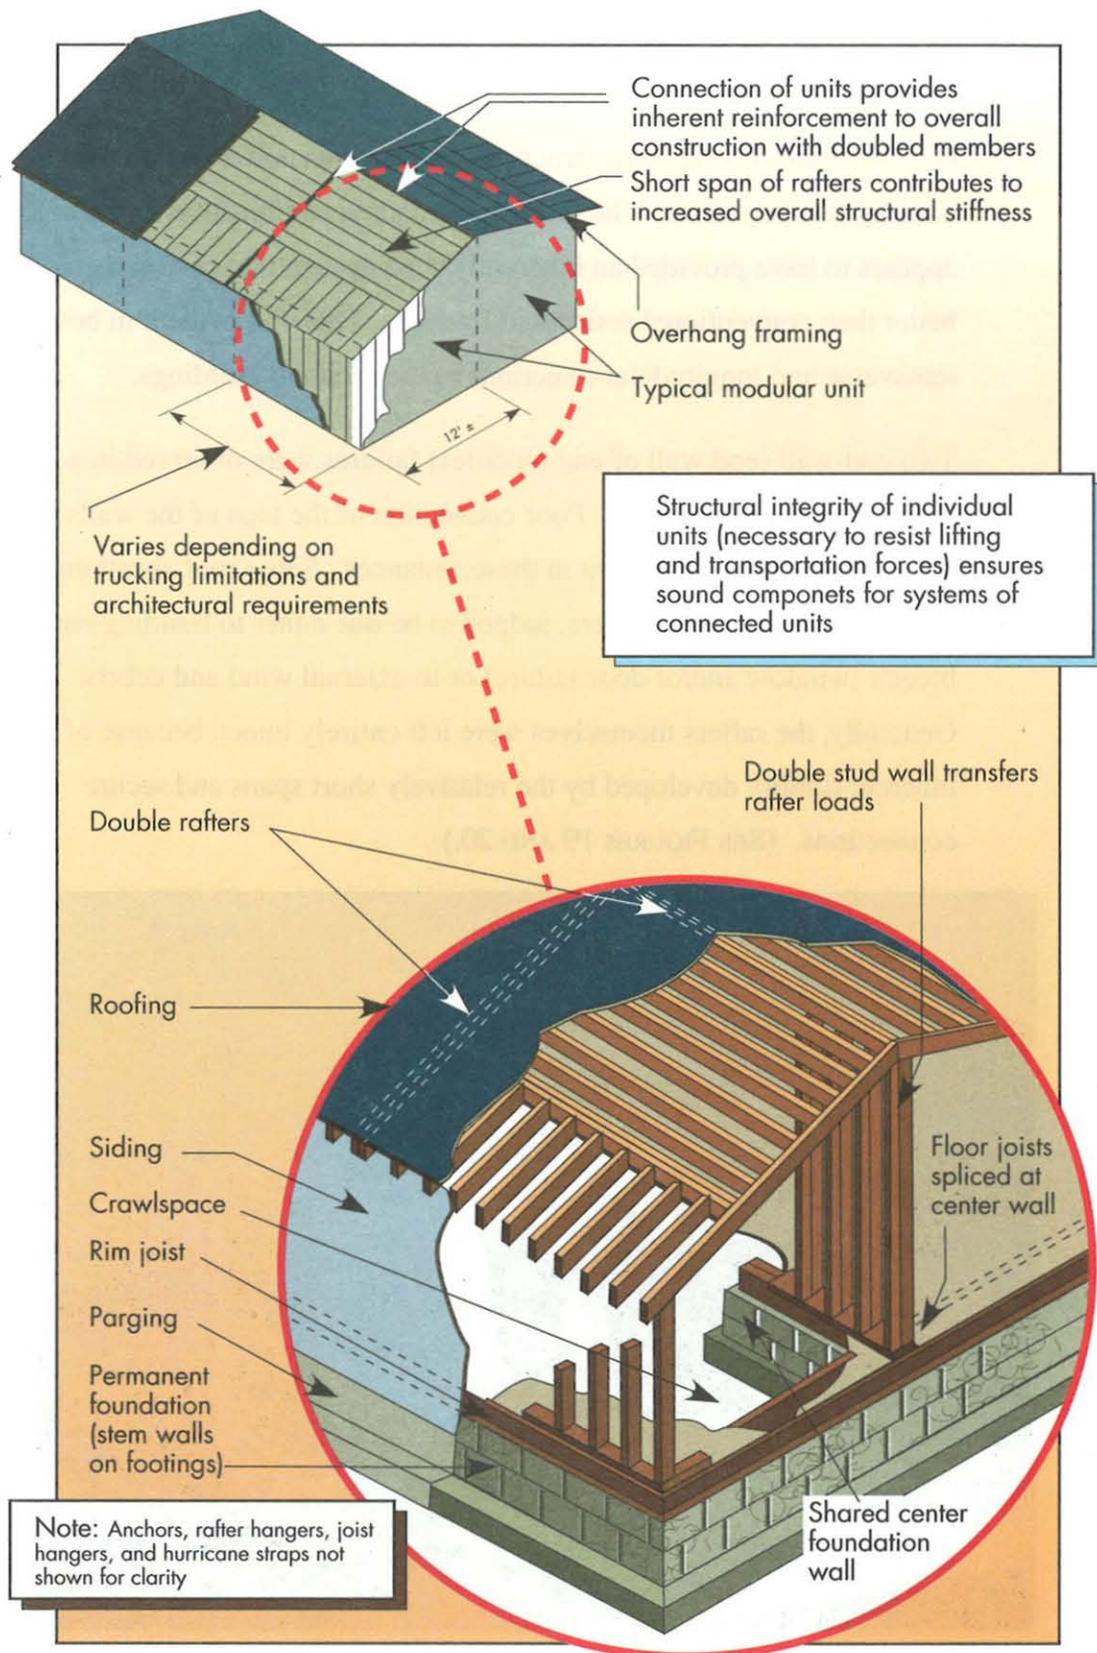
FIGURE 20. *Inherent structural strength of modular construction.*

Overall, relatively minimal structural damage was noted in modular housing developments. The module-to-module combination of the units appears to have provided an inherently rigid system that performed much better than conventional residential framing. This was evident in both the transverse and longitudinal directions of the modular buildings.
