## Basement Cargo Door Latch Replacement (pre 2000 or a bit later) -

This covers the Discovery models built before 2000 and <u>may</u> be applicable to the 2000 or even up until the 2001.5 came out (prior to August 2001).

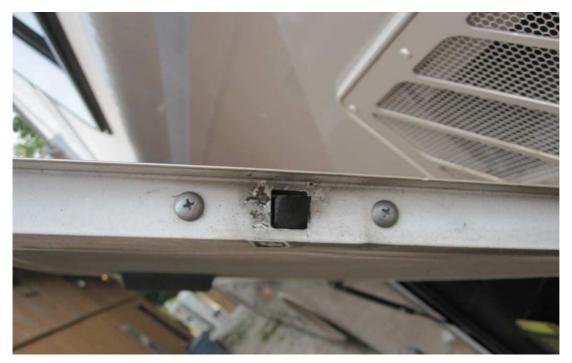
So what do you do with your broken plastic plunger inside the latch that used inside the basement / cargo door? You can either replace the entire latch or replace the plastic plunger (preferably with an aluminum plunger that will take much more abuse that the plastic one). The problem on the vintage coaches is that you can't just simply remove the latch assembly from the outside of the door.

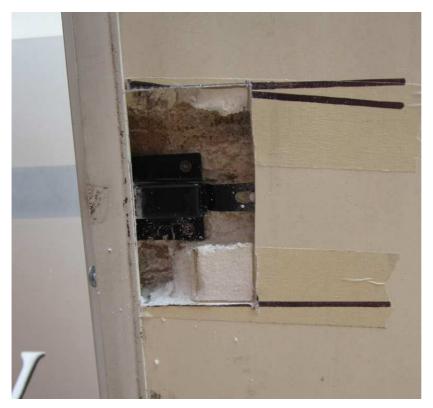
2. Saw a hole in the inside panel of the composite panel, starting where the edge of the aluminum molding stops and going towards the middle of the panel. The hole is centered over the latch, must be 4 inches tall (so that you can reach the loose (!!) nuts inside the panel and about 2 1/2 inches wide (towards the lock in the center). See the pictures. I used an oscillating multi-purpose tool which does a very clean job. A Dremel-tool with saw blade will do it too. Just remember, the latch is immediately

behind the inside panel so don't try to go too deep. The inside panel is only 1/16" thick.

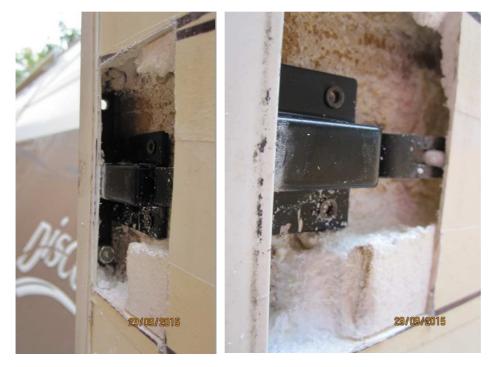
3. Using a 1/4 inch socket set with u-joint and 5/16 socket hold the nuts inside the panel so that you can unscrew them with a Philips head screw driver from the outside. Don't lose the nuts, you will need them in reassembly.

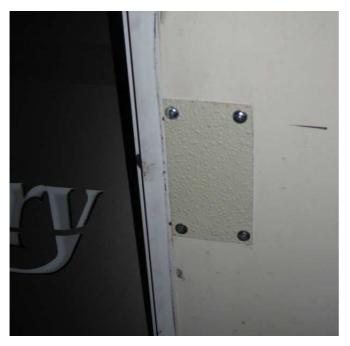
7. Cover the hole we made with a suitable cover (about 5 by 3 inches is enough and Bruce Plumb can supply these covers as well). Hope this helps some of you with the older models (as is mine). Each latch is about a 30 minute job. It is easy if you are a bit handy with tools. Anyone can feel free to copy these instructions and photos for any use.
