# RSH ENGINEERING, INC.

**PRE-POUR # 1 INSPECTION REPORT**

**INSP#: F08428**

**Address: 1234 Anywhere St. Anywhere, TX**

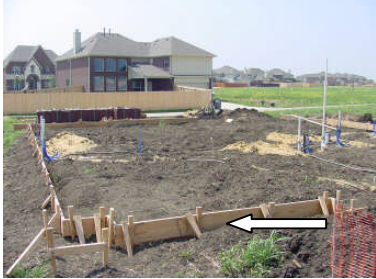
<b>LEFT SIDE OF HOUSE THIS FORM IS BOWED/CUPPED UPWARD IN THE MIDDLE – RECOMMEND REPLACEMENT OF THE FORMS.</b>	3

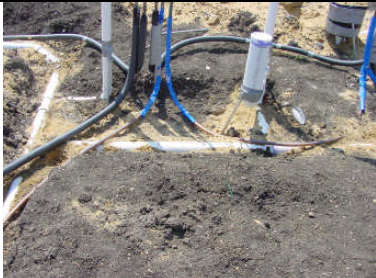
<b>DRAIN PIPE IS NOT PROPERLY SUPPORTED BY SAND: <u>P2604.1 TRENCHING AND BEDDING.</u> <u>PIPING SHALL BE INSTALLED IN TRENCHES SO THAT THE PIPING RESTS ON SOLID AND CONTINUOUS BEARING.</u> <u>WHEN OVER EXCAVATED, THE TRENCH SHALL BE BACKFILLED TO THE PROPER GRADE WITH COMPACTED EARTH, SAND, FINE GRAVEL OR SIMILAR GRANULAR MATERIAL. PIPING SHALL NOT BE SUPPORTED ON ROCKS OR BLOCKS AT ANY POINT. ROCKY OR UNSTABLE SOIL SHALL BE OVER EXCAVATED BY TWO OR MORE PIPE DIAMETERS AND BROUGHT TO THE PROPER GRADE WITH SUITABLE COMPACTED GRANULAR MATERIAL.</u></b>	7

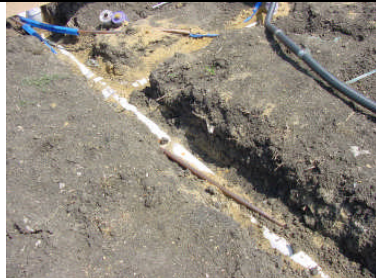
<b>SEE NOTES UNDER PIC. # 6 SUPPLY AND DRAIN PIPE IN SAME TRENCH: <u>P2904.4.1 WATER SERVICE INSTALLATION.</u> TRENCHING, PIPE INSTALLATION AND BACKFILLING SHALL BE IN ACCORDANCE WITH SECTION P2604. (SEE NOTES UNDER PIC. # 6)  WATER-SERVICE PIPE IS PERMITTED TO BE LOCATED IN THE SAME TRENCH WITH A BUILDING SEWER PROVIDED SUCH SEWER IS CONSTRUCTED OF MATERIALS LISTED FOR UNDERGROUND USE WITHIN A BUILDING IN SECTION P3002.1. (SEE PAGE # 4 FOR ACCEPTABLE MATERIALS INCLUDING PIPE AND FITTING MATERIALS INCLUDING SOLVENT CEMENT AND PRIMER SPECIFICATIONS)  IF THE BUILDING SEWER IS NOT CONSTRUCTED OF MATERIALS LISTED IN <u>SECTION P3002.1 (PG. #</u> <u>4)</u>, THE WATER-SERVICE PIPE SHALL BE SEPARATED FROM THE BUILDING SEWER BY A MINIMUM OF 5 FEET (1524 MM), MEASURED HORIZONTALLY, OF UNDISTURBED OR COMPACTED EARTH OR PLACED ON A SOLID LEDGE AT LEAST 12 INCHES (305 MM) ABOVE AND TO ONE SIDE OF THE HIGHEST POINT IN THE SEWER LINE.</b>	8

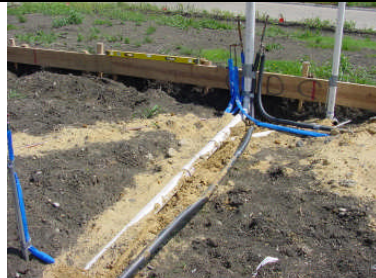
<b>DRAIN PIPE IS NOT PROPERLY SUPPORTED BY SAND: SEE NOTES UNDER PIC. # 6</b>
