**NYSDEC
Division of Water**

**A Primer on Aquatic Plant Management
in New York State**

April 2005

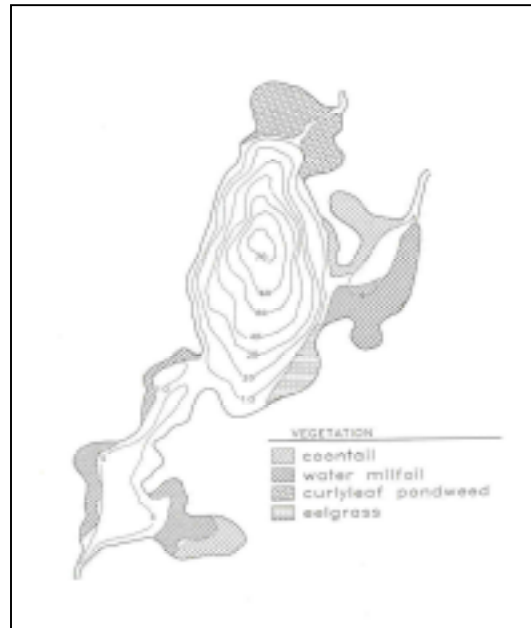
In lieu of an extensive macrophyte survey, individuals and lake associations can map the extent of vegetation coverage over the course of the year, usually during late spring to early summer and again in the fall. This can be done through aerial photography, or from on-site inspection by lake residents (preferably those who can view the lake from their rooftops!). The most common maps indicate the major plant species in each part of the lake, with little differentiation between thick beds and scattered plants. These can be seen in the figure on the right.

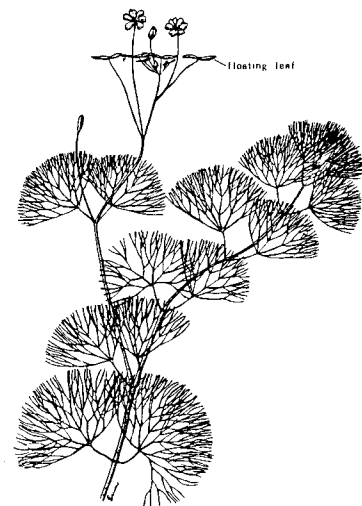
4. Fanwort (*Cabomba caroliniana*) is native to the southern states but not native to New York State or the northeastern states. It has historically been limited to Long Island (although the first sightings in New York State may have occurred in Orange County in the early 1930s), where it grows primarily in shallow water, as in most other New England states. However, in recent years it has been found in deepwaters of the isolated lakes in the southeastern Adirondacks and on both sides of the Lower Hudson River basin. It has thread-like leaves that fan out on opposite sides of the stem; while it has white or pink flowers, these rarely appear in fanwort in New York state lakes. It spreads by seeds, not by fragmentation or other asexual means. Fanwort control is mostly limited to Long Island.
