FACILITY CONDITION ASSESSMENT

Bernardo Elementary School
1122 Mountain Heights Drive
Escondido, California 92025

164076.23R000-002.017

August 17, 2023

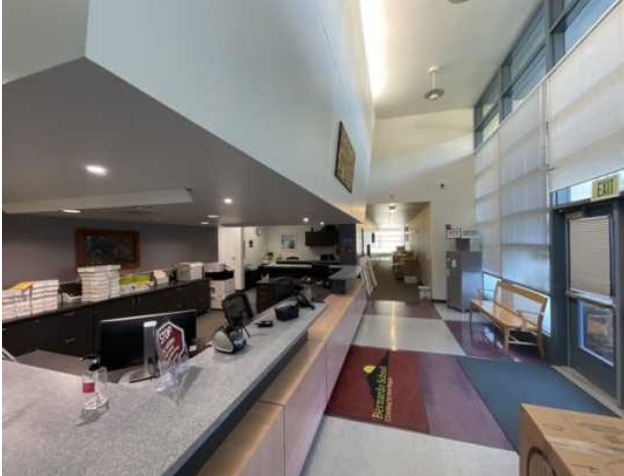
13 - ADMINISTRATIVE - FRONT DESK

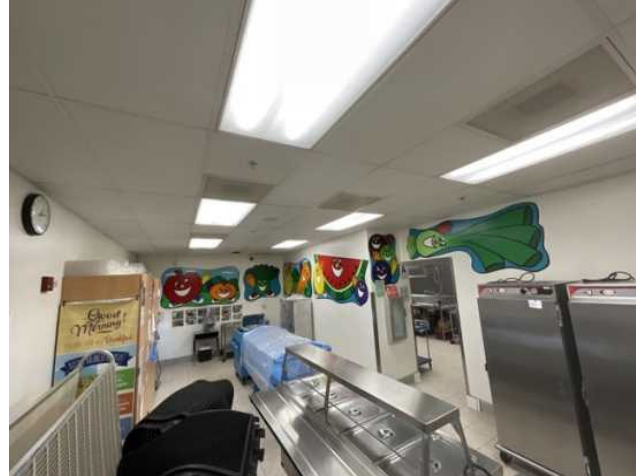
14 - CAFETERIA SERVICE ROOM

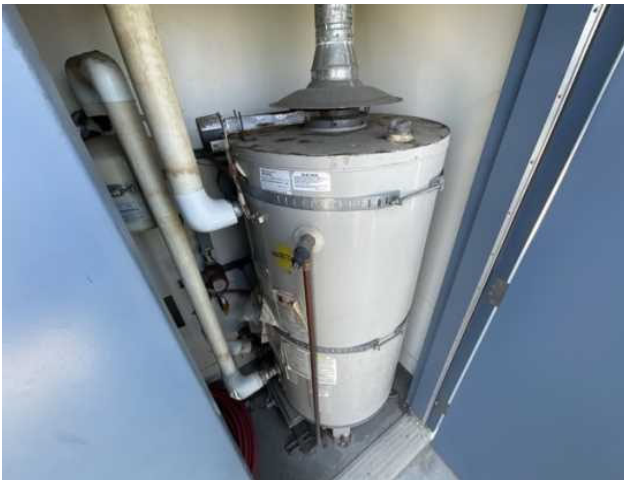
15 - GAS WATER HEATER

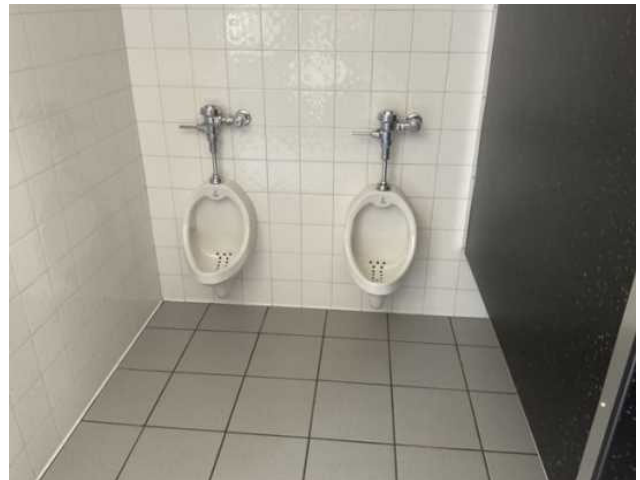
16 - URINALS

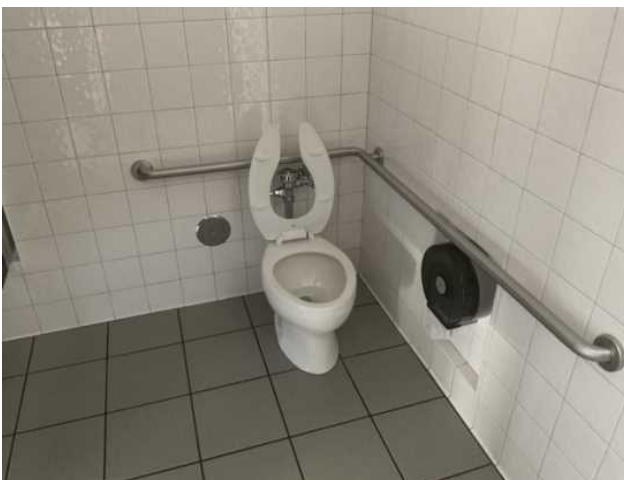
17 - COMMERCIAL TOILET

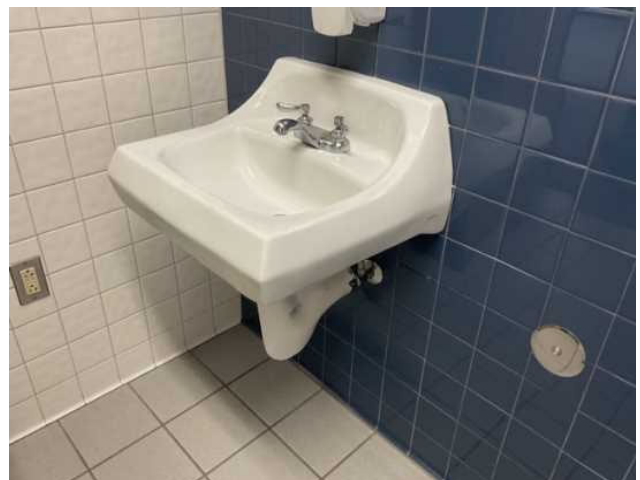
18 - WALL-HUNG SINK

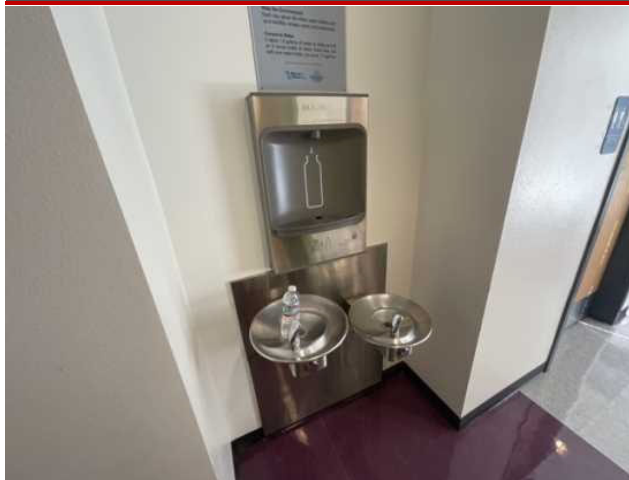
19 - DRINKING FOUNTAIN

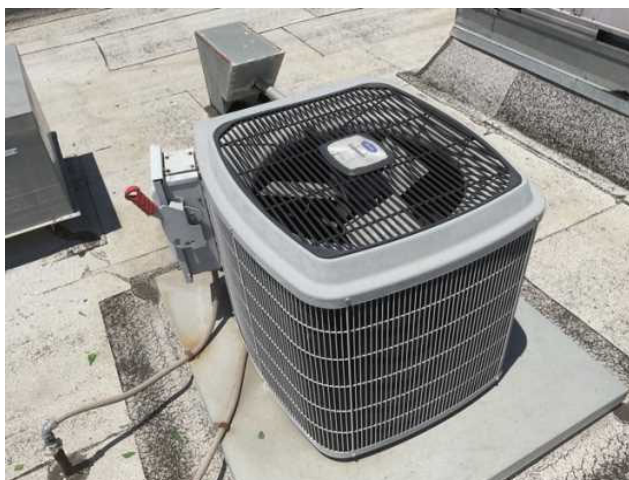
21 - SPLIT SYSTEM CONDENSING UNIT

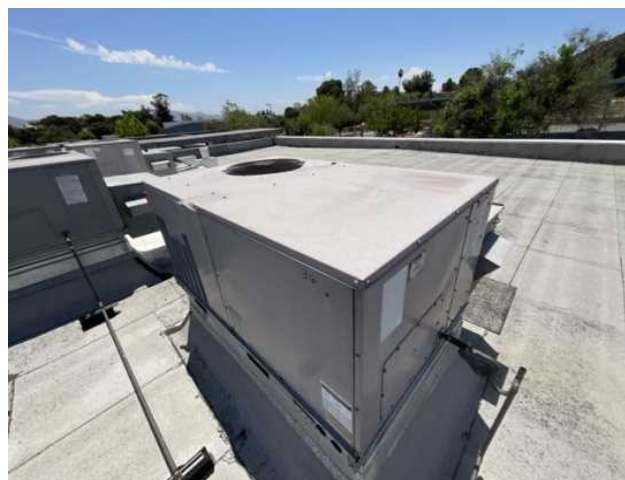
22 - PACKAGED UNIT

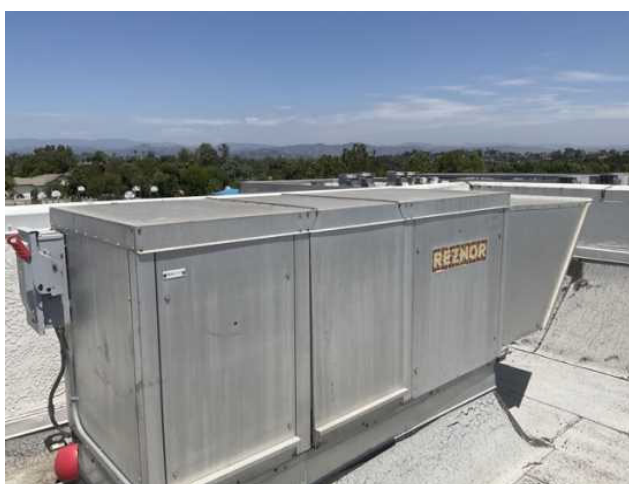
23 - MAKE-UP AIR UNIT

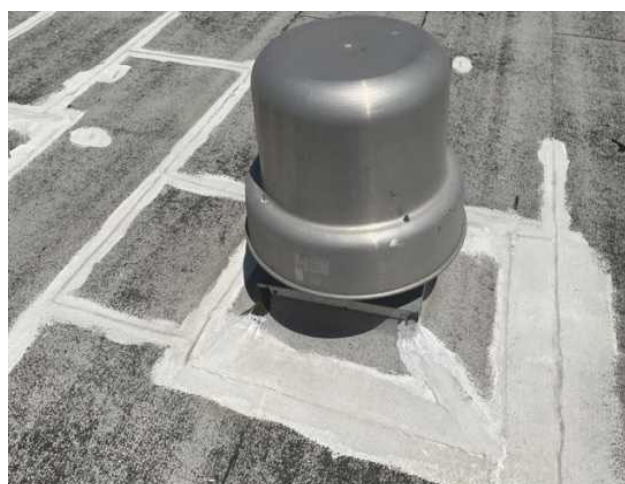
24 - EXHAUST FAN

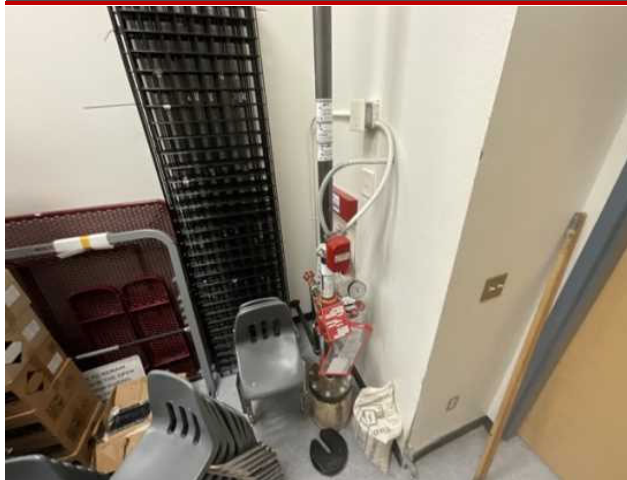
25 - FIRE SUPPRESSION SYSTEM

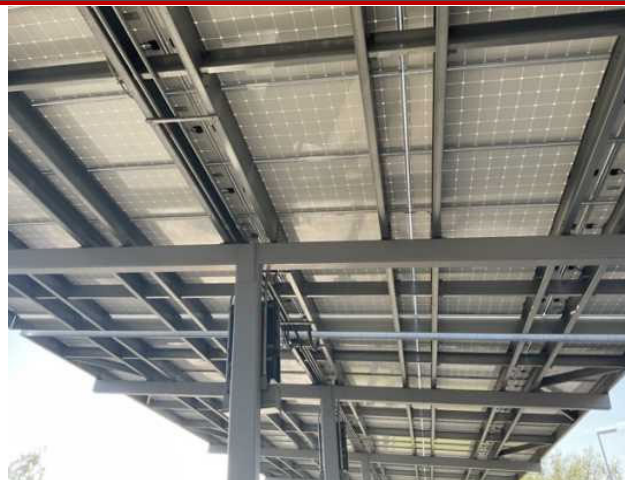
26 - SOLAR ARRAYS

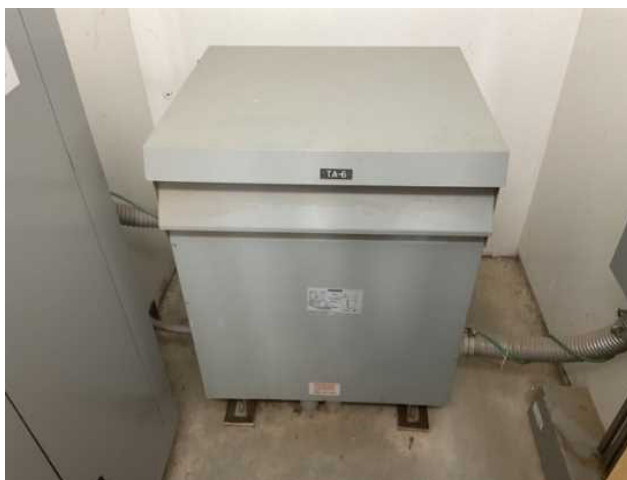
27 - SECONDARY TRANSFORMER

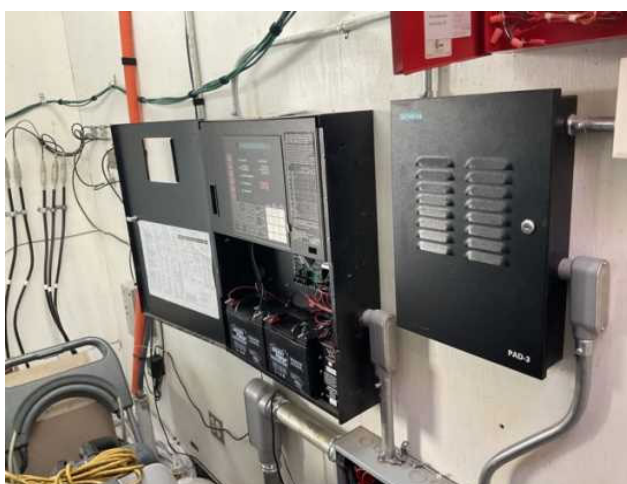
29 - FIRE ALARM PANEL

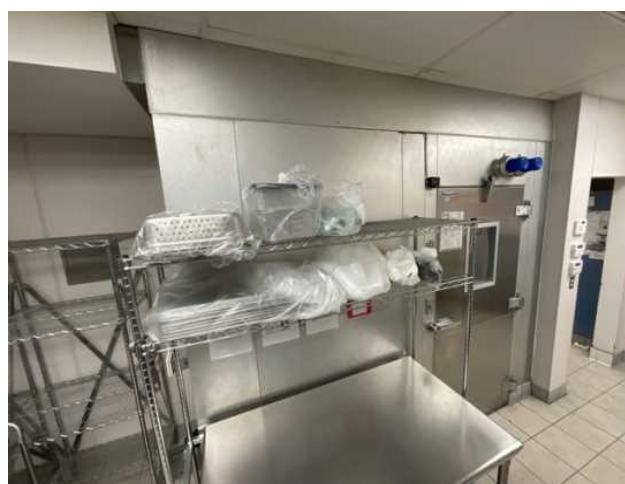
30 - WALK-IN REFRIGERATOR

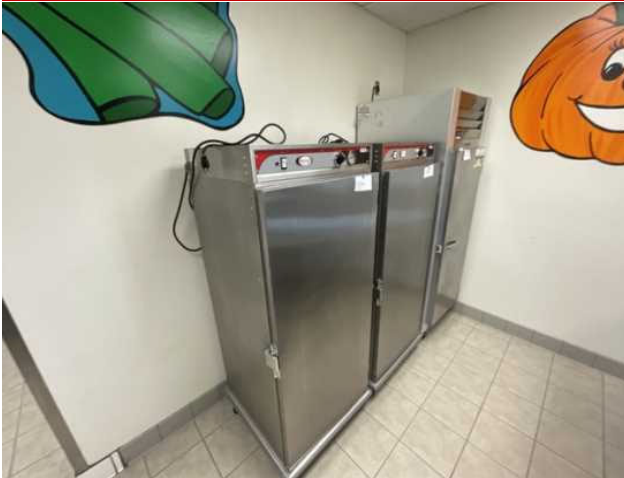
31 - KITCHEN FOOD HOLDING EQUIPMENT

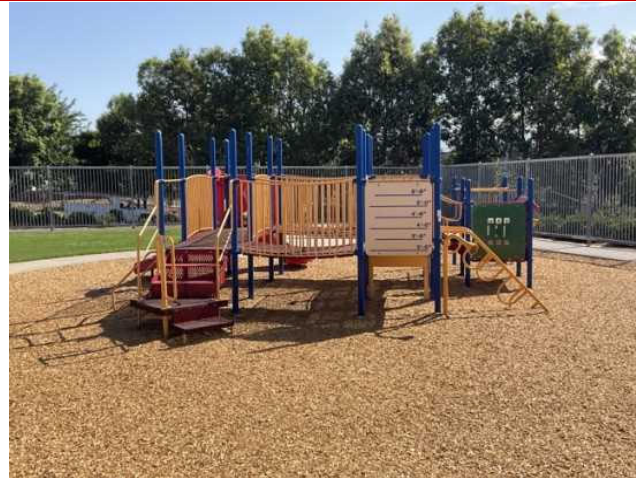
32 - PLAY STRUCTURE

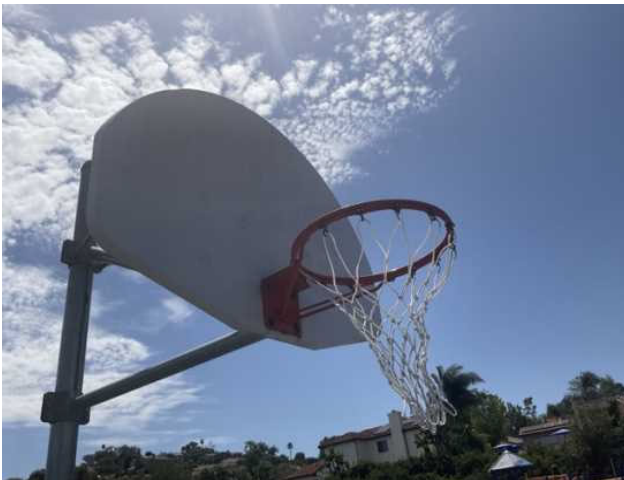
33 - BASKETBALL BACKBOARD

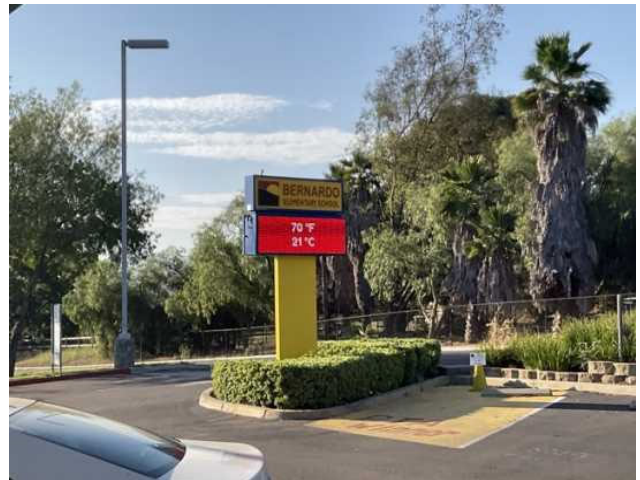
34 - ELECTRONIC ROBUST SIGNAGE

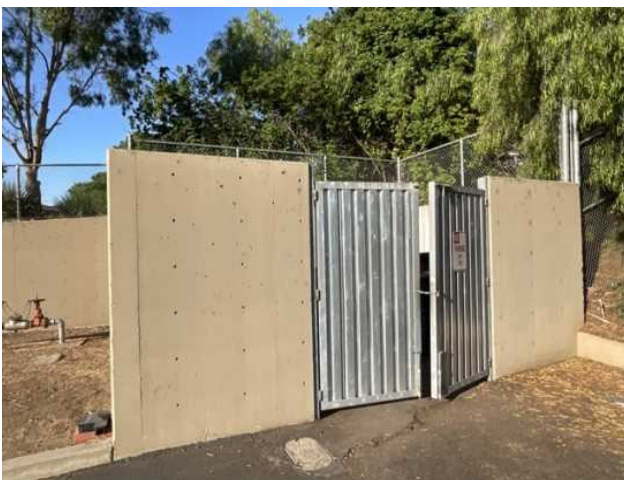
35 - CMU DUMPSTER ENCLOSURE

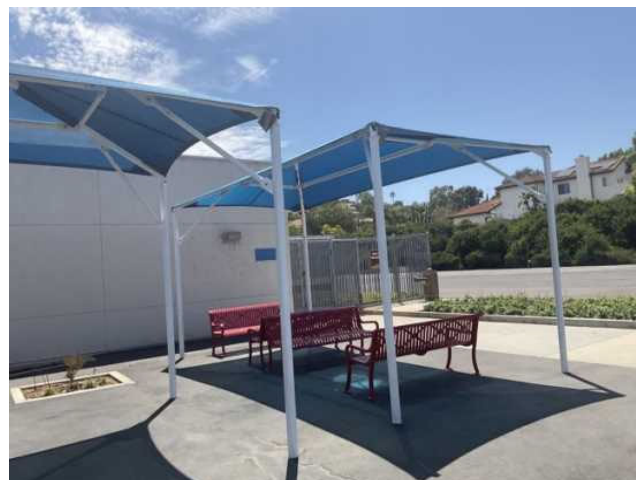
36 - METAL SHADE STRUCTURE
