FACILITY CONDITION ASSESSMENT

Hidden Valley Middle School
2700 Reed Road
Escondido, California 92025

September 13, 2023

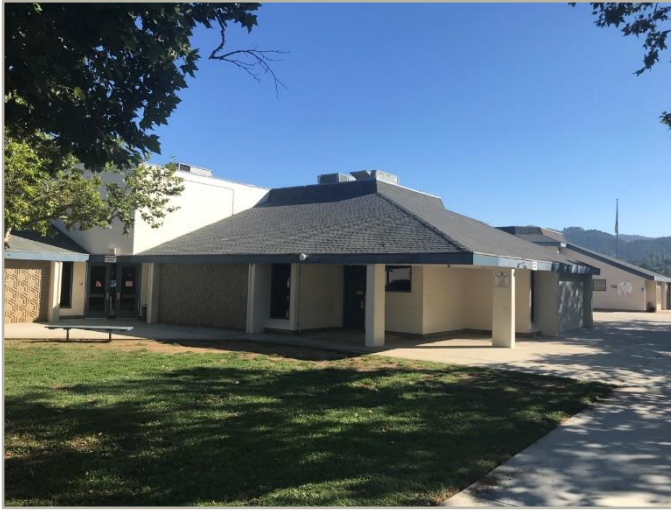
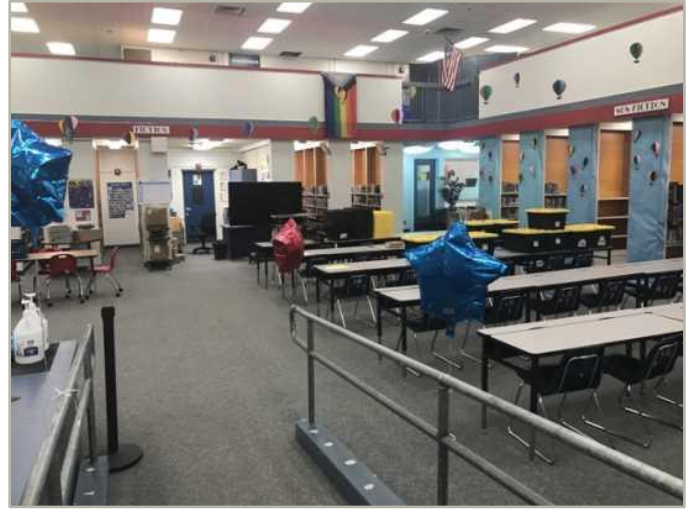
2. Building A

Building A: Systems Summary		
Electrical	Source & Distribution: Main panel with copper Interior Lighting: Linear fluorescent Emergency Power: None	Fair
Fire Alarm	Alarm panel with smoke detectors, alarms, strobes, pull stations, and exit signs	Fair
Equipment/Special	Commercial kitchen equipment	Fair
Accessibility	Presently it does not appear an accessibility study is needed for this building. See Appendix D.	
Additional Studies	No additional studies are recommended for this building at this time.	
Key Issues and Findings	Exterior windows, some antiquated HVAC components

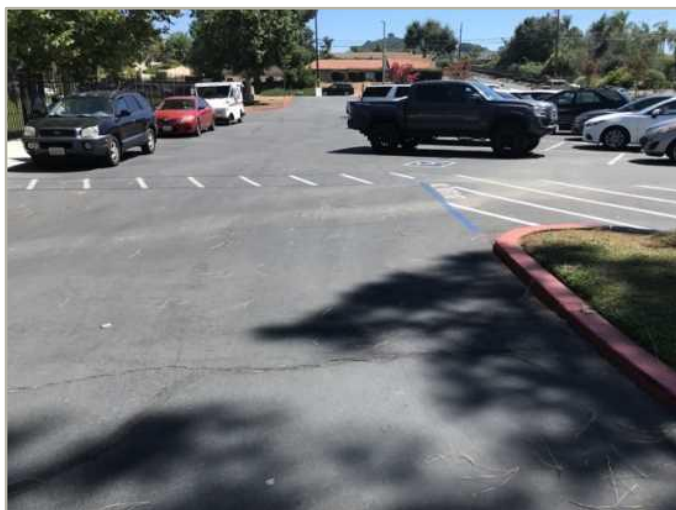
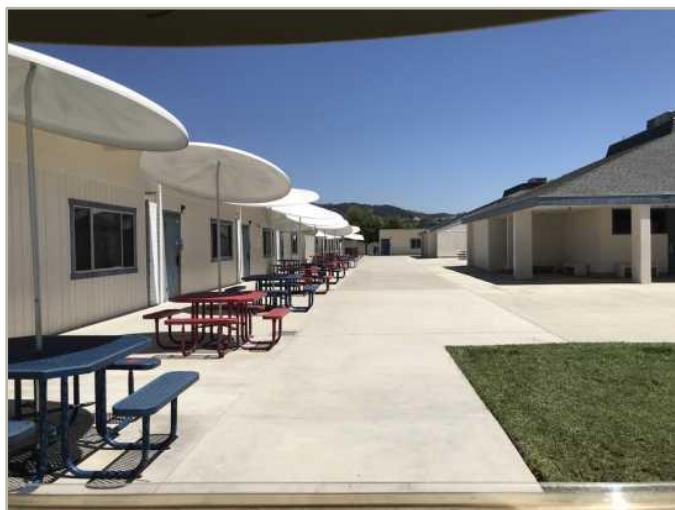
8. Site Summary

Additional Studies	No additional studies are recommended for the general site at this time.	
Key Issues and Findings	Tennis and basketball courts pavements, and sidewalk repair

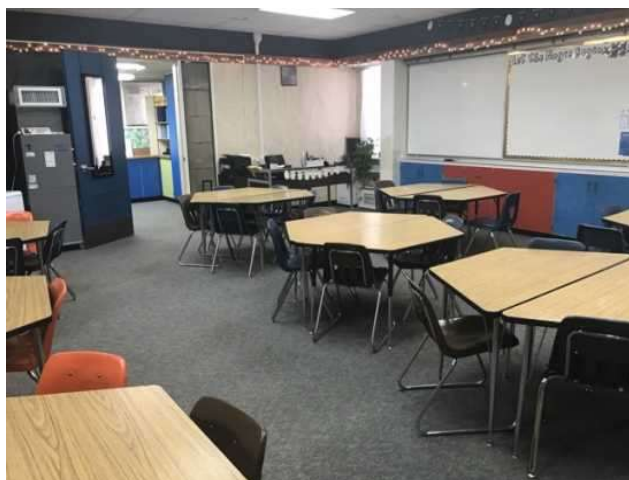
27 - CLASSROOM

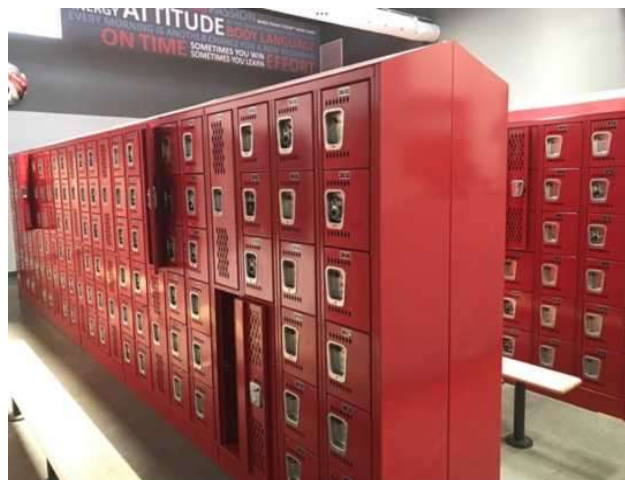
28 - LOCKERS

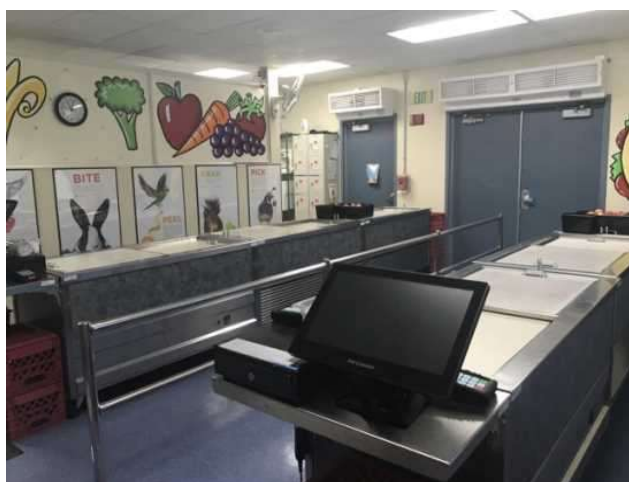
29 - COMMERCIAL KITCHEN

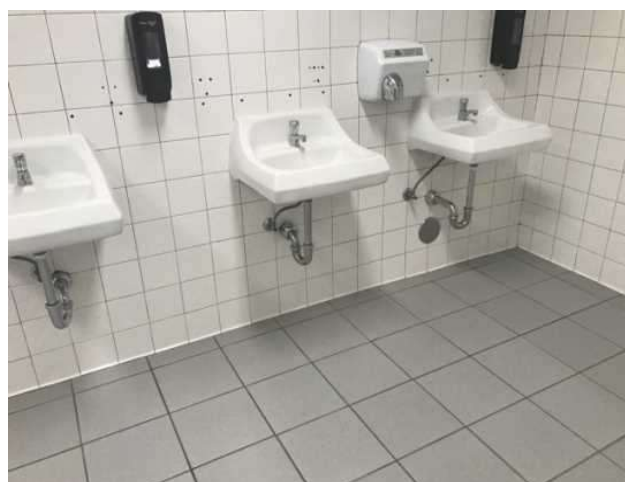
30 - SINK, FAUCET HANDLES AND ACCESSORIES

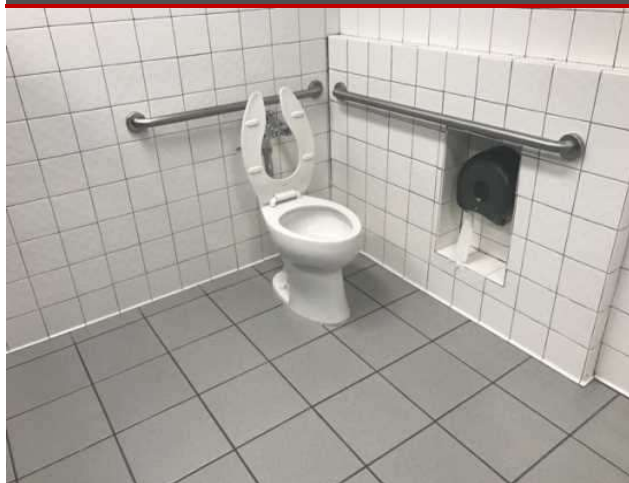
31 - TOILET

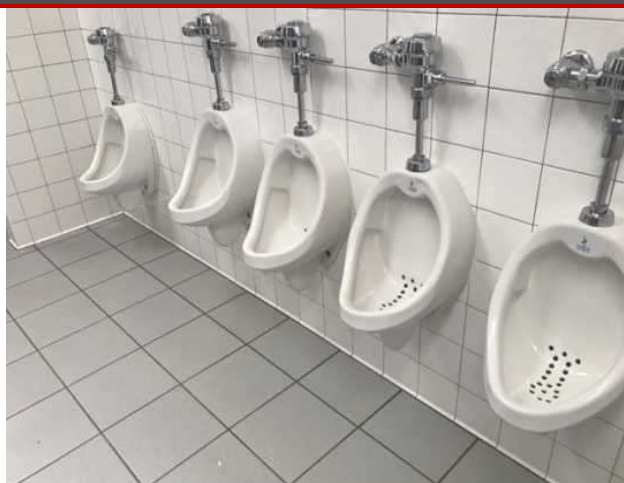
32 - URINALS

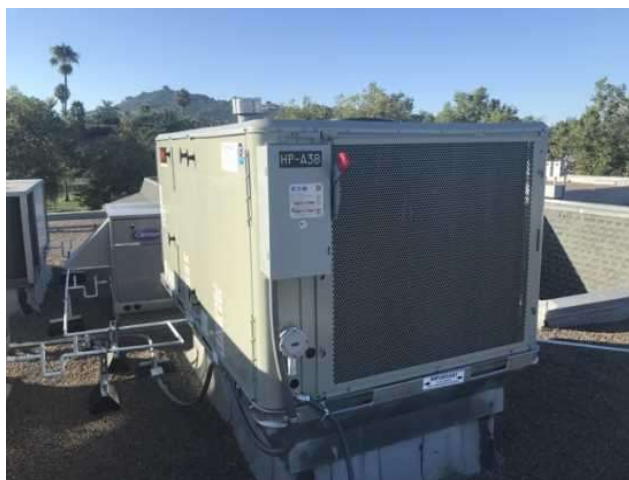
33 - PACKAGED UNIT

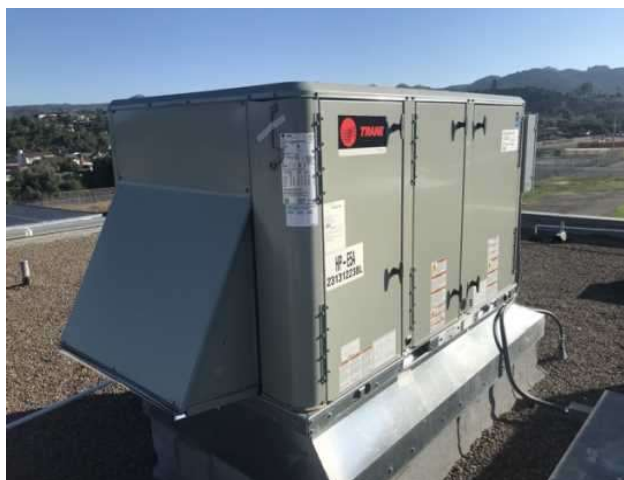
34 - PACKAGED UNIT

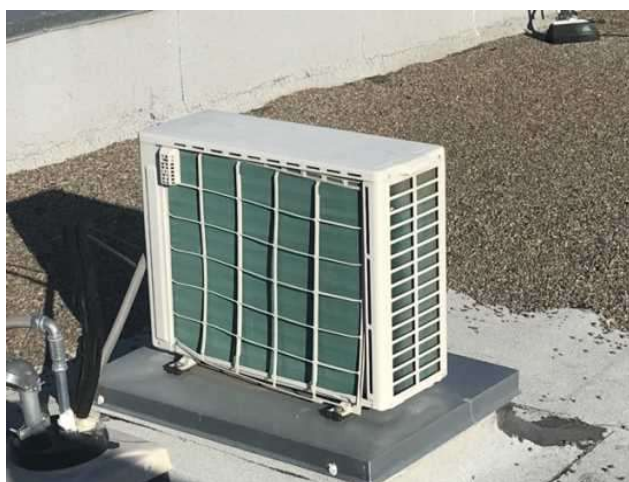
35 - SPLIT SYSTEM DUCTLESS

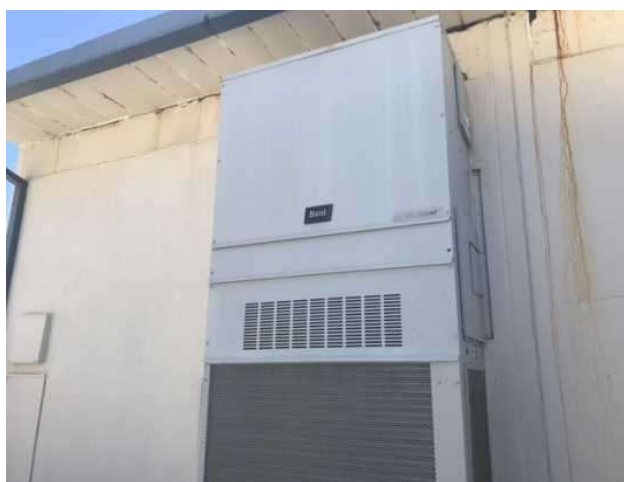
36 - HEAT PUMP

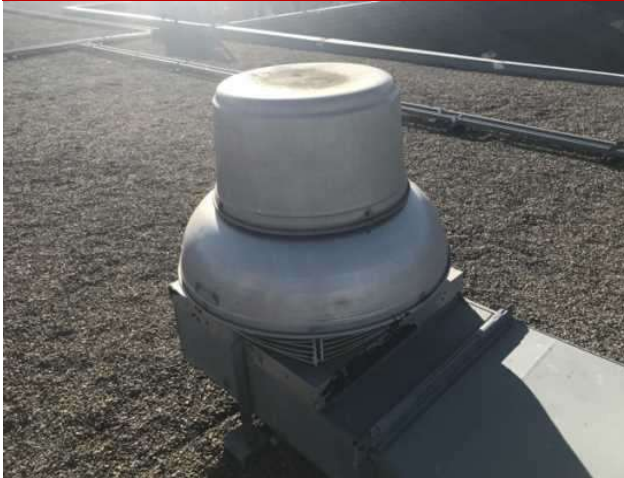
37 - EXHAUST FAN

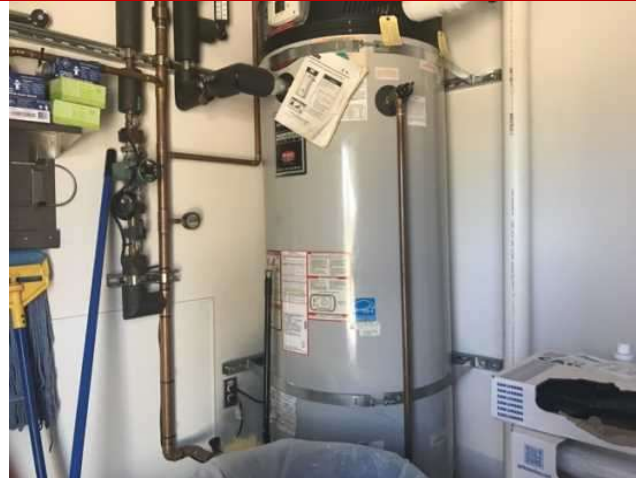
38 - WATER HEATER

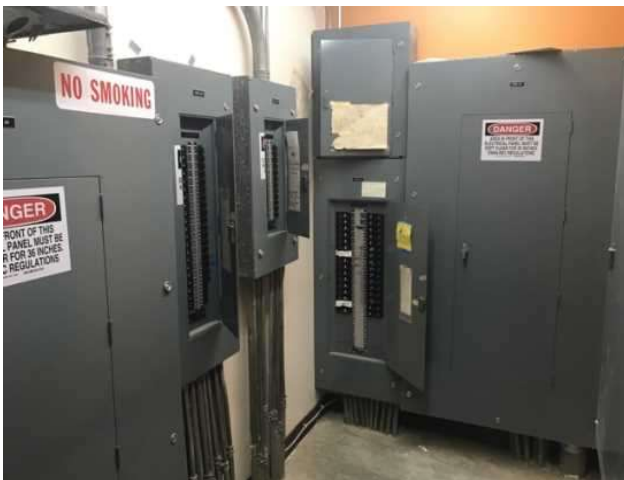
39 - ELECTRICAL SYSTEM

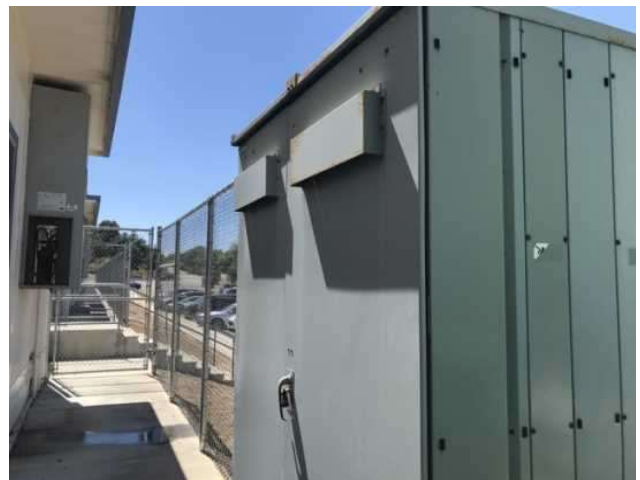
40 - SWITCHBOARD

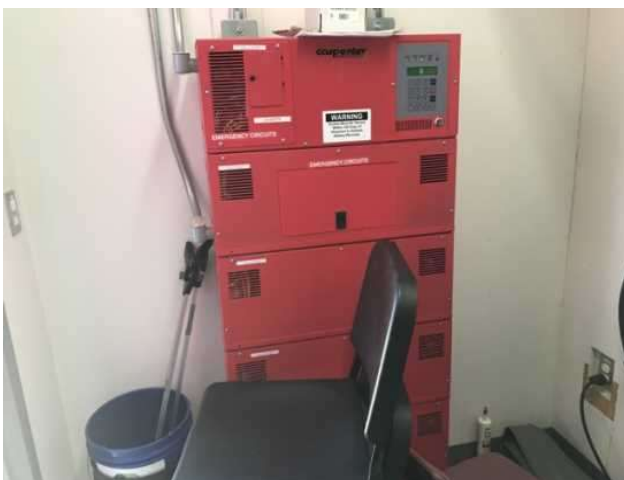
41 - UNINTERRUPTIBLE POWER SUPPLY

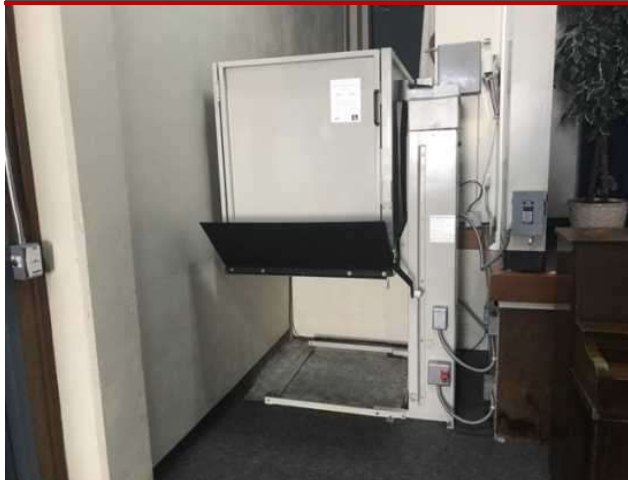
43 - VERTICAL LIFT

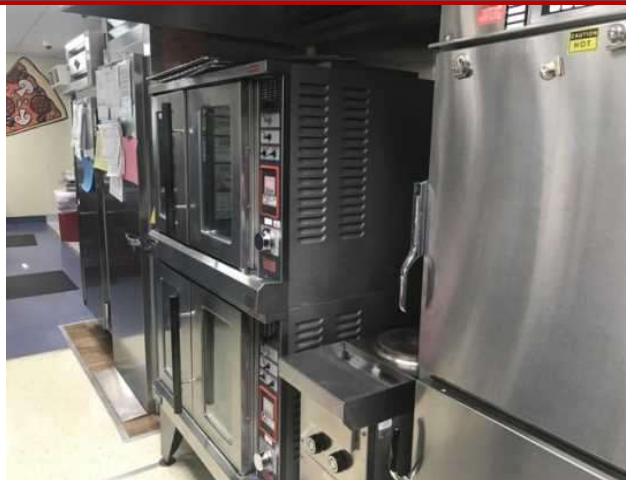
44 - FOODSERVICE EQUIPMENT

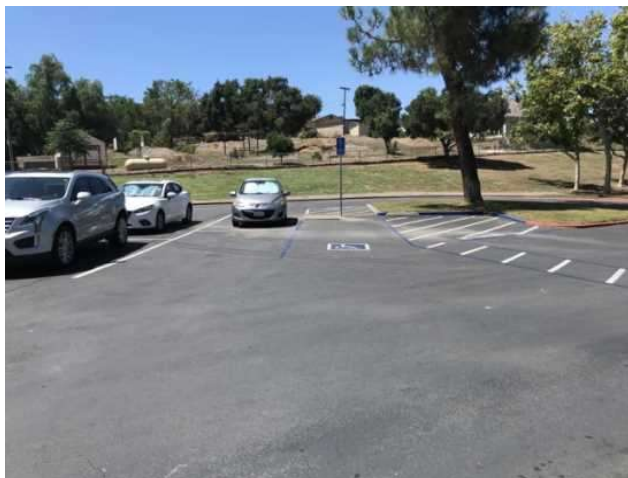
45 - PARKING LOTS

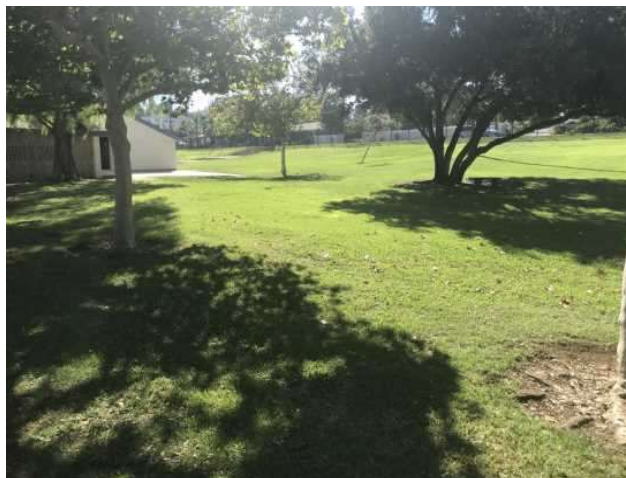
46 - LANDSCAPING

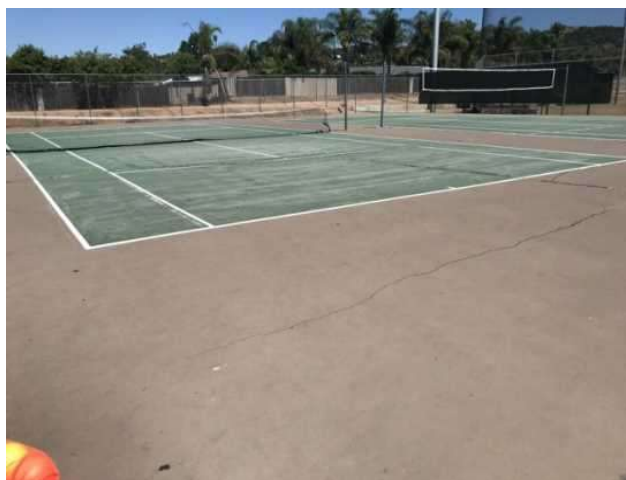
48 - TENNIS COURTS
